**In Place Rehabilitation of Pipes Using Polymer Composites**

FINAL REPORT  
December 2010

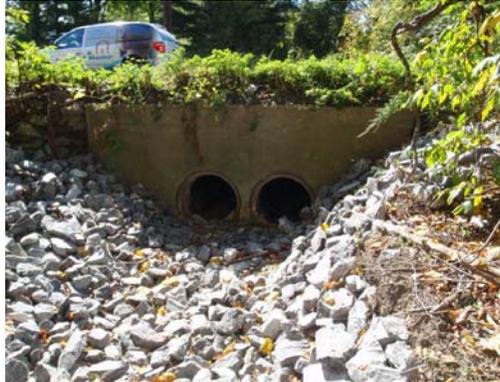
Pictures of the two culverts are shown in Figures 2, 3 and 4. The pipes were built in 2-foot segments and there were some misalignments between the segments due to settlement. The site was selected because: (a) the structure was easily accessible on both ends; (b) the length is reasonable, (c) traffic safety is not needed and (d) space is available next to the site for preparation of rehabilitation materials.

Figure 2. Clay pipe culvert: view of inlet side

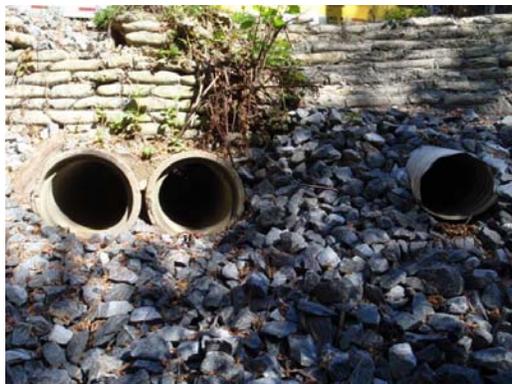
Figure 3. Clay pipe culvert: view of outlet side

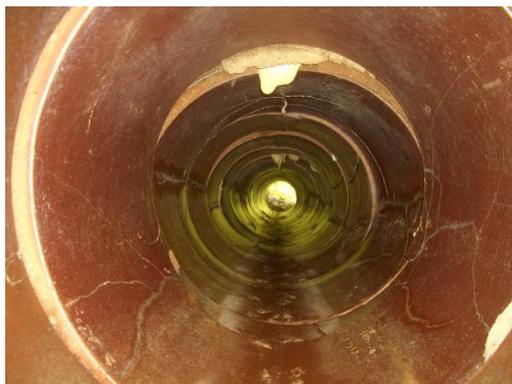
Figure 4. Clay pipe culvert: view of interior

The pipes were in reasonable condition. The joints between the pipes were deteriorated, and in certain locations, the joints had become misaligned due to settlement. This misalignment created gaps in the joints.

Additionally, there were three locations where the pipes were broken. The primary weaknesses, therefore, were the misaligned joints, the broken pipe segments and the joint between the clay pipe and the end concrete pipe.

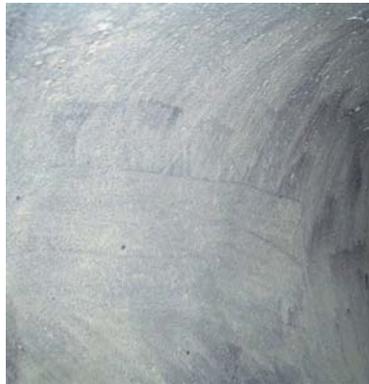
- (b) The second and more economical option was to use the composites with discrete or short fibers. For this system, 0.25 inch carbon fibers were mixed with an inorganic matrix, at a fiber loading of 1% by weight. This system provides a thin coating that can follow the contours of the pipe including the locations where the pipes were broken. A clay flower pot that was composed of material similar to the pipes in the field was coated in the laboratory. The coating adhered to the surface well and provided a continuous coated surface as shown in Figure 5.

Figure 5. Clay surface coated with inorganic polymer composite

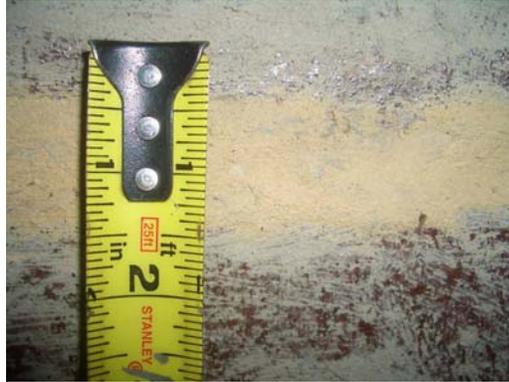
The repairs performed very well in terms of both adhesion and shrinkage free repair. Pictures taken after one year are shown in Figures 6 through 9. Figures 6 and 7 shows the repair of smaller gaps and Figure 8 shows a repair of a cracked corner of the pipe. Repair of a larger gap developed by settlement is shown in Figure 9.

Figure 6. Repair of a small gap caused by pipe settlement

1. Prepare a dry Portland cement mortar mix using a cement to mortar sand ratio of 1 to 2. Consider this as Mix 1.
2. Prepare Mix 2 by combining equal parts of Mix 1 and Quickrete set mortar.
3. Add 0.25 inch long carbon fibers to Mix 2 at the rate of 2% by weight to prepare the final dry mix.
4. Add water at the rate of 20% by total weight. The wet-mix should be of a very stiff consistency so that it can be applied to vertical and overhead pipe surfaces.
5. In the field, prepare only enough wet-mix that can be used within two hours of repair work.
6. Wet-mix can be prepared using a mortar mixer or by hand.

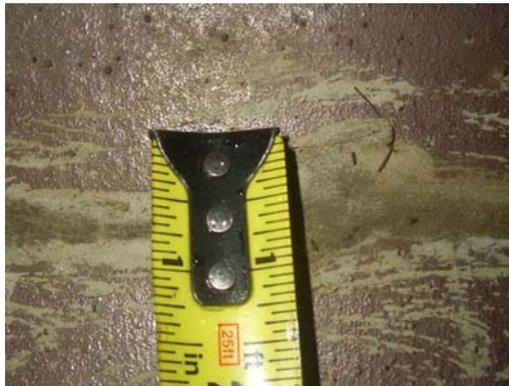
Figure 7. Repair of a winding small gap caused by pipe settlement

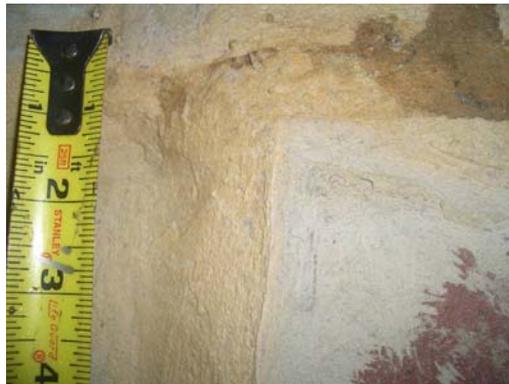
Figure 8. Repair of a cracked corner gap caused by pipe settlement

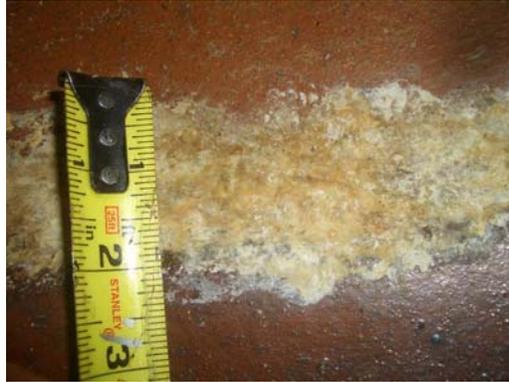
Figure 9. Repair of larger gap caused by pipe settlement

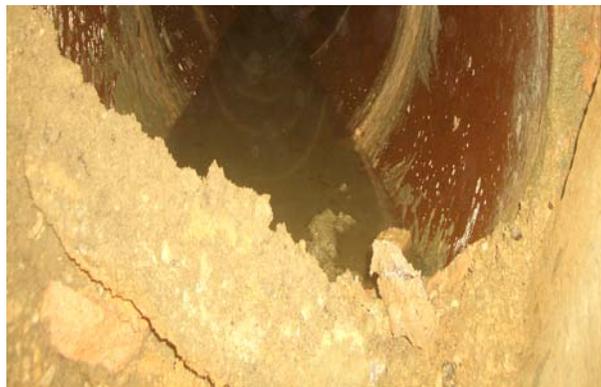
During late September 2009, there was local utility relocation construction work that was conducted perpendicular and above the twin pipe culverts. This utility relocation construction work resulted in a cave in of the twin pipe culverts, resulting in the pipes filling up with soil and other construction debris, as shown in Figure 10.

Figure 10. Damage caused to culvert by utility relocation work

Although Gloucester County water jetted the pipes clean within weeks of the cave-in, the research team couldn't apply the inorganic polymer coating because of the cold temperatures and wet conditions during the late fall of 2009.
