# ELEVATED TEMPERATURE PROPERTIES OF A588 WEATHERING STEEL

FINAL REPORT

January 2014

New Jersey Department of Transportation

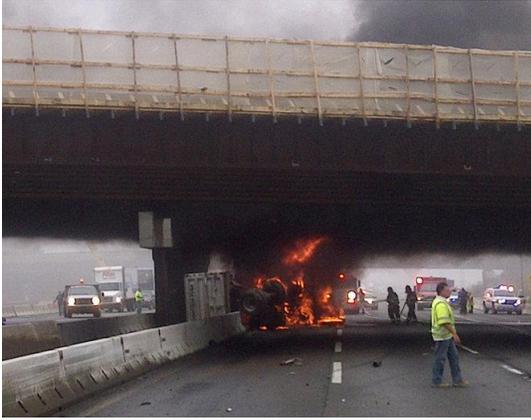
**Figure 1.** October 3, 2012 bridge fire, NJ Turnpike.

The motivating event for this work was a bridge fire that occurred on October 3, 2012. A dump truck traveling south on the NJ Turnpike crashed and caught fire under a bridge that carries I-195 over the Turnpike (Figure 1). This bridge was being widened and had timber shielding beneath it, which provided some protection for the steel from the intense heat of the fire. It was decided to not pursue any repairs since the bridge that was subject to fire was scheduled to be demolished in a few weeks and an adjacent replacement bridge was nearly complete. Instead, one of the I-195 west bound lanes was closed for precaution. This lane was reopened about a week later after a load test, with dump trucks, indicated that the fire-affected bridge had significant load capacity. [CAIT newsletter Jan. 2013].

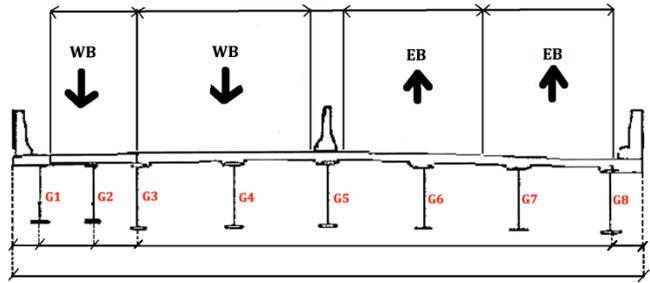
**Figure 2.** Cross-section of I-195 bridge.

The cross-section of the bridge is as shown in Figure 2. Girders G3 through G8 were part of the original bridge and made of A588 weathering steel Grade 50 [NJDOT 2010]. Girders G1 and G2 are the expansion to the bridge and based on the construction drawings they are of A709 Grade 50 (not weathering steel). The fire developed under G1, G2, and G3. This project examines the two types of steel that comprised this bridge. A588 weathering steel is the main focus of this study, and it is compared to another type of steel (which based on ASTM specifications can be classified as an older type of weathering steel (A242), A709, or A992) is examined as well. It was not possible to obtain the material of the actual I-195 bridge itself, so other material was procured as described in later sections.

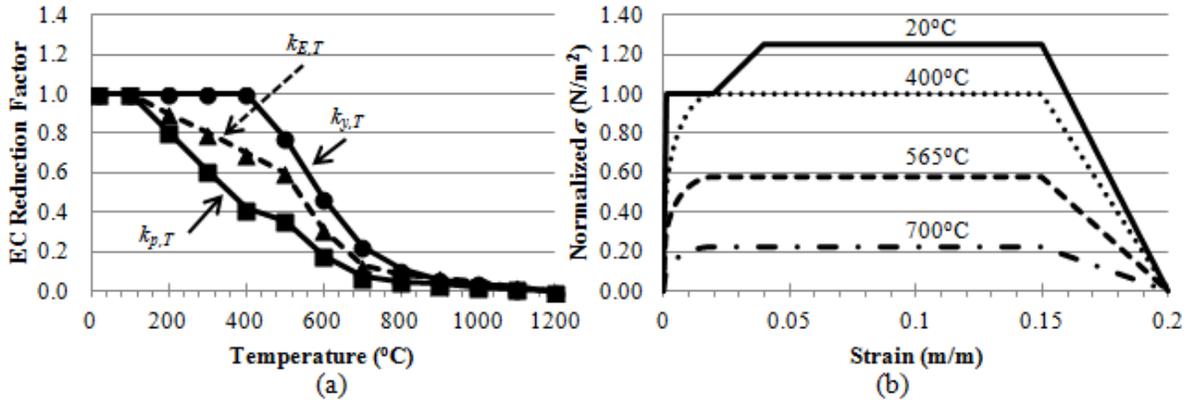
**Figure 3.** Plots of (a)  $k_{y,T}$ ,  $k_{p,T}$  and  $k_{E,T}$  versus temperature based on [30], and (b) stress-strain curves at 20°C, 400°C, 565°C, and 700°C, where the stress is normalized by  $\sigma_y$  at ambient temperature, for the “fully nonlinear” material properties based on the Eurocode [30].

The Eurocode provides high temperature material properties of structural steel [CEN 2002]. Reduction factors for yield stress ( $\sigma_y$ ), proportional limit stress ( $\sigma_p$ ), and Young's modulus ( $E$ ) as a function of temperature are provided ( $k_{y,T}$ ,  $k_{p,T}$  and  $k_{E,T}$ , respectively). The Eurocode permits strain hardening for steel heated up to 400°C, and assumes that at 1200°C steel has lost all mechanical strength. Figure 3 provides plots for typical stress-strain curves based on Eurocode, where the assumption of yield stress is based on a strain of 0.02. Other models for estimating the high temperature properties of steel are available such as that by ASCE [Lie 1992] and NIST [Leuke et al. 2011].

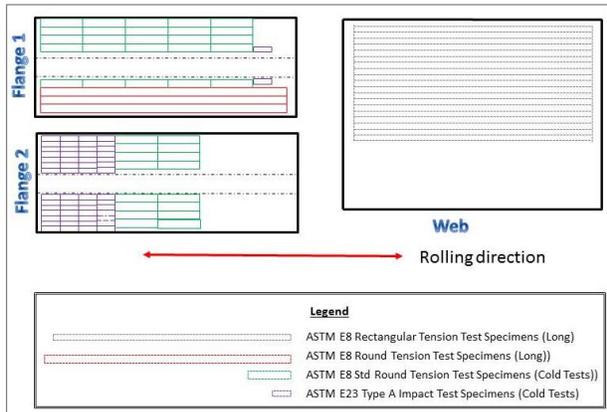
Figure 4. Layout of specimens for Material 1.

The steel specimens were cut from Material 1 as shown in Figure 4, and from Material 2 (A588) as shown in Figure 5. Figure 6 shows the ASTM E8 standard round tension test specimens used for the residual tests. Figure 7 shows the ASTM E8 standard rectangular (flat) tension test specimens used for the hot tests in the furnace. Figure 8 shows the ASTM E23 Type A impact test (CVN) specimens.

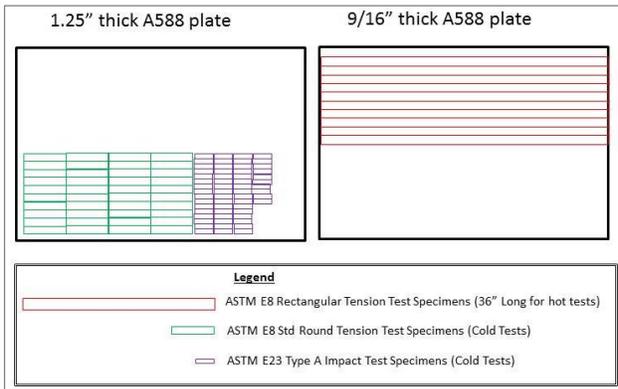
Figure 5. Layout of specimens for Material 2.

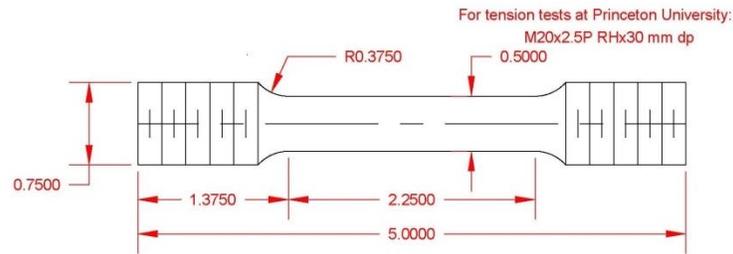
Figure 6. ASTM E8 standard round tension test specimens used for the residual tests (inches).

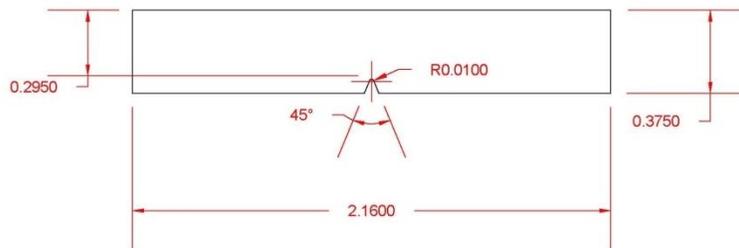
Figure 8. ASTM E23 Type A impact test (CVN) specimens (inches).

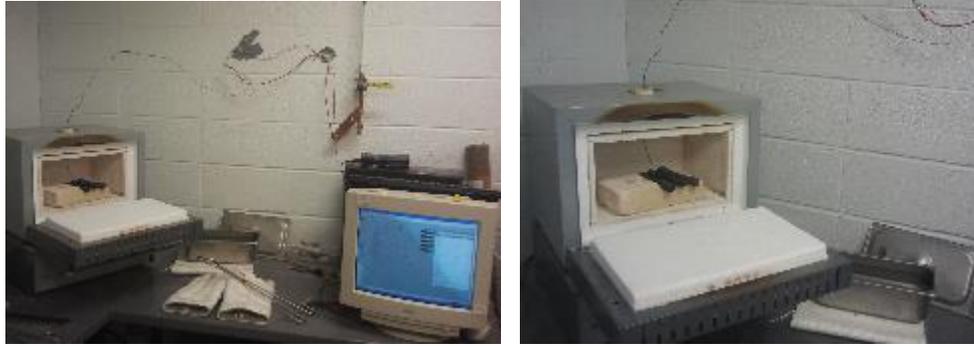
**Figure 9.** (a) Heating and cooling test setup. (b) Furnace with three standard round specimens placed inside. The companion specimen is on the far right (with the thermocouple sticking out from one side), while the two specimens that will be mechanically tested after they have been heated and cooled are to the left of the companion specimen.

To ensure the standard round and CVN test specimens had reached the target temperature, a companion specimen was fabricated that was heated alongside the test specimens used to determine the residual mechanical properties. The companion specimen, shown in Figure 6 alongside its mechanical test specimen, had a 1/16” diameter hole drilled longitudinally from one end of the specimen to the center of the gauge length. An Omega TJ48-CAXL-116U-60 high temperature resistant thermocouple was inserted into this drilled hole to track the internal temperature of the companion specimen. This particular thermocouple was selected since it could handle the high temperatures of the experiment (up to 1500°F) and could also be placed in water to track how the steel cooled when dunked in water. Temperature data was read using an Iotech personal daq (data acquisition) along with the DaisyLab 7.0 software. Additional wired thermocouples were used to measure the ambient air temperature of the lab, which was important information for the specimens that were cooled in air. The entire setup (furnace, data acquisition system, thermocouple, water bath, and ceramic blanket) is shown in Figure 9(a).

Both the companion and mechanical test specimens were placed close together in the furnace (see Figure 9(b)) such that the temperatures of the companion and mechanical test specimens could be safely interpreted to be the same. Once the target temperature was recorded by the thermocouple, a hold of at least 10 minutes was maintained to ensure uniformity and stability of the specimen temperatures. Following this 10 minute hold, the test specimens and companion specimen (with thermocouple still attached) were removed from the furnace and either placed on a ceramic blanket (for the CIA test) or immediately dunked in water (for the CIW test). The thermocouple remained inside the companion specimen at all times to track the cooling rate. Figure 10(a) shows the test and companion specimens cooling on top of a ceramic blanket (CIA), while Figure 10(b) shows the test and companion specimens after they have been dunked in water. Two people were typically present to remove the test and companion specimens from the furnace using tongs and heat-resistant gloves (shown in Figure 10(c)).

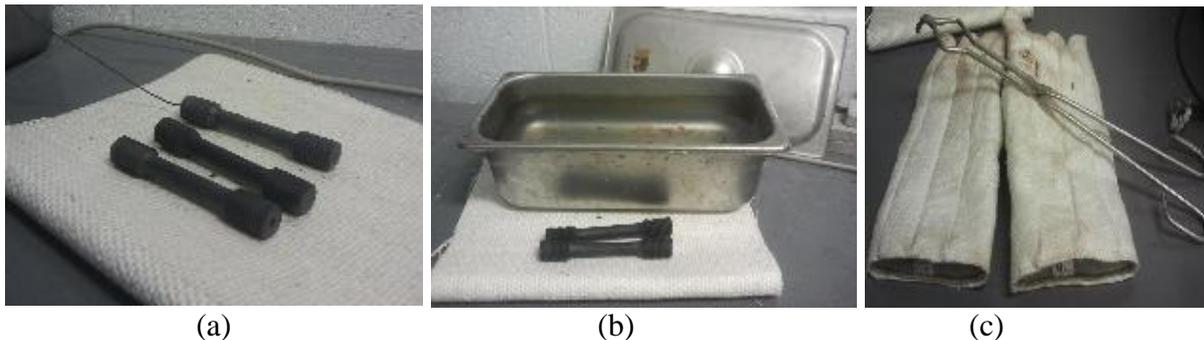
**Figure 10.** (a) Companion specimen (with thermocouple inserted) along with two mechanical test specimens cooling in air on top of a ceramic blanket; (b) two mechanical specimens after being dunked in the water bath shown; (c) heat-resistant gloves and tongs used to remove the specimens from the furnace after heating.

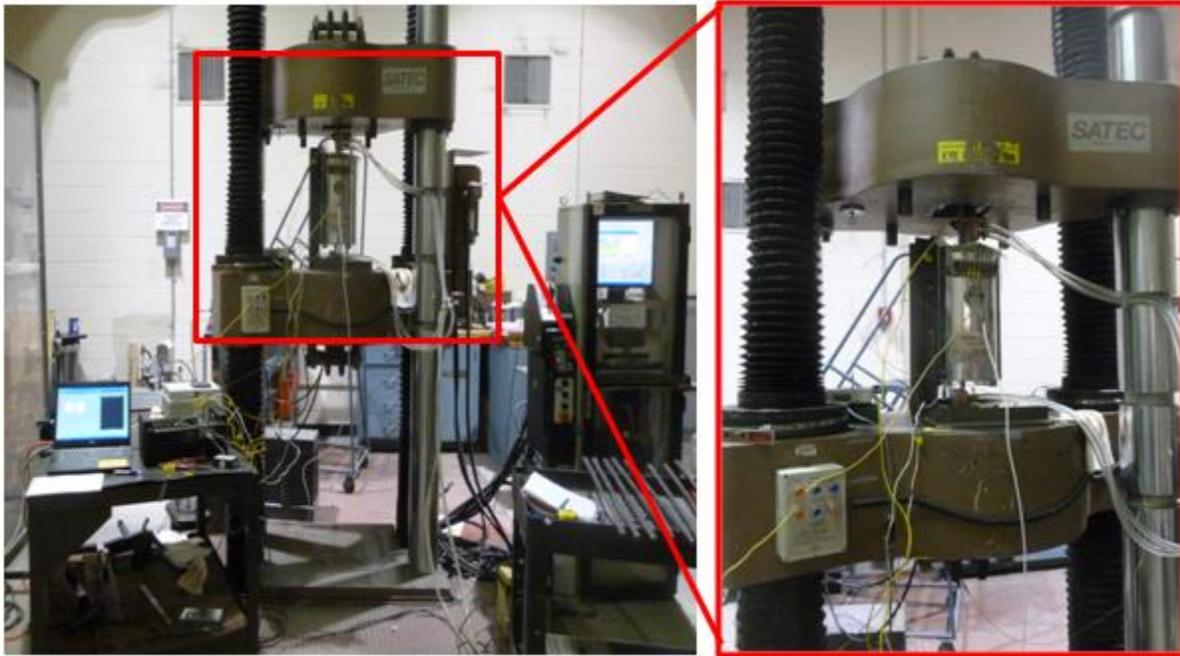
**Figure 11.** Furnace and tensile test frame setup at Lehigh University. A schematic of the setup is shown in Figure 9.

Tensile strength of both materials were investigated at high temperature. The specimens were placed in a SATEC furnace, and could be tested in tension while being heated by the furnace. Setup is illustrated in Figures 11 and 12. These tests, conducted at Lehigh University, used “long” steel specimens to accommodate for the dimension of the furnace and tensile testing equipment. The Material 1 “long” specimens were 30 inches long, and the A588 were 36 inches long.

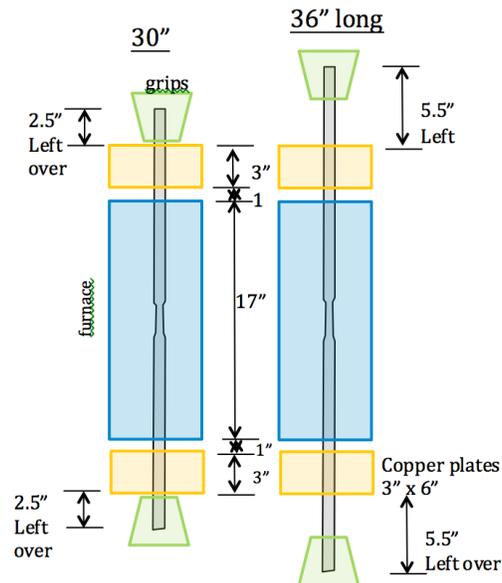
**Figure 12.** Spacing of furnace, cooling plates, and grips on the 30'' and 36'' long specimens. The copper plates (shown as yellow squares) cooled the steel specimen as it exited the furnace so that excess heat did not travel into the grips (shown as green trapezoids).

In addition to the furnace, the experimental apparatus consisted of SATEC tension machine, high temperature resistant thermocouples (Omega TJ48-CAXL-116U-60), and cooling clamps. The latter consisted of copper plates clamped to the specimen, through which cold water was continuously running, and that ensured the temperature at the grip location would remain sufficiently cool to not compromise the tensile testing procedure (see Figure 12).

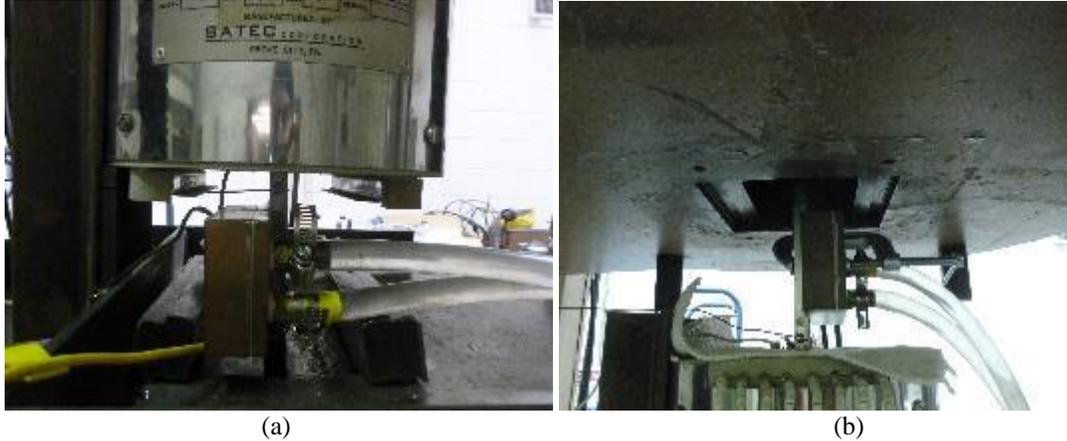
**Figure 13.** Close up images of the cooling plates attached to the (a) bottom and (b) top of the specimen as it left the furnace. The cooling plates were made of copper with cold water continuously running through them to remove heat from the specimen before it reached the clamps.

Once prepared, the specimen was placed inside the furnace and testing apparatus (see Figure 13). Note that during the heating procedure, only the bottom clamps were attached (free to elongate at top). An insulating blanket was placed above the furnace to minimize heat losses and protect equipment from rising heat, and the cooling plates attached above and below the furnace. While we tried to maximize the length of the specimen that was placed in the grips, a minimum length within the grips of 2" was maintained for the 30" long specimens; a 3" minimum was maintained for the 36" long specimens.

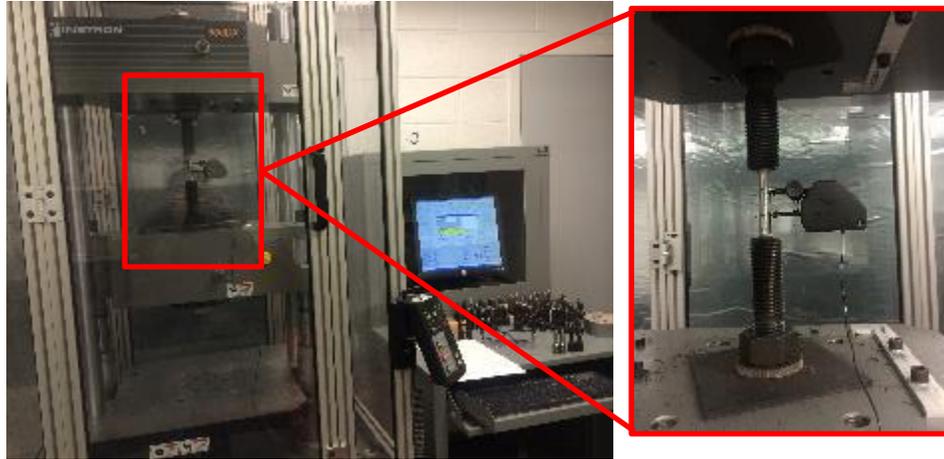
**Figure 14.** Ultimate tensile machine setup with standard round specimen and extensometer attached.

Residual tensile strength tests were done for standard round specimens that were heated to 800°F, 1000°F, 1200°F, and 1500°F, and were subsequently cooled in air (CIA) or cooled in water (CIW). These tensile tests conformed to ASTM E8 and were conducted at Princeton University using an Instron 600 DX loading frame with a 600 kN load capacity, shown in Figure 14. An extensometer was used to measure strain during the initial portion of the tensile test. This extensometer was removed well before ultimate tensile strength was reached to avoid damaging the extensometer at fracture, but after yield was reached in all cases. The loading rate specified for the tensile test was 0.1 in/min, which was the same loading rate used for the hot tension tests at Lehigh University based on ASTM E8 guidelines.

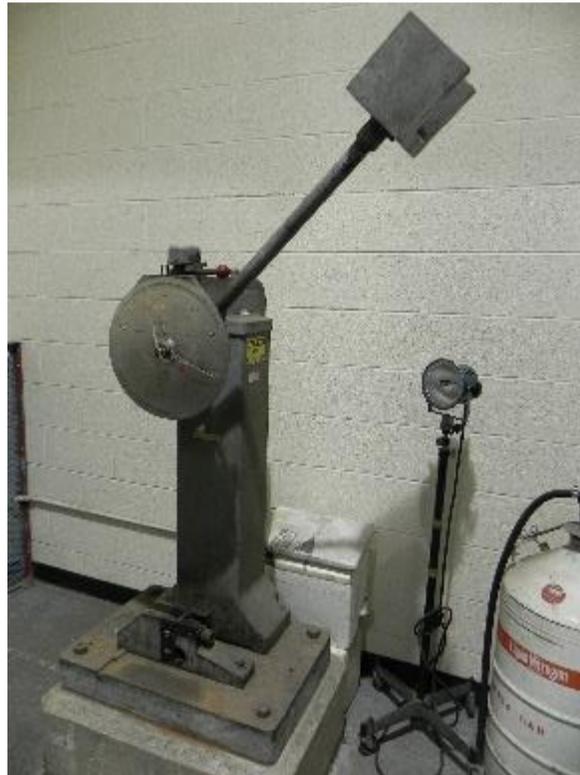
**Figure 15.** CVN fracture hardness test.

Charpy V-notch tests were conducted according to ASTM E23/AASHTO T266 guidelines. Lehigh University provided the impact test machine for these tests. Figure 15 shows an image of the instrument and the specimen setup.

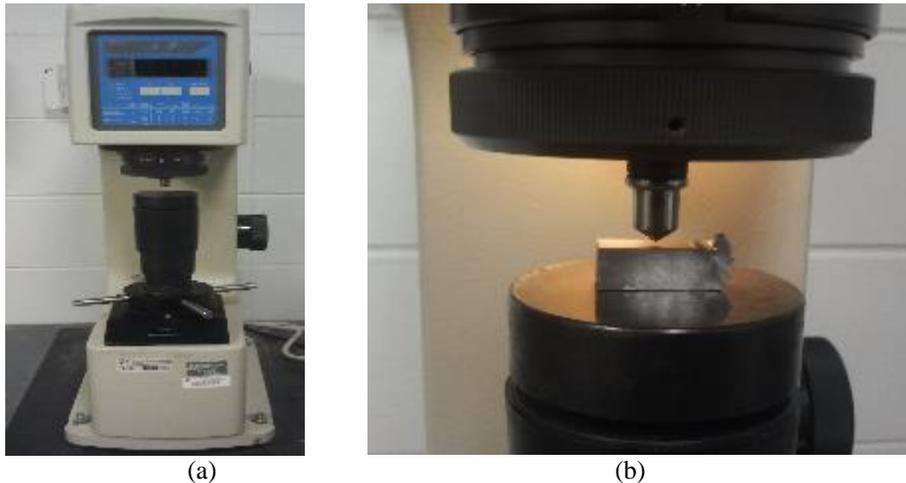
**Figure 16.** (a) Rockwell hardness machine setup, and (b) specimen placed beneath the indenter.

We used HRB in all of our tests, except in one case where the cooled metal was too hard, and had to use HRC, and used a Hardness testing machine Mitutoyo ATK-600.

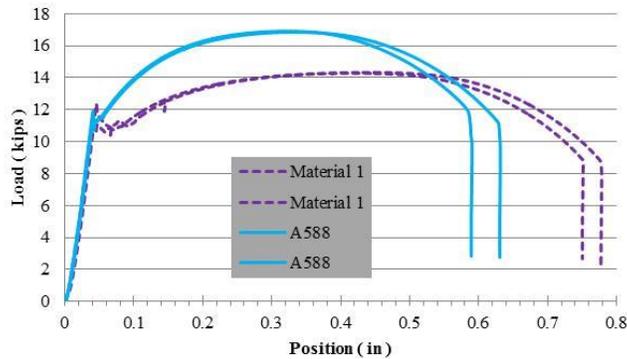
**Figure 17.** Ambient tensile test results for Material 1 and Material 2.

A summary of the ambient test results are presented in Table 3 where  $\sigma_y$  is the yield stress,  $\sigma_u$  is the ultimate stress, and E is the modulus of elasticity. These results are what will be used for comparison and represent the ‘control group’. It is seen that both materials have similar properties at ambient except that Material 1 has a larger fracture toughness (as represented by the CVN tests) and smaller  $\sigma_u$  than A588. Figure 17 shows the tensile test results for the two materials.

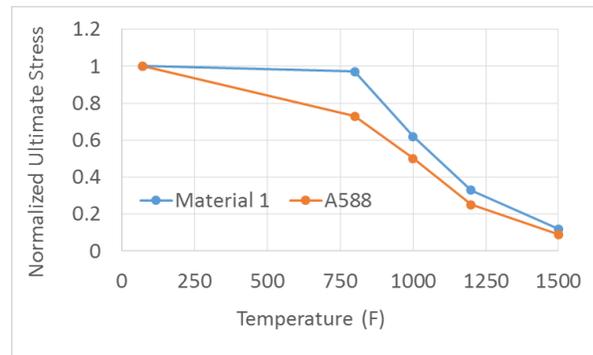
**Figure 18.** Normalized ultimate stress versus temperature

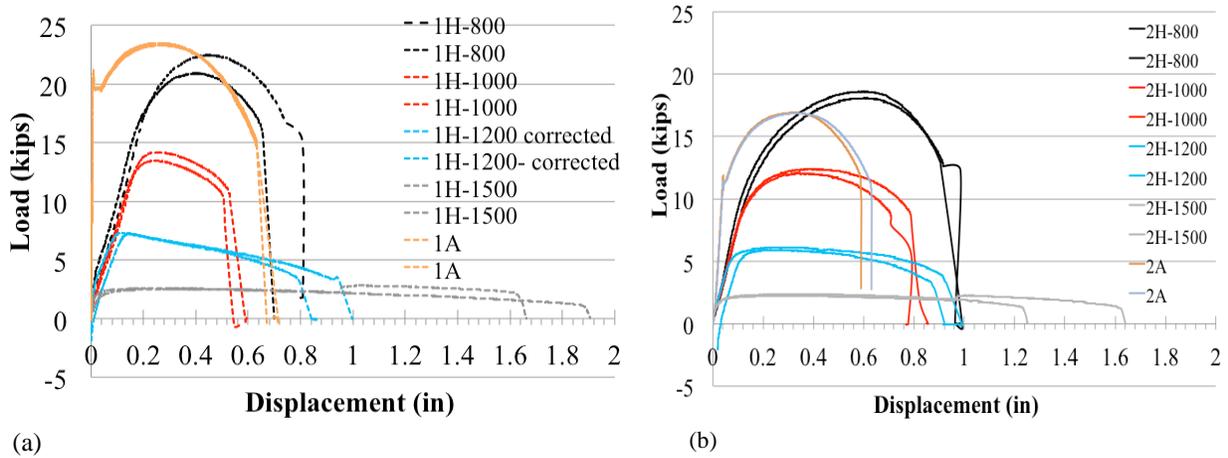
Figure 19. Load-displacement curves for (a)Material 1, and (b) A588

Figure 19 plots the load-displacement curves of the heated specimens for Material 1 and Material 2 (A588). For Material 1, all the specimens presented in these figures were the flat 30 inch long specimens. Material 2 used 36 inch long specimens (Fig.7) except for the ambient temperature tests (2A), which were the standard 5-inch long round specimens (Fig. 6). Note that data for the two 1H-1200 specimens has had to be corrected due to initial pre-compression due to closing of the clamps. Also, it can be seen from Figure 19 that one curve for 2H-1200 is off from the origin of the plot. This is because for this particular specimen the initial pre-compression applied by clamping was not zeroed. For this reason, results for this specimen were omitted from Table 4.

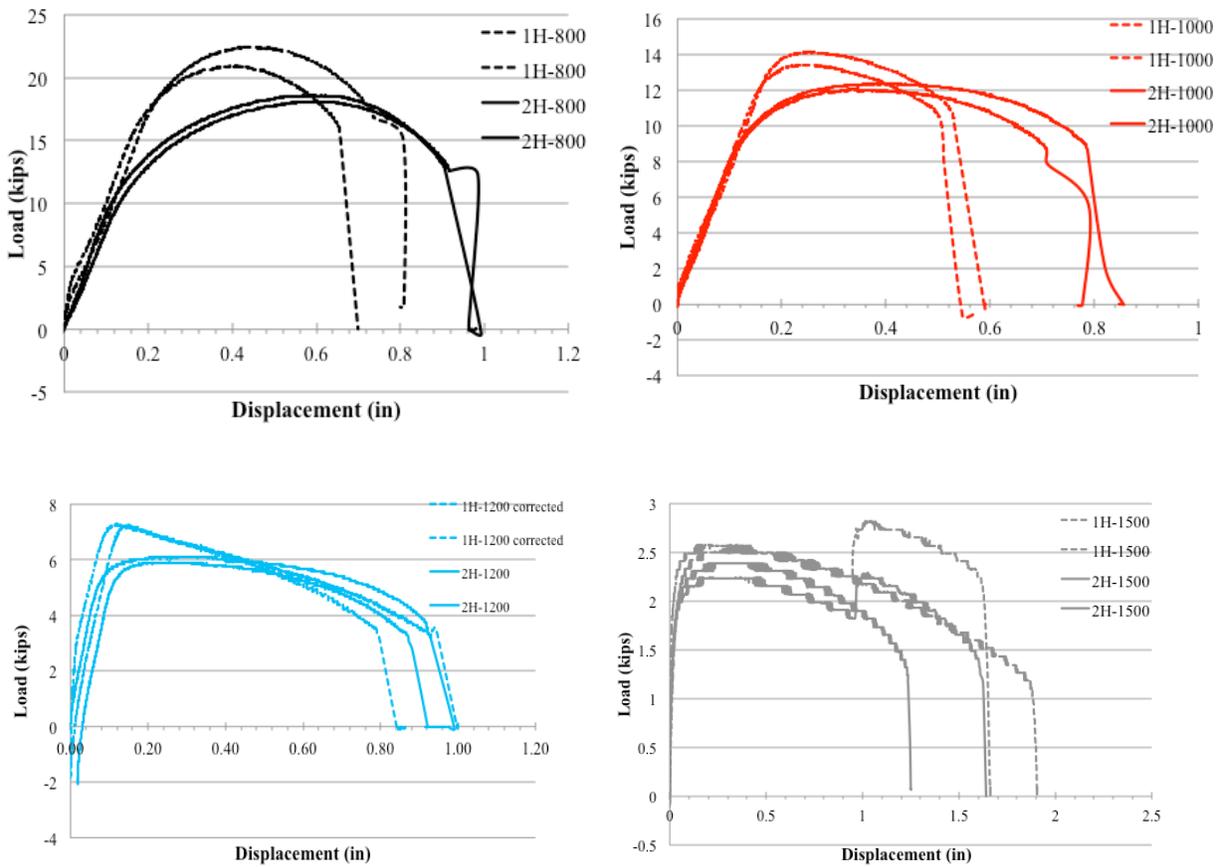
Figure 20. Comparison of Materials 1 and 2 (A588) at (a) 800°F, (b) 1000°F, (c) 1200°F, (d) 1500°F.

In addition to observing the difference in tensile test results with increasing temperature it is interesting to compare the load-displacement behavior at a given temperature between the two different steels studied in this report. In Figure 20, for the 1500°F tests, some unusual jumps in the stress-strain curves can be observed. These were caused by a change in the strain rate that was programmed into the controller software without the researchers being aware of it. In the software used to control the tensile test, a strain rate of 0.1 in/min was set until 1” total displacement was measured. After this amount of head travel, the software automatically changed strain rate to 0.5 in/min. Unknowingly, the strain rate changed during two of the four 1500°F tests (1H-1500A, 2H-1500).

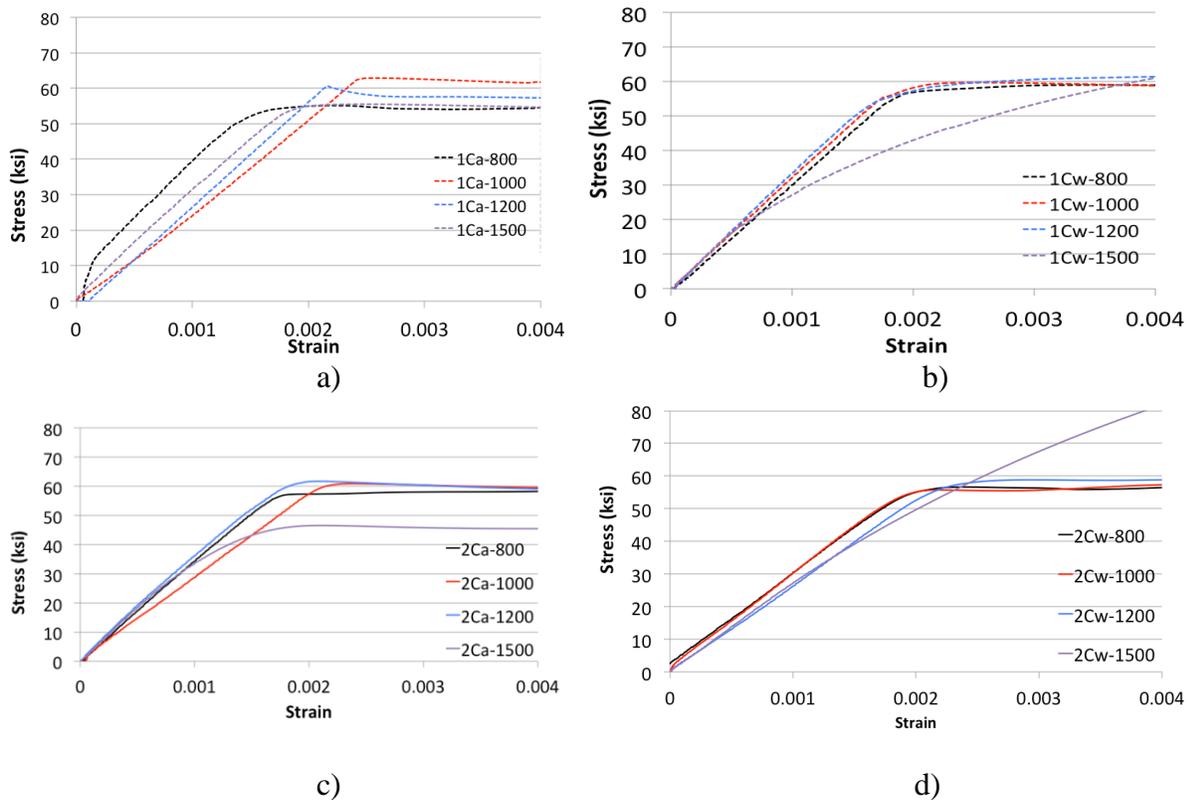
**Figure 21.** Stress-strain relationships for few specimens of (a) *Material 1 CiA* (b) *Material 1 CiW* (c) *Material 2 (A588) CiA* and (d) *Material 2 (A588) CiW* at temperatures varying from 800 to 1500°F.

Two standard round specimens were tested for each CIA and CIW specimen (see Table 1). Tables 5 and 6 summarize the results for these specimens (for Material 1 and 2, respectively), which represent the residual strength of the material after being heated and cooled. The yield 0.2% offset method was used to calculate the yield stress ( $\sigma_y$ ) for all specimens. Figure 21 shows the stress-strain curves for some of the residual tension strength tests. The strains were measured using the extensometer, which needed to be removed after yield to protect it from falling off the specimen and breaking.

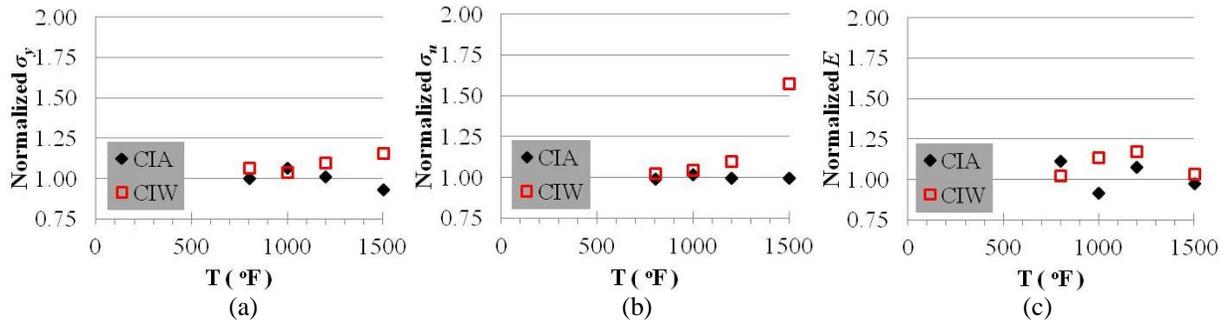
**Figure 22.** Normalized plots of average values of (a)  $\sigma_y$ , (b)  $\sigma_u$ , and (c)  $E$  for Material 1 specimens that were heated to the temperature specified on the x-axis and cooled in air (CIA) or cooled in water (CIW). The normalization is based on the average ‘control’ value from the specimens that were not heated.

Figure 22 plots the average results for Material 1 steel specimens normalized by the control values (specimens that were never heated). From Table 5 and Figure 22(a) it is observed that for both cooled in water (CIW) and CIA specimens,  $\sigma_y$  typically stays within 10% of the control value, except for the CIW specimens heated to 1500°F. The same is observed for  $\sigma_u$  in Figure 22(b) with one major exception: the CIW specimens at 1500°F experience a 58% increase in value. The residual  $E$  value is plotted in Figure 22(c) and it is shown that the CIA specimens generally fluctuate within 10% of the control value, but the CIW values all tend to be larger than the control value and for CIW at 1200°F  $E$  exceeds the control by 17%.

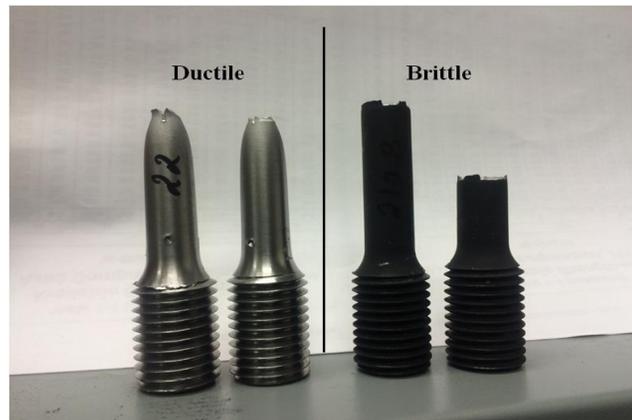
**Figure 23.** Ductile and brittle failure of Material 1 test specimens. Ductile failure is shown on the left for specimen 1A (unheated) compared to brittle failure observed on the right for specimen 1Cw-1500.

Another general observation of these experiments is that for Material 1, brittle failure was observed for the CIW specimens that were heated to 1500°F. Figure 23 compares the image of the control (1A) specimen to the CIW specimen heated to 1500°F. The lack of ‘necking’ in the CIW specimen on the right is a visual representation of the brittle nature of the material.

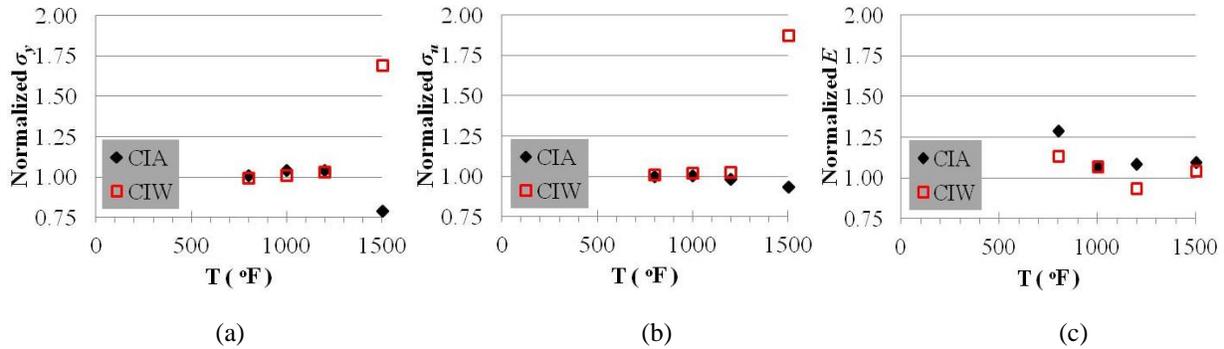
**Figure 24.** Normalized plots of average values of (a)  $\sigma_y$ , (b)  $\sigma_u$  and (c)  $E$  for A588 steel specimens that were heated to the temperature specified on the x-axis and cooled in air (CIA) or cooled in water (CIW). The normalization is based on the average ‘control’ value from the specimens that were not heated.

Figure 24 plots the average results for A588 steel specimens normalized by the control values (specimens that were never heated). From Figure 24(a), it is seen that for temperatures up to 1200°F,  $\sigma_y$  does not differ significantly compared to the control value regardless of cooling

method. At 1500°F however, the CIA specimens only retain 79% of  $\sigma_y$  and the CIW specimens have a 69% increase in  $\sigma_y$ . Figure 24(b) shows that  $\sigma_u$  is hardly affected when the CIA method is used. The same is observed for the CIW method except for 1500°F where an 88% increase in  $\sigma_u$  is observed. Figure 24(c) shows that the CIA specimens experienced an increase in  $E$  values on the order of 10% except for the 800°F specimen where  $E$  increased 29%. The CIW specimens had residual  $E$  values that were generally within 10% (above or below) of the control specimen value.

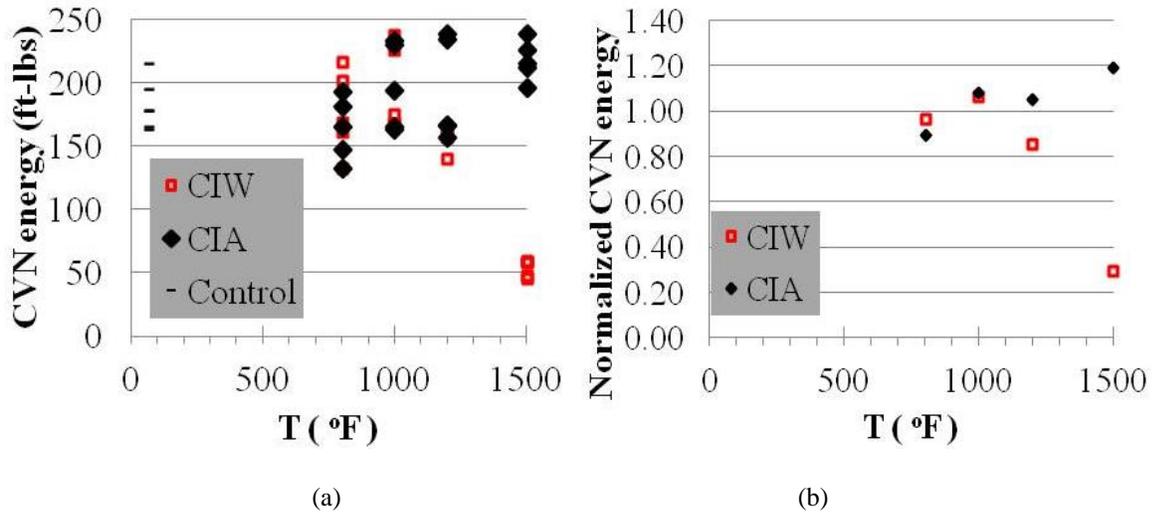
**Figure 25.** Residual CVN energy for Material 1 specimens that were heated to the specified maximum temperature and cooled in water (CIW) or cooled in air (CIA): (a) Results from all tests for each temperature and cooling method, (b) CVN values normalized by the average ‘control’ value (specimens that were not heated).

Table 7 summarizes the CVN test results that measure fracture toughness. Figures 25a and 26a plot the CVN energy (ft-lbs) for specimens with Material 1 and 2 (A588), respectively. Figures 25b and 26b plot the CVN results normalized by the control CVN specimens (those that were neither heated nor cooled). The results from Figure 25 show that for Material 1, the CVN specimens that were heated to 800°F and 1000°F, the CVN values remain about the same regardless if the specimen is CIA or CIW. For the CVN specimens heated to 1200°F, the CIW specimens tend to have lower CVN energy than the CIA specimens. For CVN specimens heated to 1500°F, the CIA specimens have slightly higher CVN energy compared to the control, while the CIW specimens show a dramatic reduction.

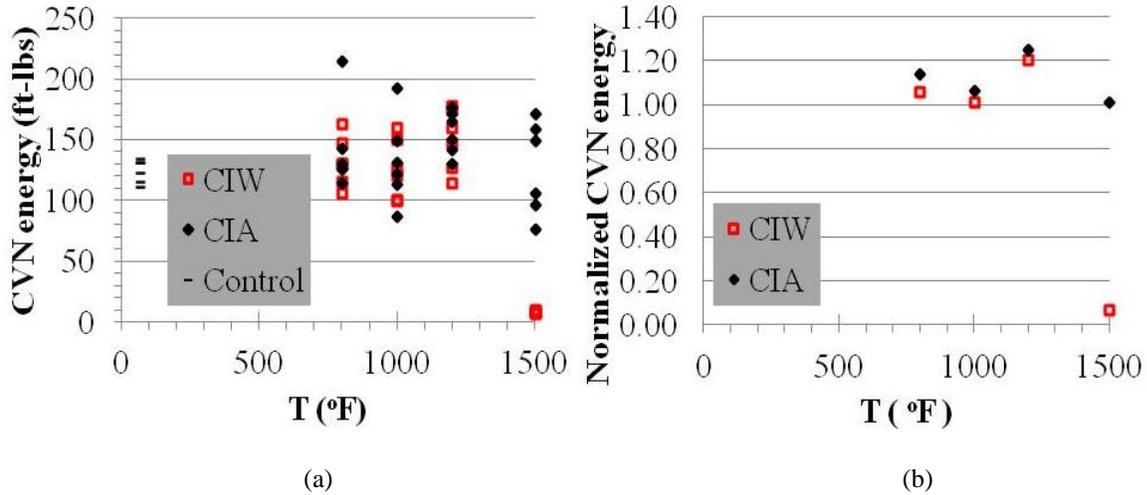
**Figure 26.** Residual CVN energy for A588 specimens that were heated to the specified maximum temperature and cooled in water (CIW) or cooled in air (CIA): (a) Results from all tests for each temperature and cooling method, (b) CVN values normalized by the average ‘control’ value (specimens that were not heated).

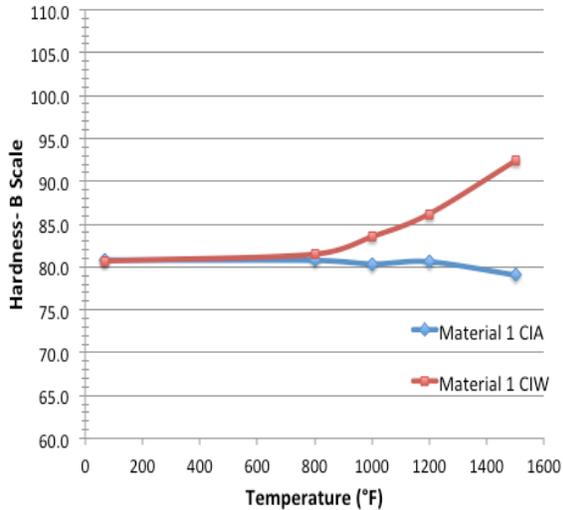
**Figure 27.** Residual Rockwell hardness results for Material 1.

Figures 27 and 28 plot the hardness values measured for Material 1 and A588, respectively. It is observed that the CIA specimens, for both materials, retain their hardness values (essentially unaffected). For the CIW specimens, however, a clear trend is observed where the larger the temperature, the larger the residual hardness.

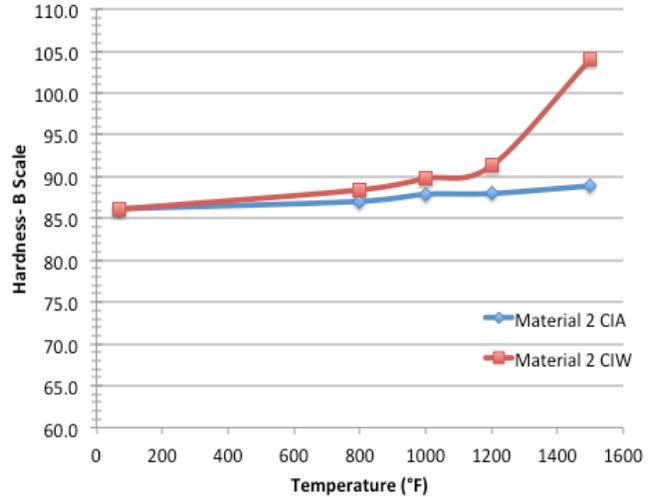
**Figure 28.** Residual Rockwell hardness results for Material 2 (A588)
