Long-Term Monitoring of a Geosynthetic Reinforced Soil Integrated Bridge System (GRS-IBS)

FINAL REPORT
November 2017

Christopher L. Meehan
Associate Professor

University of Delaware, Department of Civil and Environmental Engineering
301 DuPont Hall, Newark, DE 19716, U.S.A.

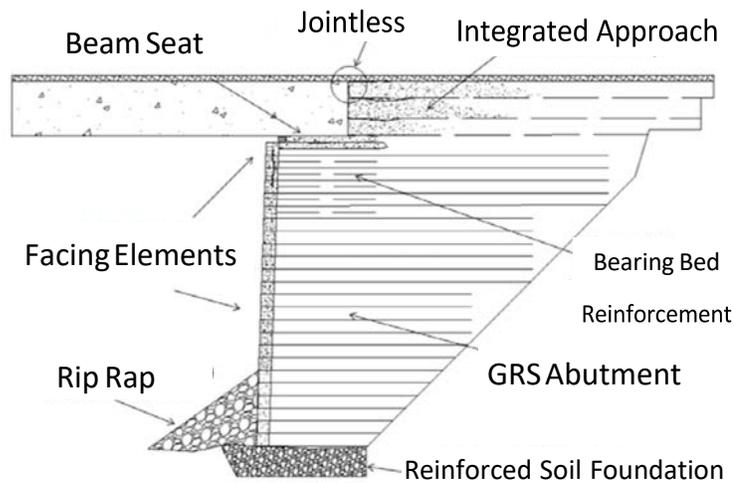
Figure 1.1 Typical GRS-IBS cross-section (modified after Adams et al. 2011)

compacted soil layers with geosynthetic, a reinforced soil foundation (RSF) is used to support the base of the reinforced soil zone in fair foundation conditions. Rip rap scour protection is placed in front of the facing wall elements to prevent undermining and soil erosion if the GRS-IBS passes over a waterway. The composite soil/geosynthetic mass within the GRS abutment is strong enough to directly support the dead and live loads that are applied to the bridge superstructure due to the significant compressive and tensile strength. For the bridge span itself, a concrete box beam superstructure is popular for shorter span bridges but other steel, concrete, or composite superstructures can also be used (Russell 2011). It is common to support a concrete box beam superstructure on a beam seat which is directly built in to the GRS abutment. To help with load shedding from the bridge loads, additional bearing bed reinforcement is placed beneath the beam seat which helps serve as an embedded footing in the reinforced soil mass; this bearing bed reinforcement should be placed at a minimum of half the spacing seen in the GRS abutment (Adams et al. 2011). An integrated approach consisting of reinforced backfill in conjunction with a jointless continuous pavement interface is used at the end of both sides of the bridge beams. The elements discussed above are shown in Figure 1.1 (Adams et al. 2011).

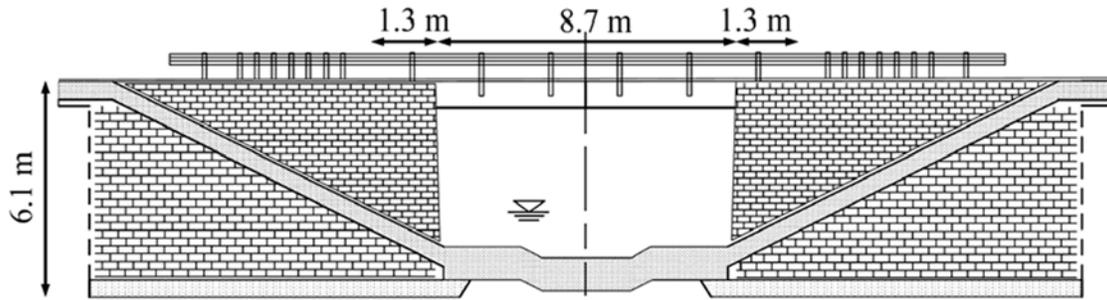
Figure 2.1 Cross-section of Bridge 1-366, along the roadway centerline

DelDOT engineers provided preliminary geometrical details for this project and concluded that the maximum height from the road elevation to the bottom of the foundation was to be approximately 6.1 m. This is less than the maximum allowable height of approximately 9 m that is specified for GRS-IBS structures (Adams et al. 2011). The span length of the structure was determined to be 8.7 m and the overall bridge superstructure length was 11.3 m (giving a 1.3 m bearing seat width for both ends of the bridge). The width of the bridge was determined to be 12.2 m and includes two lanes with shoulders. The length and width of each abutment measure 9.8 m and 14.6 m respectively. Figures 2.1 and 2.2 depict the cross-sectional view of the GRS-IBS structure along the roadway centerline and the plan view of the structure, respectively.

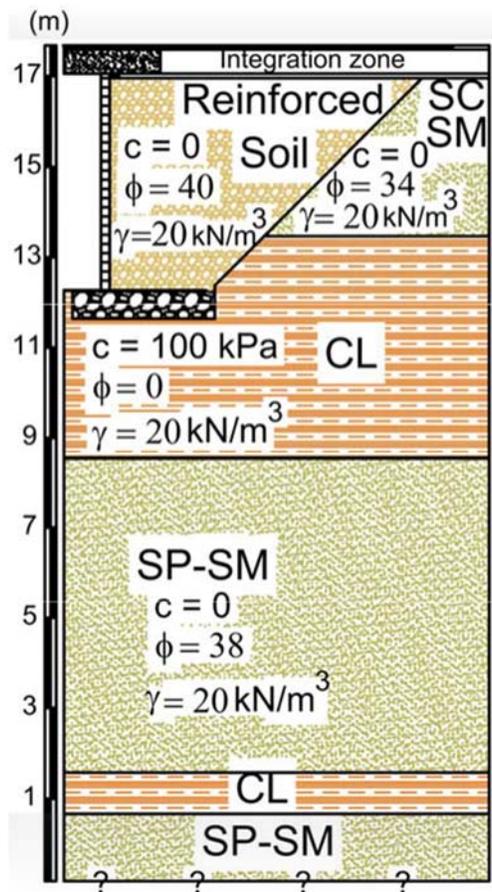
Figure 2.3 Soil layer geometry with engineering properties used for Bridge 1-366 design

One borehole was drilled in each abutment as part of the geotechnical exploration process for a total of two total boreholes. Each borehole was drilled to a depth of 18.3 m in which bedrock was not observed in either of the borings and groundwater was observed at a depth of approximately 3.5 m from the ground surface. Also from these borings, 41 soil classification tests, six consolidation tests, two unconfined compression tests, four unconfined undrained triaxial shear tests, and 11 organic content tests were performed. In depth details from the boring data and the test results mentioned can be found in the appendix of Talebi (2016). Soil layer geometry was determined from the laboratory tests in addition to published correlation and engineering judgement; soil unit weights and strength parameters were also determined for the design of the GRS-IBS. Figure 2.3 displays this soil layer geometry with engineering properties assigned to each

layer. The soil exploration showed a soil profile consisting of granular and fine materials ranging from SM-SC to CL in the United Soil Classification System (USCS). Using the standard penetration testing (SPT) results and recovered samples, approximately the first 4 meters of soil was determined to be a medium dense, fine sandy material with silt and clay. Following this layer, a thin layer of stiff orange sandy clay was detected followed by a grayish-brown silty fine sandy clay layer which continued to a depth of approximately 8.5 m; this larger layer is medium stiff to stiff and includes organic material at some depths. After this layer, a dense to very dense, fine sand layer with silt was observed, extending to the end of the borehole exploration with the observance of a thin clay layer at approximately 1 m from the end of the borehole.

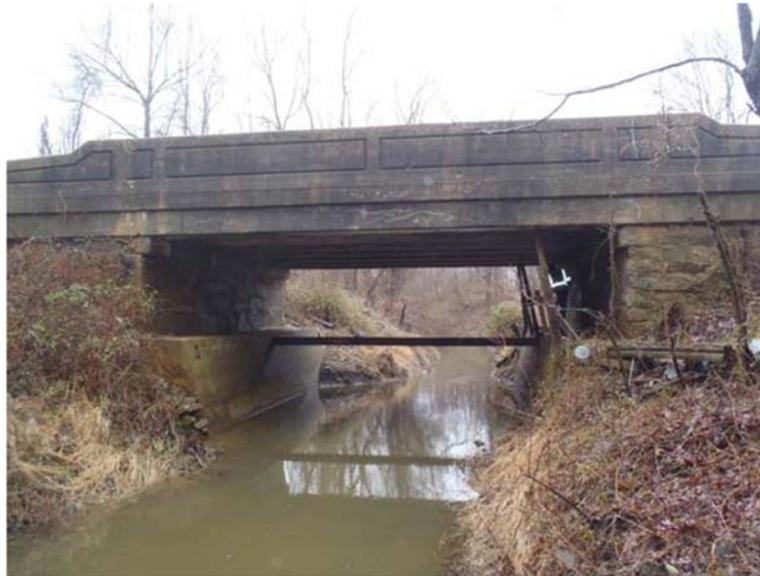
Figure 2.5 Existing Bridge 1-366 before demolition

The existing bridge before its demolition in March of 2013 can be seen in Figure 2.5. As discussed in previous sections, the bridge was to be replaced since it was at the end of its service life. Excavation for the east abutment foundation began on March 22, 2013 and the east abutment was completed on April 5, 2013. Excavation for the west abutment began on April 3, 2013 and the west abutment was completed on April 23, 2013. On April 25, 2013 the bridge beams were placed and the integrated zone was constructed over the three weeks following that. After the construction of the integration zone, paving was completed and guard rails were installed, thus completing the

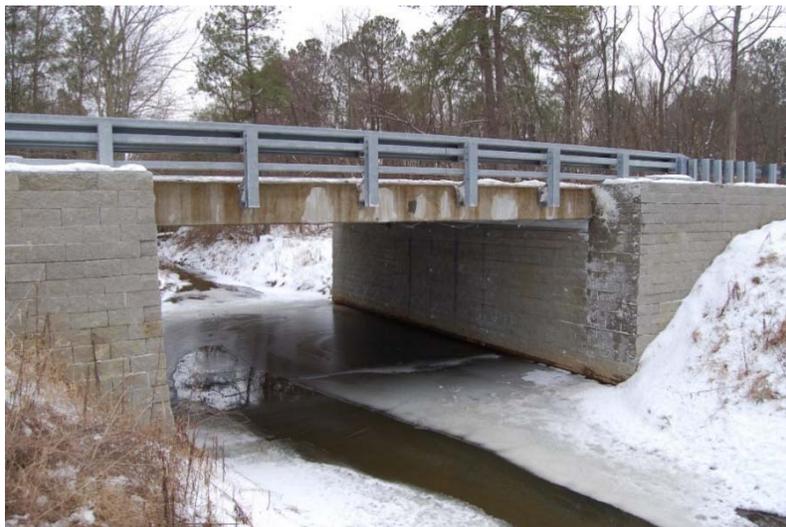
Figure 2.6 Completed Bridge 1-366

GRS-IBS structure. The speed of construction was fairly quick given that this was the first GRS-IBS constructed in the state of Delaware and it is expected that similar future projects can be built at a more accelerated pace as contractors become familiar with the technology. Figure 2.6 shows the GRS-IBS structure approximately eight months after the completion of construction.

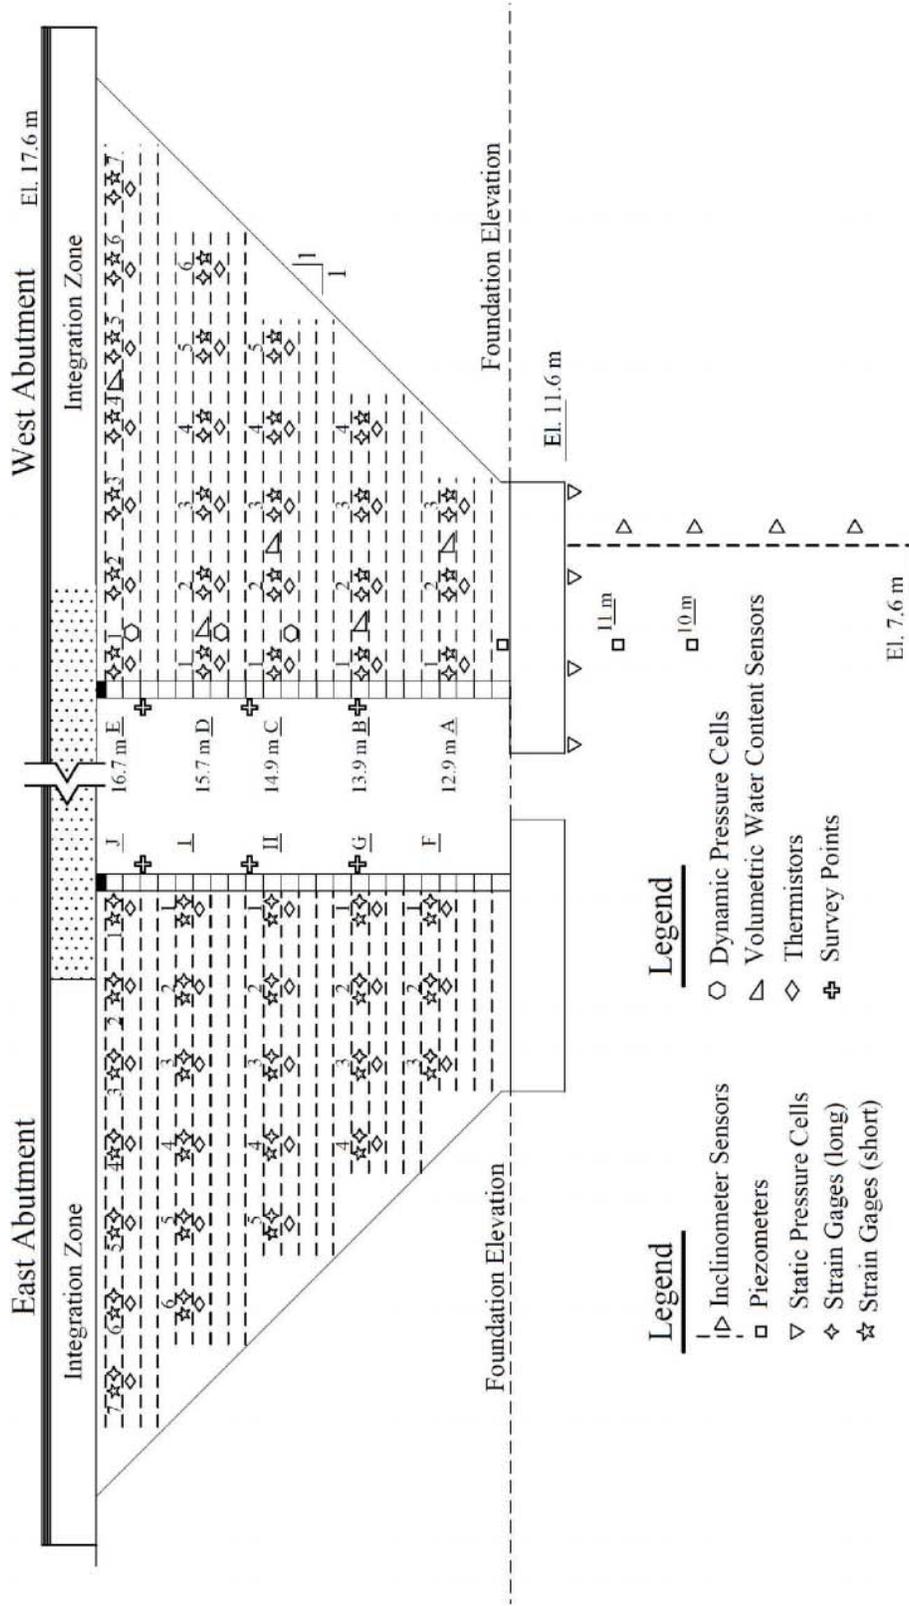
Figure 3.1 Bridge 1-366 instrumented section about the roadway centerline

As shown in Figure 3.1, the four in-place inclinometer (IPI) sensors were installed beneath the RSF of the west abutment in the clay foundation; the IPI sensors were placed in this layer to measure its displacement during construction and over the monitoring periods of the structure. Beneath the clay layer was a relatively stiff sandy layer so the inclinometer casing was terminated in the sandy soil. The inclinometer boreholes were drilled before the existing bridge was demolished as it was determined that drilling after removal of the existing bridge would have been too time consuming and difficult given the site foundation conditions. The inclinometer holes and its casing were left in place during the excavation and the sensors were installed once the excavation reached the base elevation for new construction to take place. By employing a fixed chain of sensors affixed to a series of connected rods, the IPI sensors provide an in-place alternative to traditional traversing probe-type inclinometers. Displacements were measured in both the N-S and E-W directions since vertical biaxial IPIs were used. Figures 3.2 and 3.3 show a typical IPI sensor used in the project and installation of the IPI array in the field, respectively.

To measure pore water pressure in the clay foundation three vibrating wire piezometers were installed. As shown in Figure 3.1, two piezometers were installed beneath the RSF of the west abutment and one was installed within the abutment, closer to the bottom. The piezometer within the abutment was not only used to measure water pressure but it was also used to determine the water elevation within the abutments. The borehole used for the piezometers was the same borehole for the IPI sensors mentioned in the previous section and the casing was used to protect the cables down to the foundation elevation during excavation. The piezometers are able to record

Five volumetric water content sensors (MAS-1) provided by Decagon were utilized in this project. They were installed at different elevations within the west abutment, as shown in Figure 3.1, to monitor soil moisture content and its effect on the strains in the geotextile. The use of these

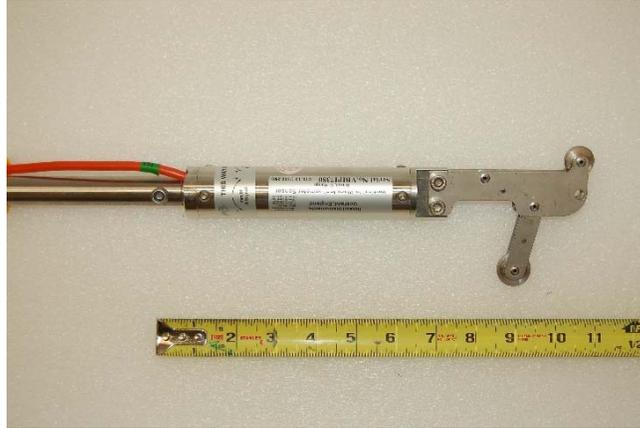
Figure 3.2 In-place inclinometer (IPI) sensor

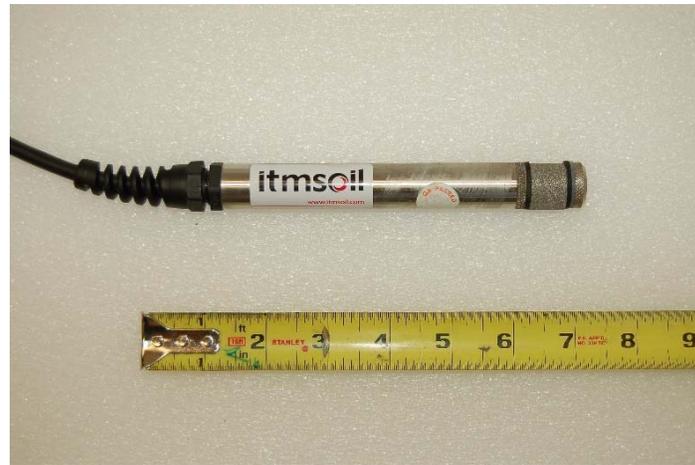
Figure 3.4 Piezometer sensor

pressures from 0-300 kPa. Figures 3.4 and 3.5 show a typical piezometer sensor utilized in this project and its installation, respectively.

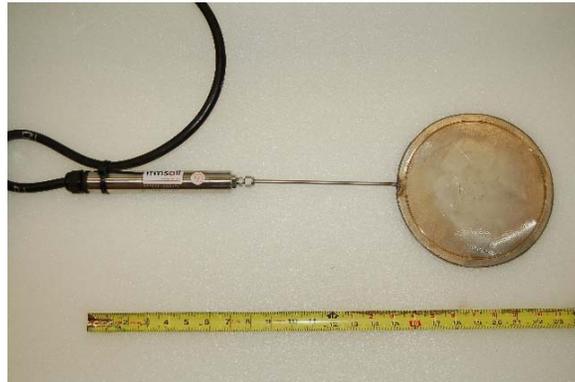
Figure 3.6 Pressure cell

Figure 3.1 displays the respective locations of the eight total pressure cells that were utilized in this project (four beneath the RSF, three within the west abutment, and one in-between the end of the concrete bridge and the integration zone). The four pressure cells located beneath the RSF measure the static pressure and its distribution beneath the RSF. The three pressure cells

installed within the abutment have the capability to measure both static and “instantaneous” pressure produced by live load on the road; this is possible in this case because a foil-based strain sensor is utilized within these total pressure cells to measure fluid pressure. For the instantaneous pressure measurements to be accurate, they must be made with a data logger that is capable of taking readings at a high rate of data acquisition; the datalogger used in the current study was a budget model that did not have this capability. The pressure cell between the concrete bridge and the integration zone measures the horizontal stress induced by loads and temperature-induced changes on the bridge deck. The pressure range for these cells are similar to that of the piezometers, 0-300 kPa. During installation, sand bags were used to provide a flat surface around the cells to prevent stress concentrations from forming at the sensor location. Figures 3.6 and 3.7 display a typical utilized pressure cell and its installation, respectively.

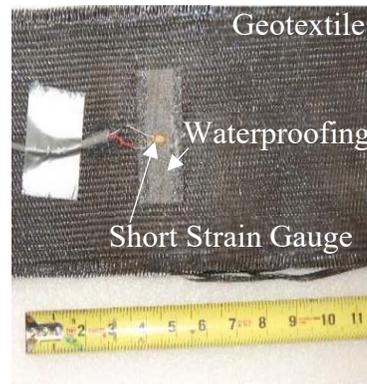
Figure 3.8b Short strain gauge

Two different gauge attachment techniques (Lechchinsky and Fowler 1990, Wu et al. 2013) were utilized in conjunction with the two different sized strain gauges. This gauge layout was intentional, as one of the goals of this instrumentation plan was to assess the effect of the strain gauge installation methodology on the resulting strain readings; more details regarding the strain gauge attachment techniques utilized in this project can be found in Talebi (2016). The strain gauges were installed on the geotextile, waterproofed, and wired in the University of Delaware lab prior to construction and installation. The strain gauges were protected from the granular fill material by placing sand above and below each sensor area. Using this installation process, all

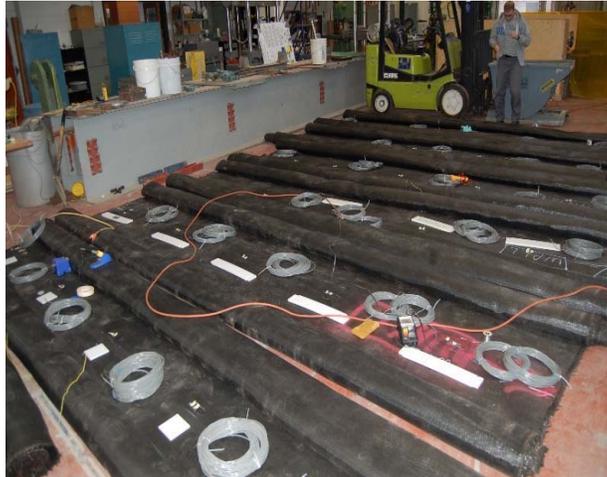
Figure 3.9 Strain gauge wiring in the University of Delaware lab prior to site installation

strain gauges survived the GRS-IBS construction process in the field. Figure 3.9 shows the strain gauge wiring that was performed in the University of Delaware laboratory before installation, while Figure 3.10 shows the gauge installation and protection at the site.

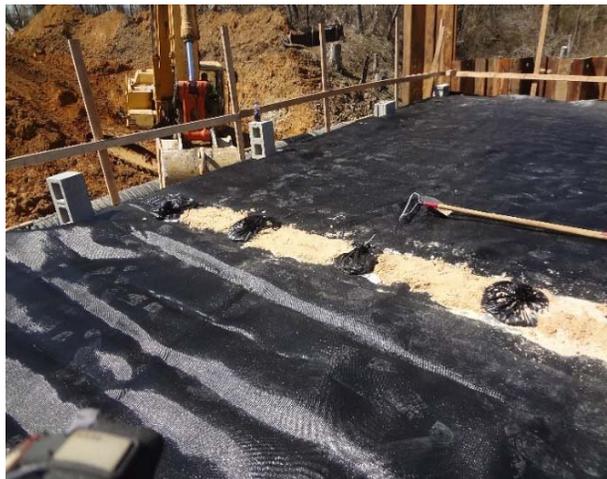
Figure 3.10 Strain gauge protection and installation at the site

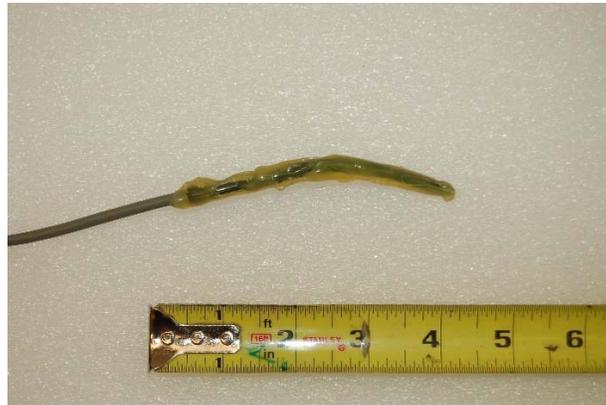
Figure 3.11 Thermistor

thermistor was placed between the long and short strain gauges on the geotextile. The thermistors were provided by Therm-x, the YSI 55000 series. To protect the thermistors against the presence of water in the abutment, the thermistors were waterproofed prior to their installation; more details regarding the thermistor waterproofing process can be found in Talebi (2016). Figures 3.11 and 3.12 display a typical waterproofed thermistor and its installation.

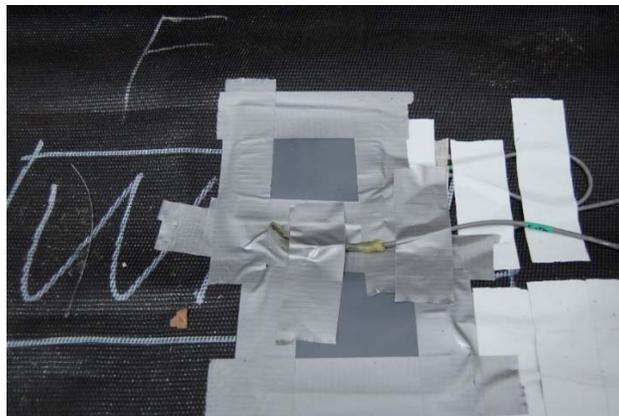
Figure 3.12 Thermistor installation

A total of 50 thermistors were utilized for this project to monitor the effect temperature has on the GRS-IBS structure, and on the measured strains in the geotextile. As Figure 3.1 shows, the thermistors were placed in the same location as the strain gauges (25 in each abutment); each

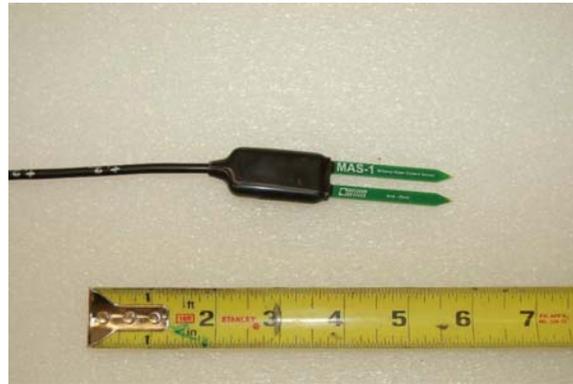
Figure 3.13 Volumetric water content sensor

sensors also makes it possible to investigate the effect of increase in water content due to precipitation or changes in the river elevation on the structure's behavior. Figure 3.13 displays a typical volumetric water content sensor that was utilized for this project.

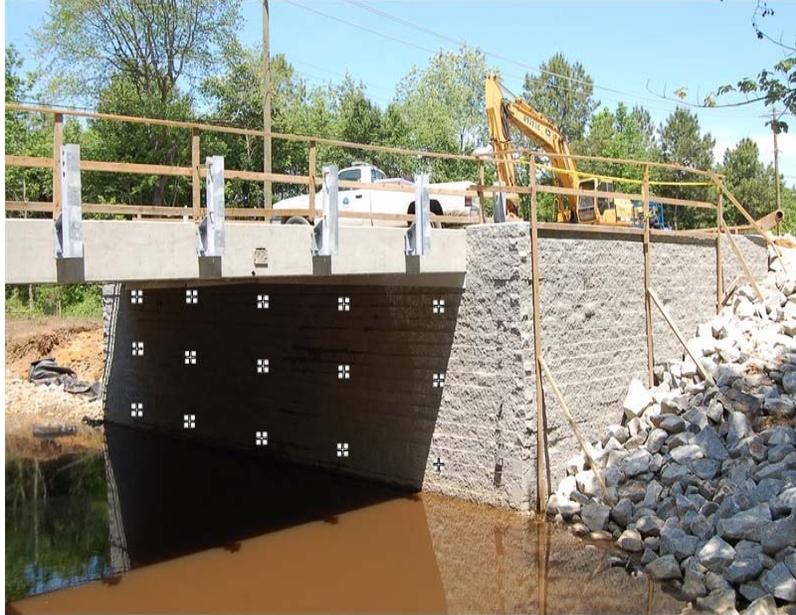
Figure 3.14 East abutment facing wall surveying points

Surveying targets were installed on each abutment facing wall to monitor facing wall settlement and lateral deflection during in-service operation of the GRS-IBS. Fifteen targets were installed on each abutment facing wall; targets were installed at three different elevations with five targets at each elevation spanning the width of the abutment facing wall. Surveying data was collected on a weekly basis for the first two months of the project to ensure no significant displacements were occurring. After this, data was collected monthly for approximately the following year. Data was then collected bi-monthly for the year after that, and bi-annually for the year after that. As time went on, it was concluded that the structure was not moving significantly so surveying was performed less frequently. The relative accuracy of measurements for the surveying approach that was used in this study was approximately 6 mm. Figure 3.14 shows the surveying points on the east abutment facing wall; the surveying points are located in the same positions on the west abutment facing wall.

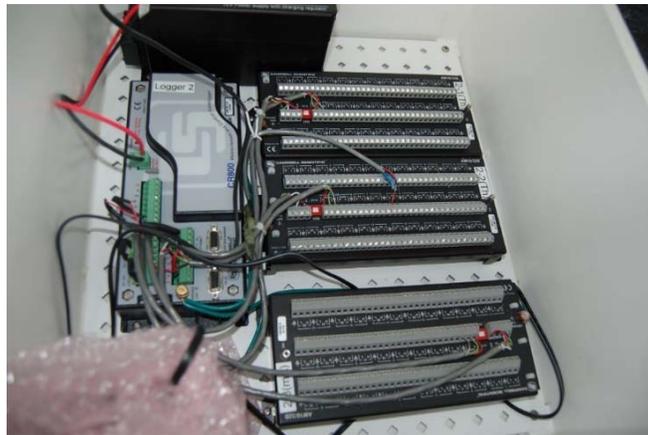
Figure 3.15 CR800 logger

The loggers are programmed with CRBasic and the source of the logger program, named Logger1 CR1000.CR1, is supplied on the USB drive; it is viewable with an ASCII editor. Logger

I had the program already loaded into it by itmsoil USA. To send the program to the logger, the PC200W program provided by itmsoil USA was used. Figure 3.15 and 3.16 display the loggers.

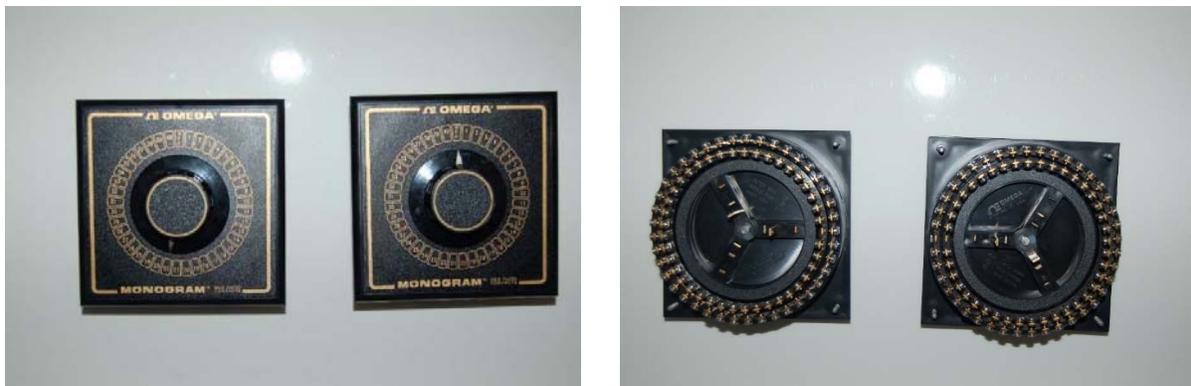
Figure 3.17 Front and back view of rotary data switches

For the east GRS-IBS abutment, two rotary data switches manufactured by Omega (OSWG5-40) were utilized for the data collection of the 75 installed sensors (Figure 3.17). From these rotary switches, raw data was collected manually approximately every two weeks over the course of each monitoring period. A multimeter was used to collect this data as the raw data was outputted in ohms and the data was later converted to engineering units.

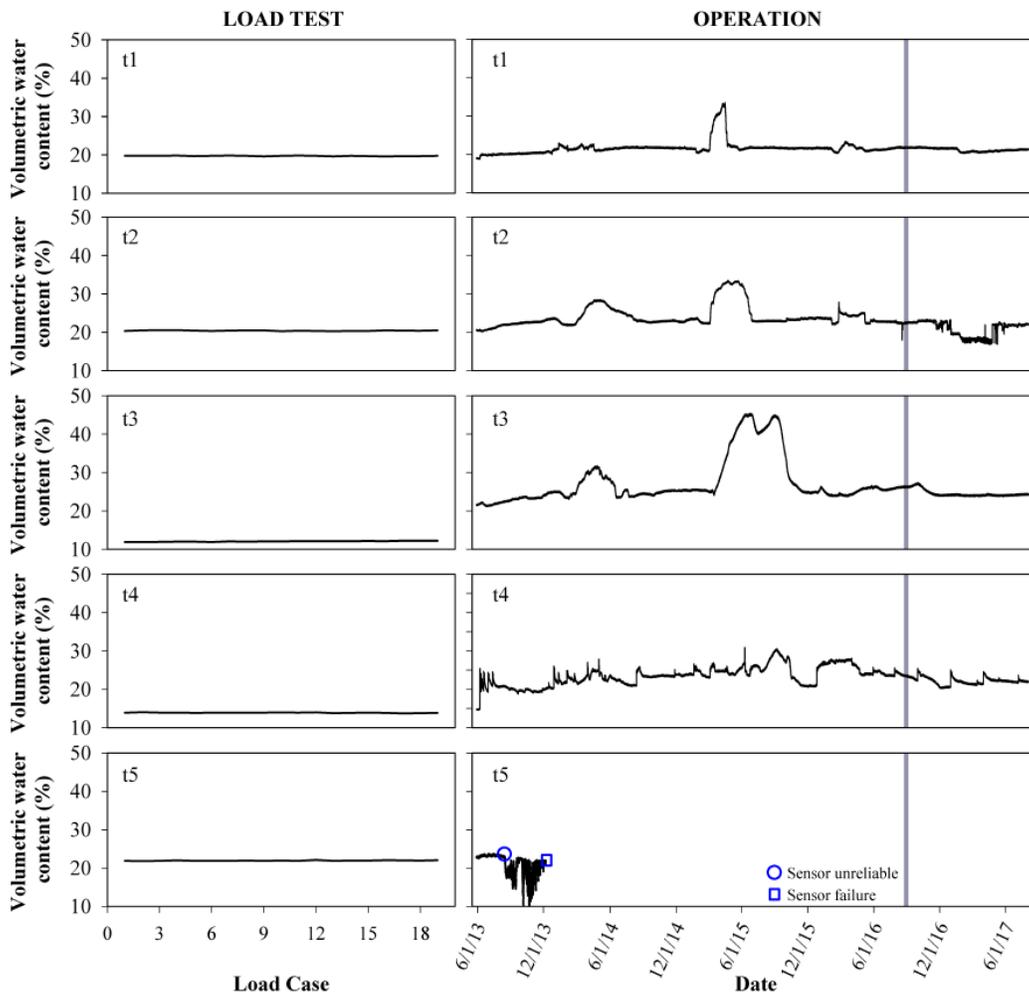
Figure 4.1 Measured volumetric water content

Five volumetric water content sensors were installed at different elevations in the west abutment to measure the change in moisture content within the abutment over time. As discussed in Chapter 3, the use of these sensors also makes it possible to investigate the effect of increases in water content due to precipitation or changes in the river elevation. Figure 4.1 shows the changes in volumetric water content that occurred during live load testing and both monitoring periods; no data was recorded for these sensors during the construction process.

water elevation between the two monitoring periods. The spikes seen in the measured pore water pressures are consistent with the spikes seen in Figures 4.7 and 4.8, suggesting that storm events or any increase in precipitation affects the river water elevation, as expected, while also increasing the water content within the abutment and the pore water pressure readings. This is directly supported by what is presented in Figures 4.1 and 4.6.

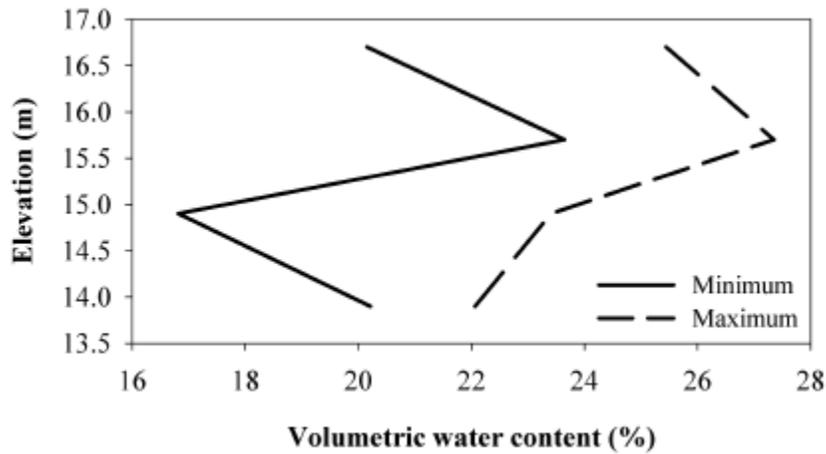
Figure 4.5 Minimum and maximum measured water content profile for the current monitoring period

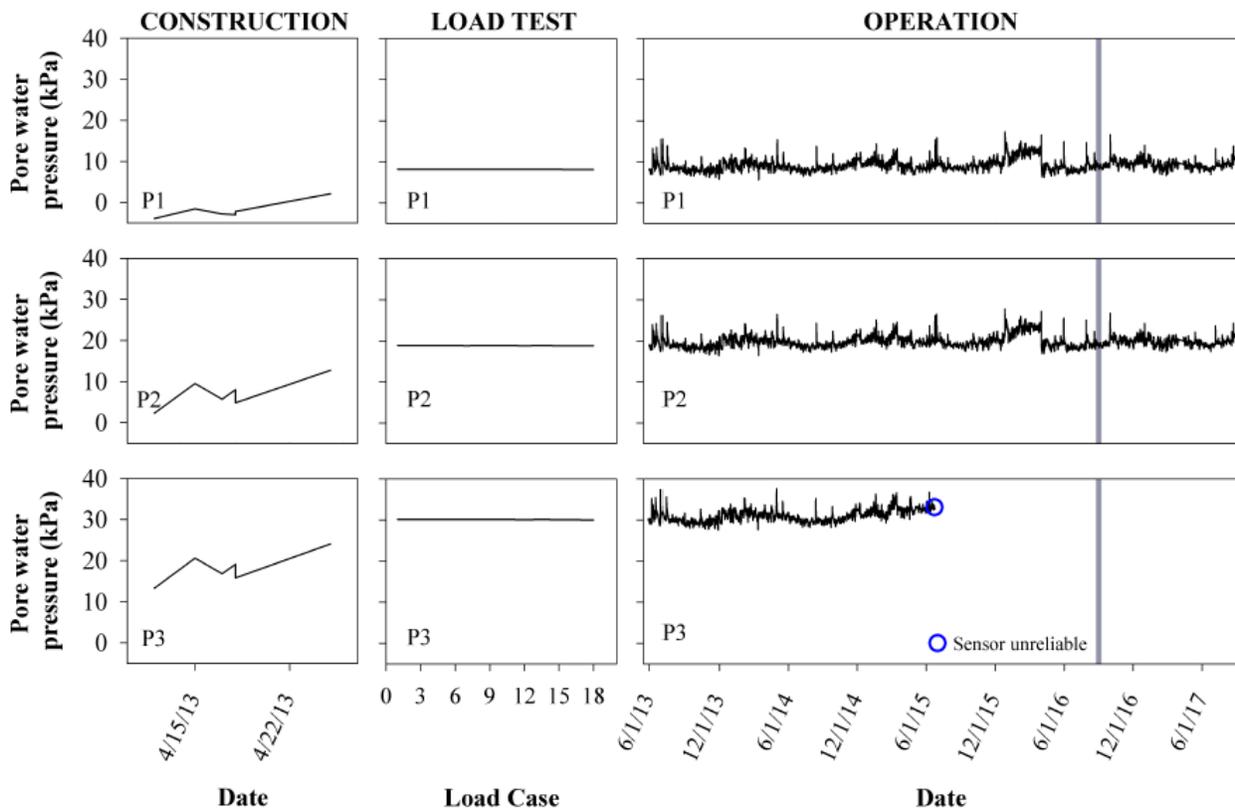
Figure 4.6 Measured pore water pressures

As shown, the pore pressure was generally steady over both monitoring periods of operation with spikes in pore pressure at the same time in each sensor. The pore water pressure for the current monitoring period is consistent with what was observed in the previous monitoring period.

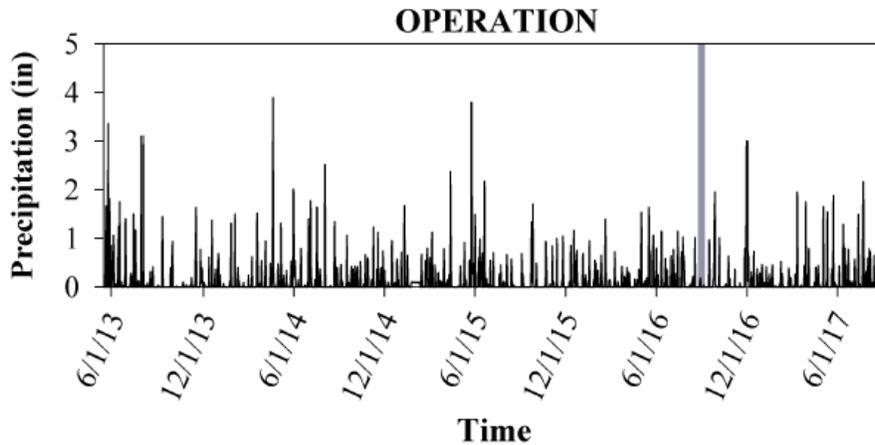
Figure 4.7 Measured precipitation

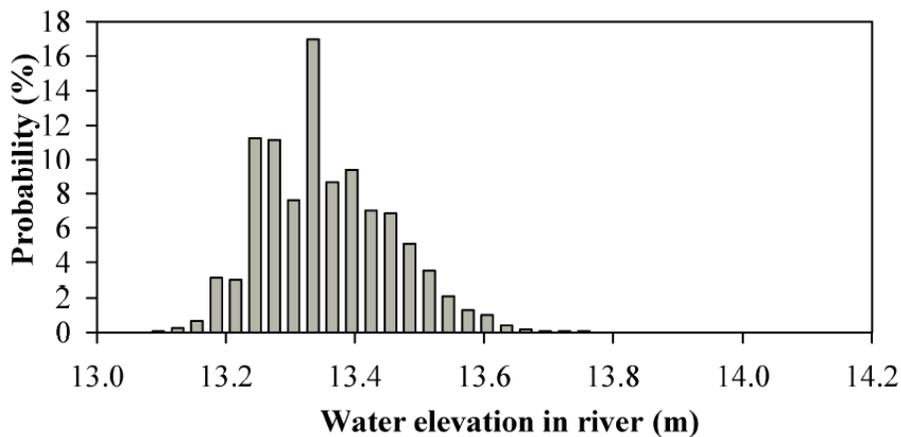
Figure 4.10 Histogram of water elevation in the river for the current monitoring period

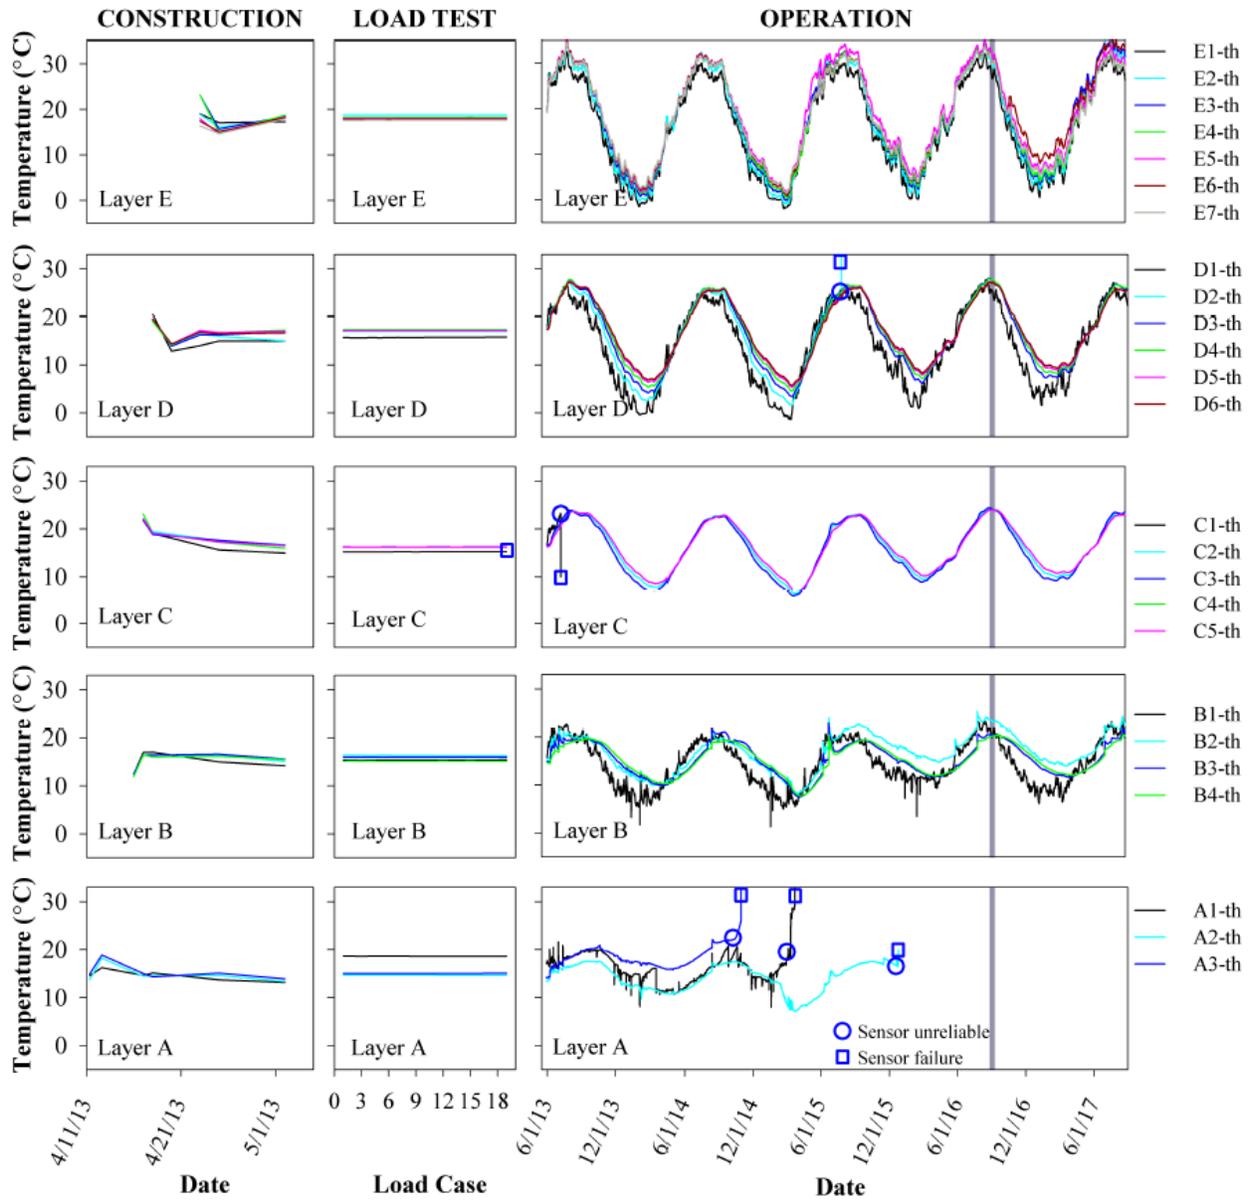
Figure 4.11 Recorded temperatures in the west abutment

The majority of the sensors are still working after the last monitoring period, which shows that the initial waterproofing process that was utilized for the thermistors was successful. Sensors A1-th, A-2th, A3-th, C1-th, C4-th, D2-th, G1-th, H2-th, J6-th and J7-th all failed during the first monitoring period. As stated in Talebi (2016), the reason for sensor failure is not clear but it is speculated the presence of water is to blame.

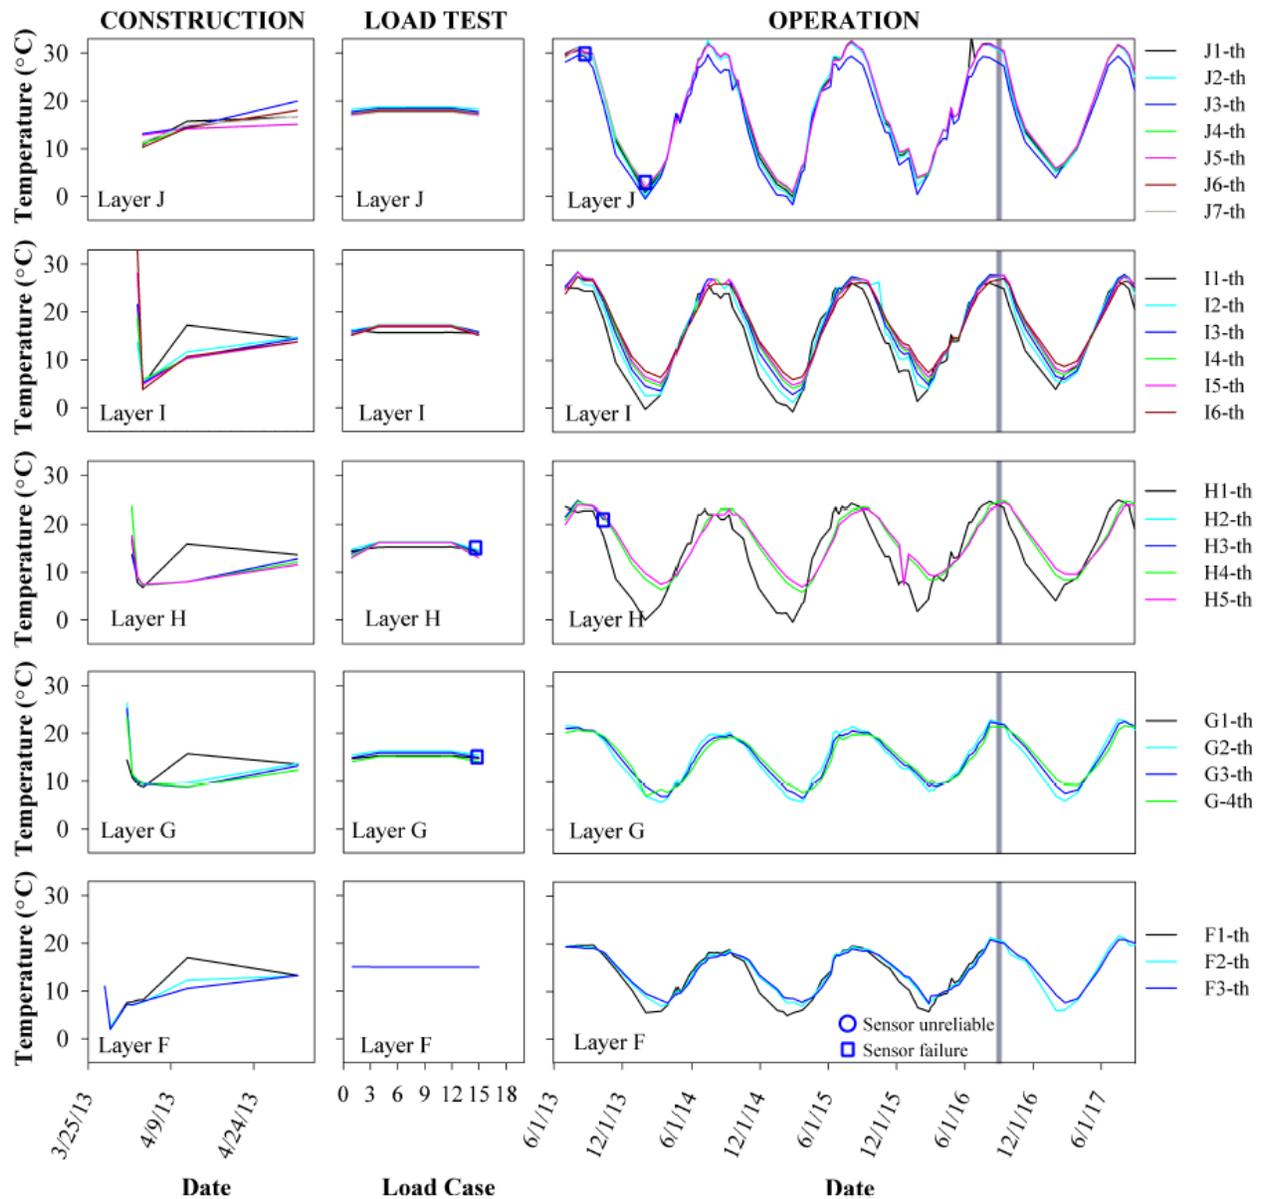
Figure 4.12 Recorded temperatures in the east abutment

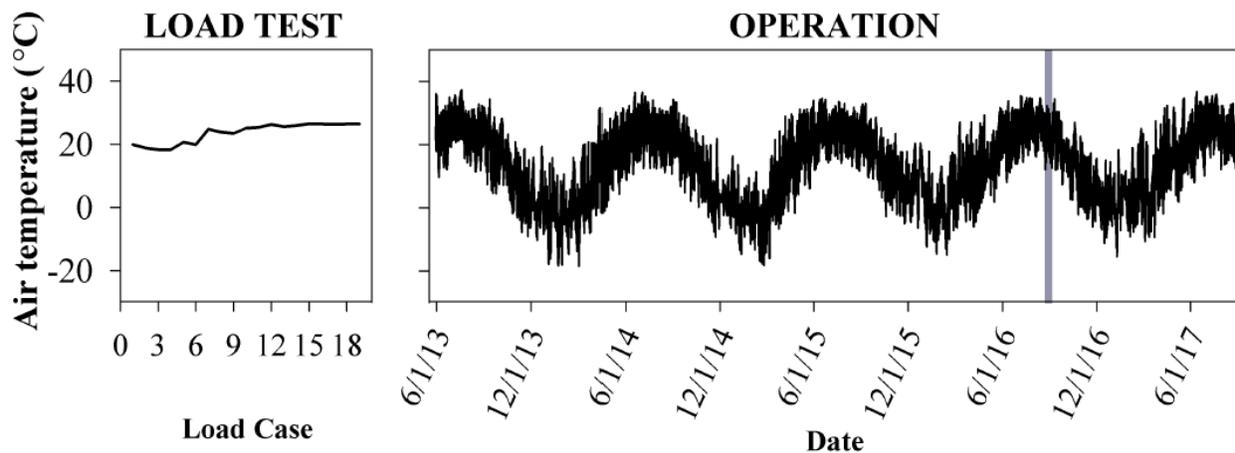
Figure 4.13 Ambient air temperature

Figure 4.13 displays the ambient air temperature that was recorded at the datalogger location. It can be seen that the thermistor readings follow the same trend as the ambient air temperature readings but with less noise.

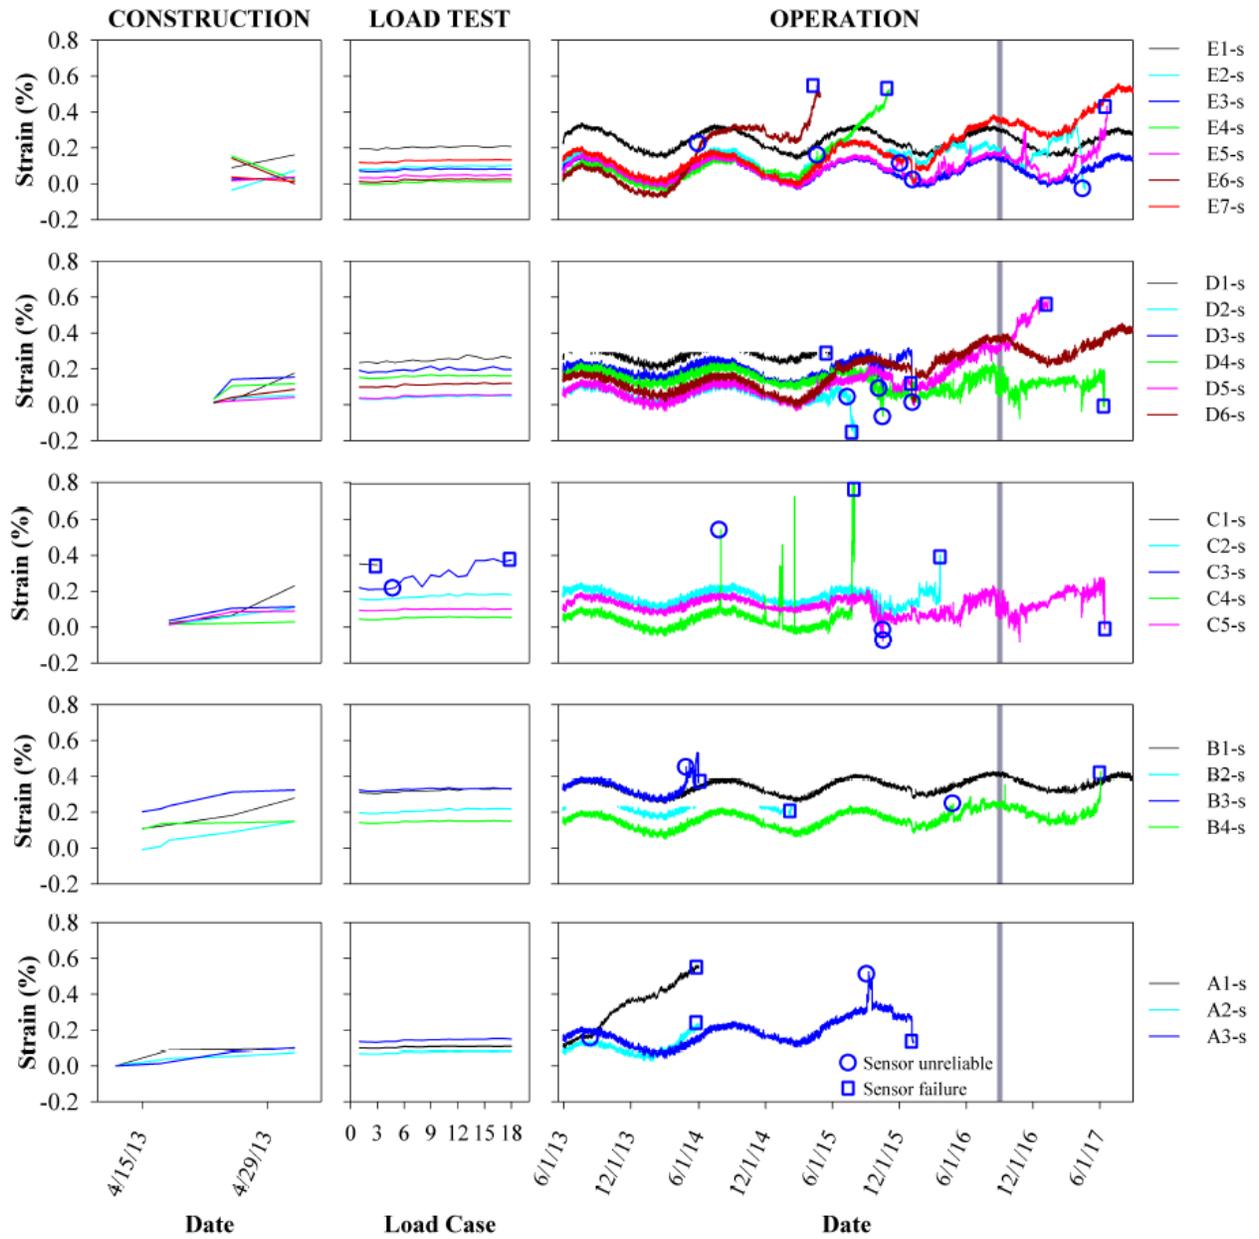
Figure 4.14 West abutment short strain gauge readings (uncorrected)

Two different types of strain gauges were utilized in this project to monitor strain in the geotextile. Figures 4.14 and 4.15 show the strain gauge readings in the west abutment during construction, live load testing, and both monitoring periods for the short and long strain gauges, respectively. As shown, all strain readings of properly working gauges were less than 0.5%. It can also be observed that the strain readings follow the same pattern as the temperature readings produced by the thermistors. As explained in Talebi (2016), there is a clear effect of temperature on strain gauge readings and it should be corrected for. A detailed method for correcting field strain measurements to account for temperature effects is presented in Meehan and Talebi (2017). The resulting corrected strains for each short strain gauge and each long strain gauge in the west abutment are presented in Figures 4.16 and 4.17 respectively; plots for C1-s and C3-s are not presented since they stopped working during the live load testing. From these figures, it can be observed that the estimated amount of creep from the start of the first monitoring period to the end of this current monitoring period was generally less than 0.1%.

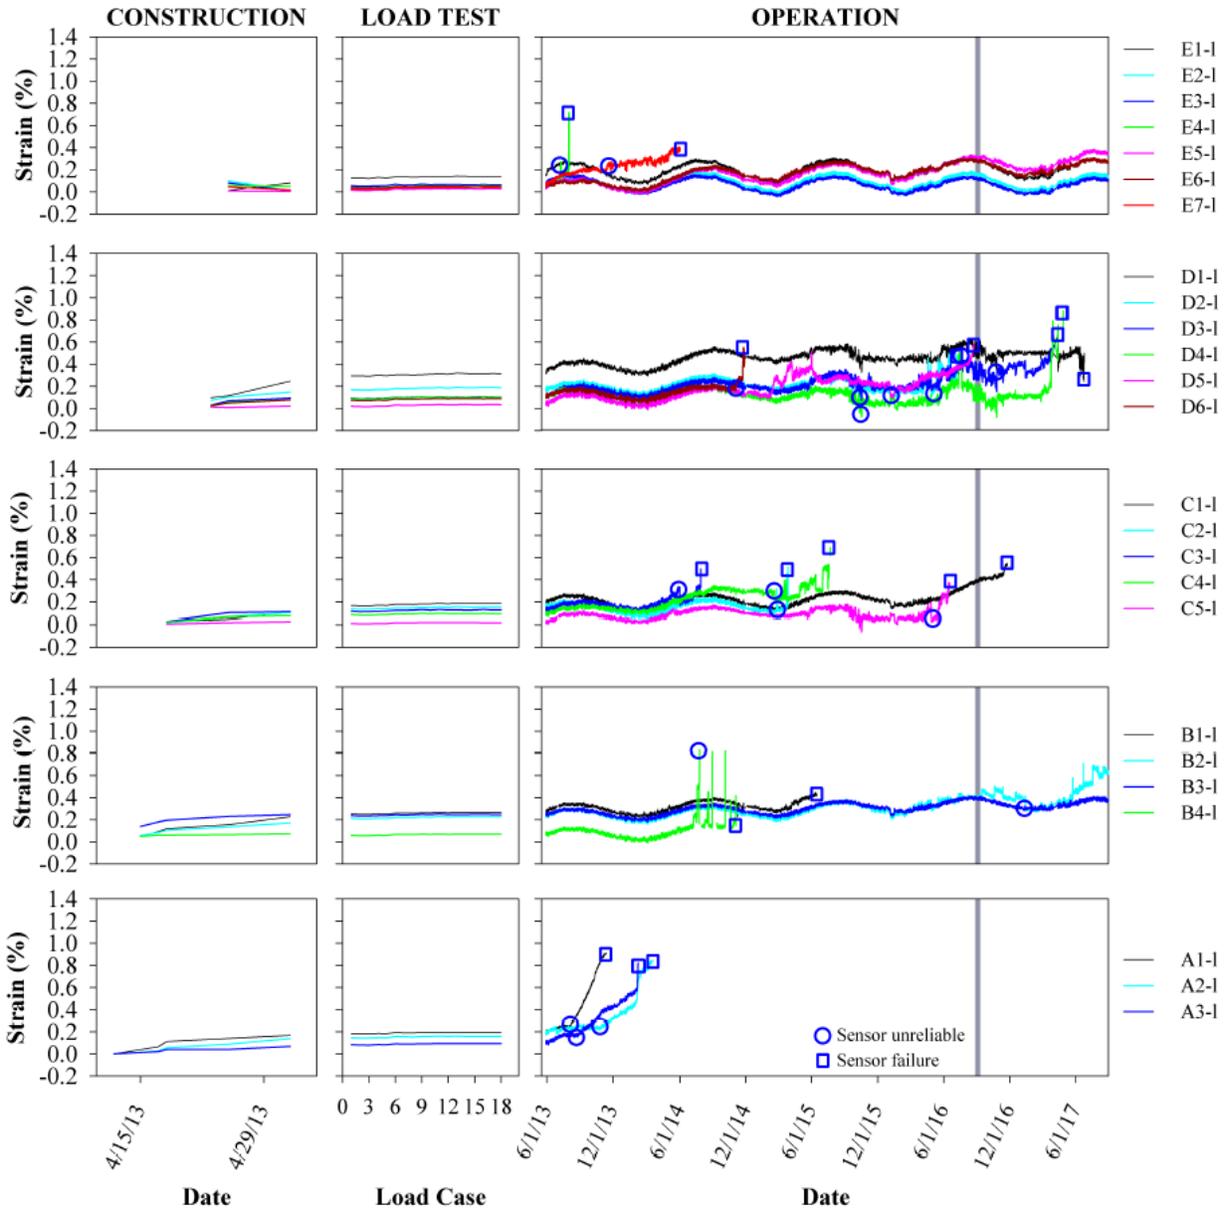
Figure 4.15 West abutment long strain gauge readings (uncorrected)
