Long-Term Monitoring of a Geosynthetic Reinforced Soil Integrated Bridge System (GRS-IBS)

FINAL REPORT
November 2017

Christopher L. Meehan
Associate Professor

University of Delaware, Department of Civil and Environmental Engineering
301 DuPont Hall, Newark, DE 19716, U.S.A.

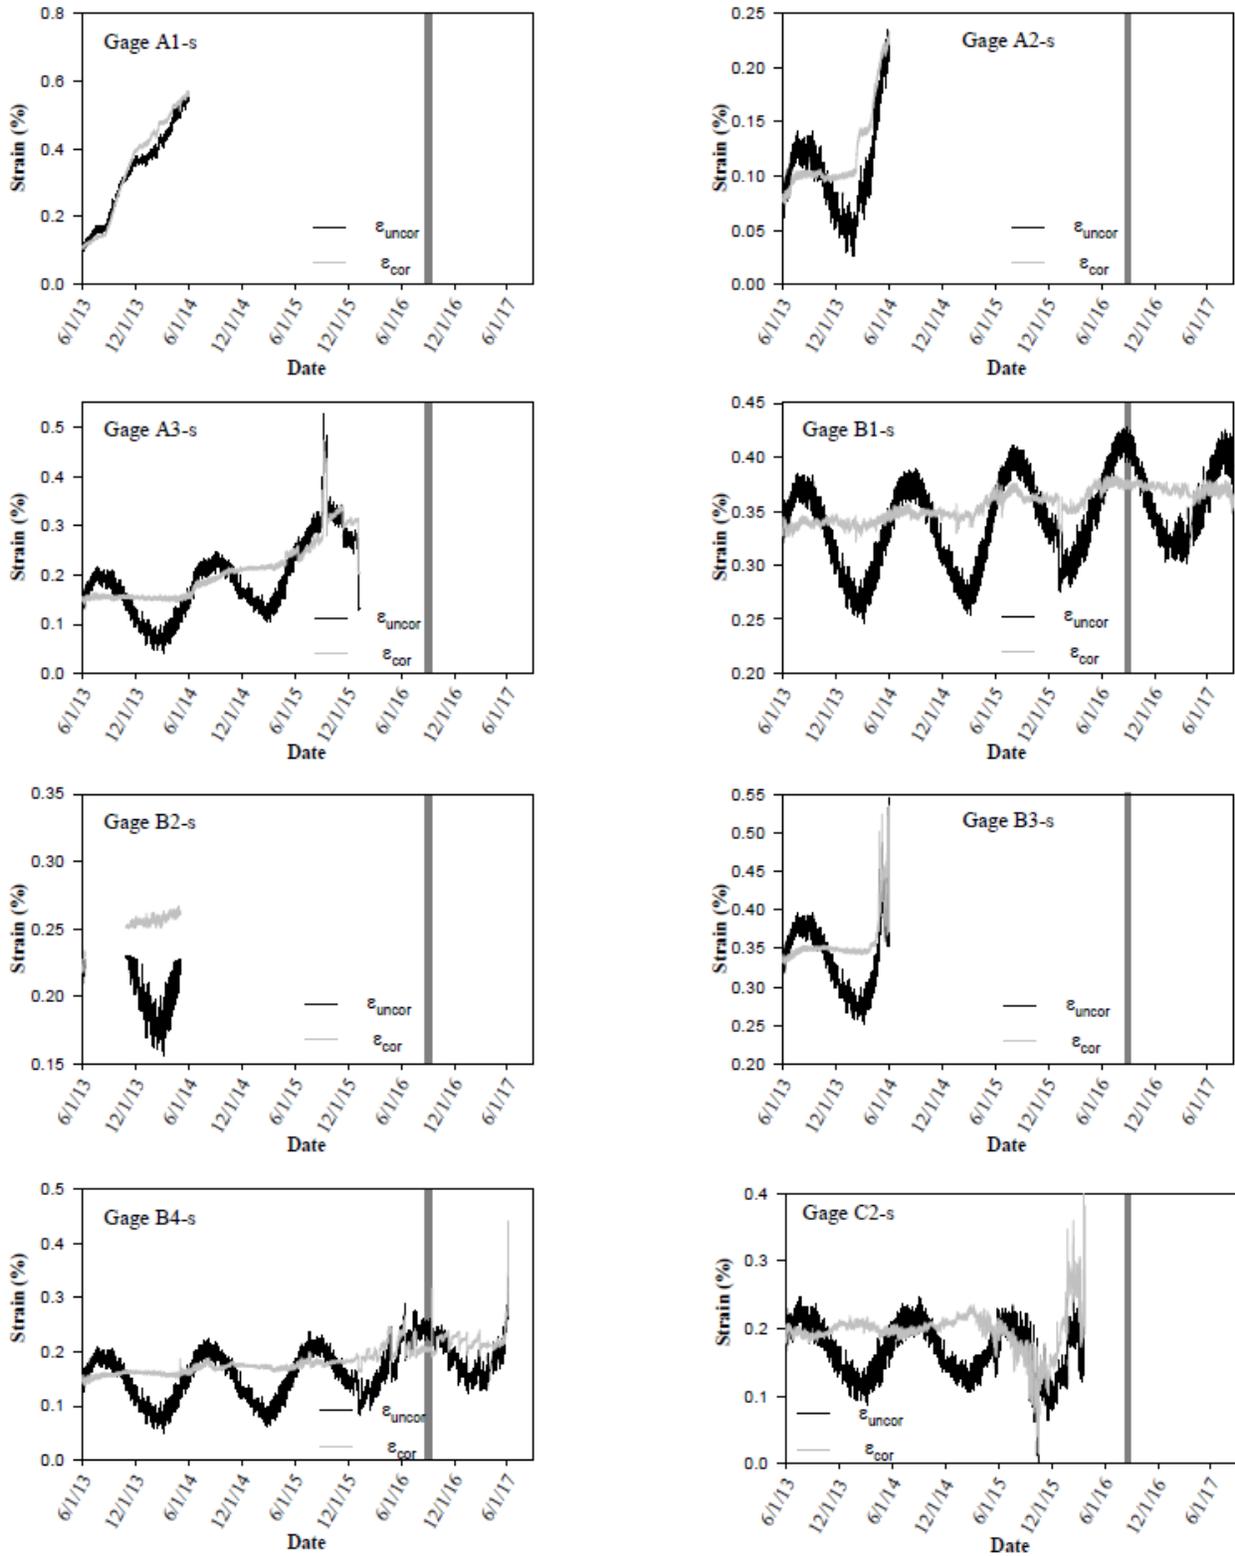
Figure 4.16 West abutment short strain gauge readings (corrected)

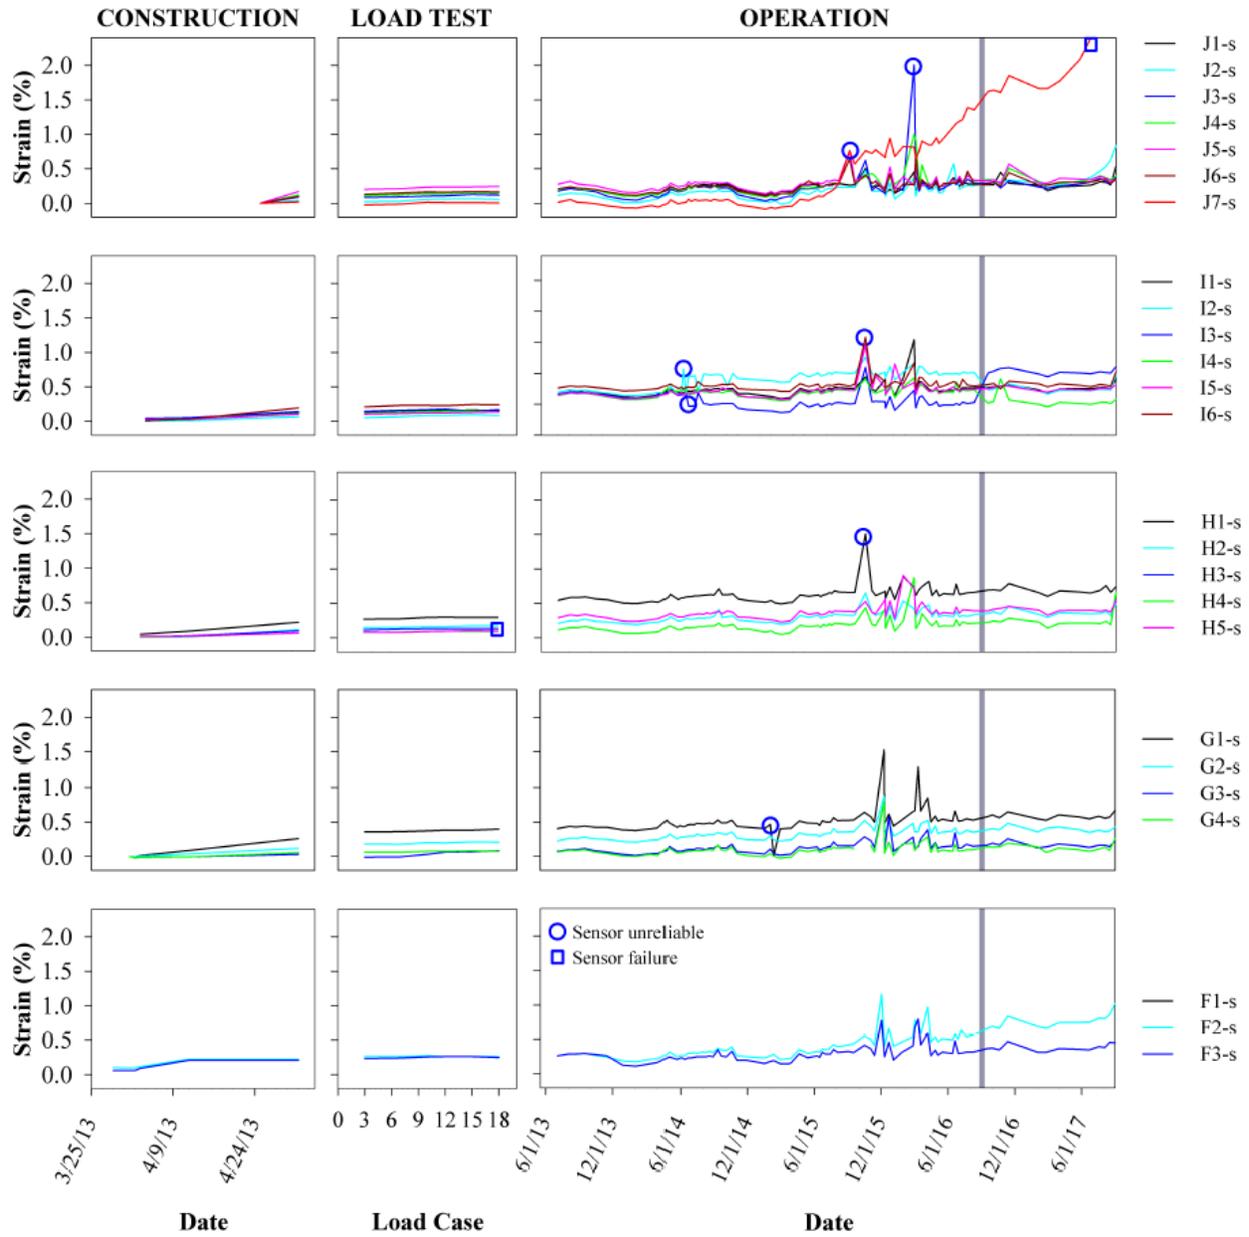
Figure 4.18 East abutment short strain gauge readings (uncorrected)

this is in part due to the fact that readings were taken more frequently in the west abutment over the east abutment so outlying data points can be picked up on more accurately.

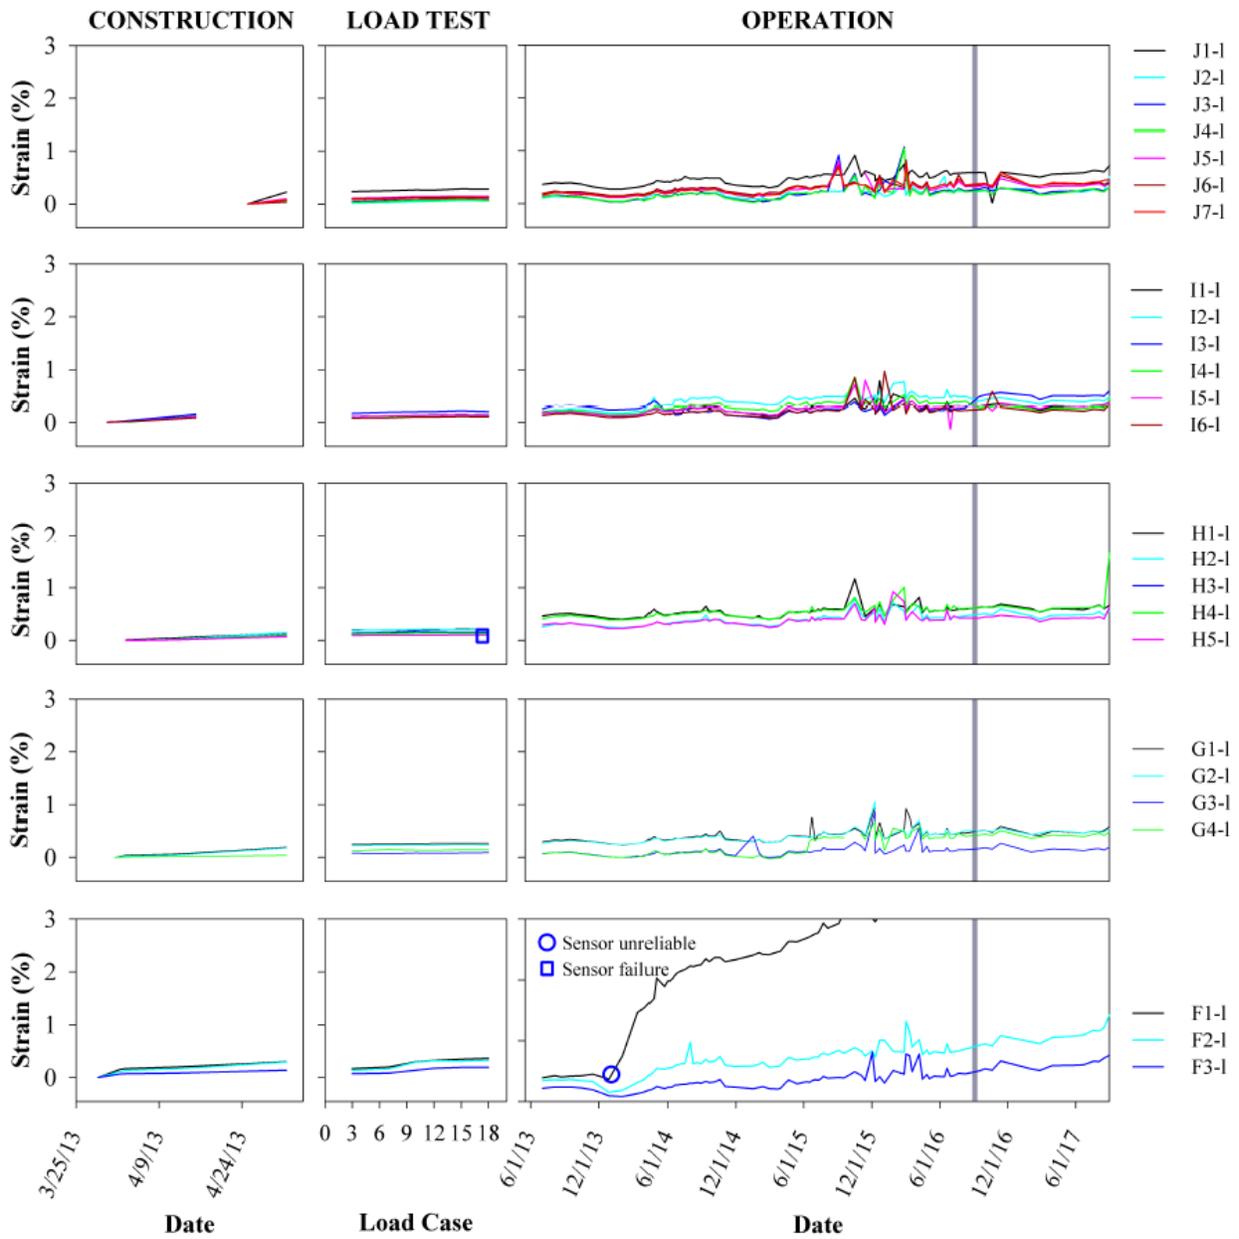
Figure 4.19 East abutment long strain gauge readings (uncorrected)

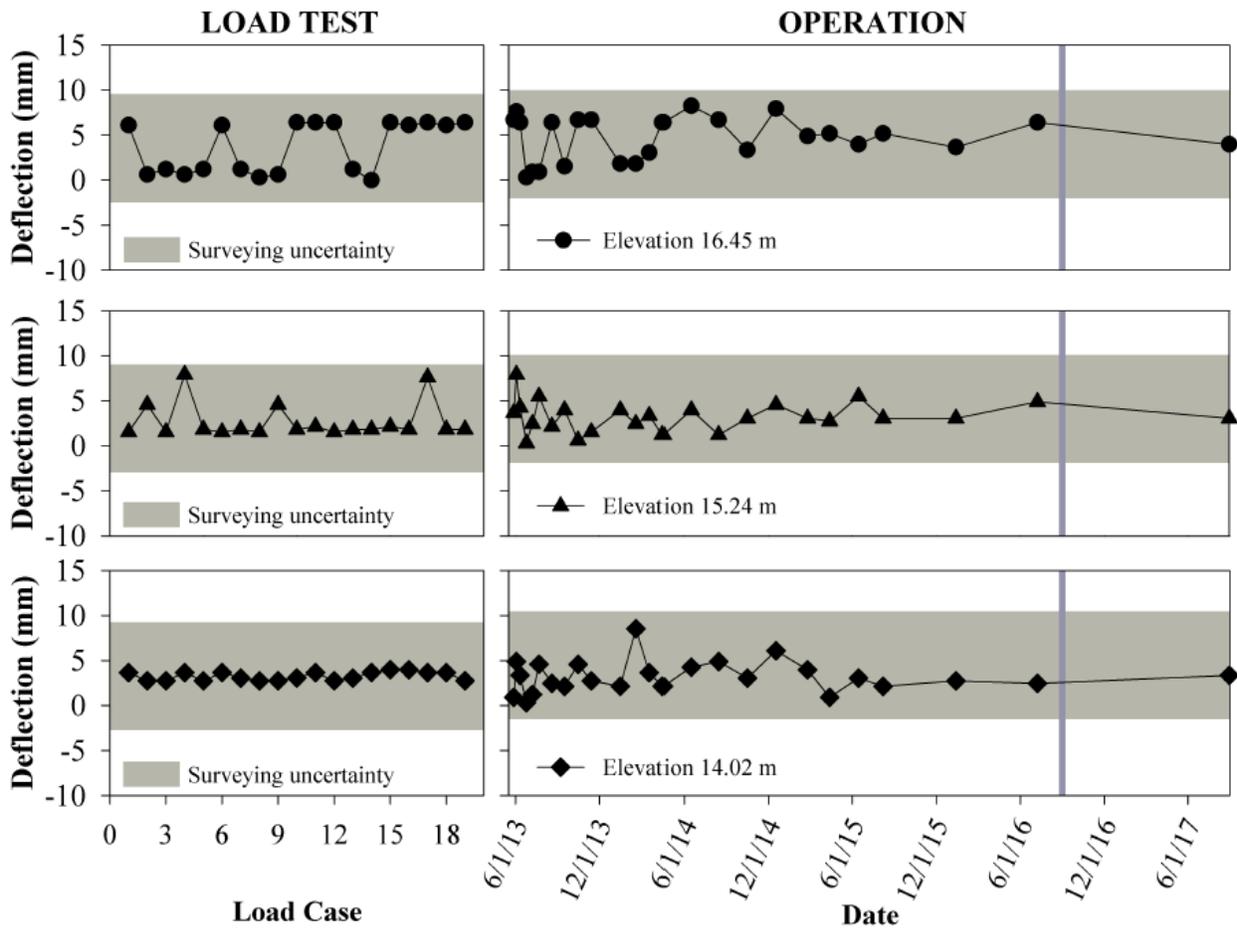
Figure 4.21 Lateral deflection of the east facing wall at the abutment centerline

The maximum measured settlement and maximum lateral wall deflection were both approximately 13 mm. Generally speaking however, measurements of settlement and displacement were much lower than this, and exhibited noise due to accuracy limitations of the surveying approach that was utilized. Clearly, with all of the measured settlements and lateral deflections being this small, it can be concluded that a very low amount of overall deformation of the abutment occurred.

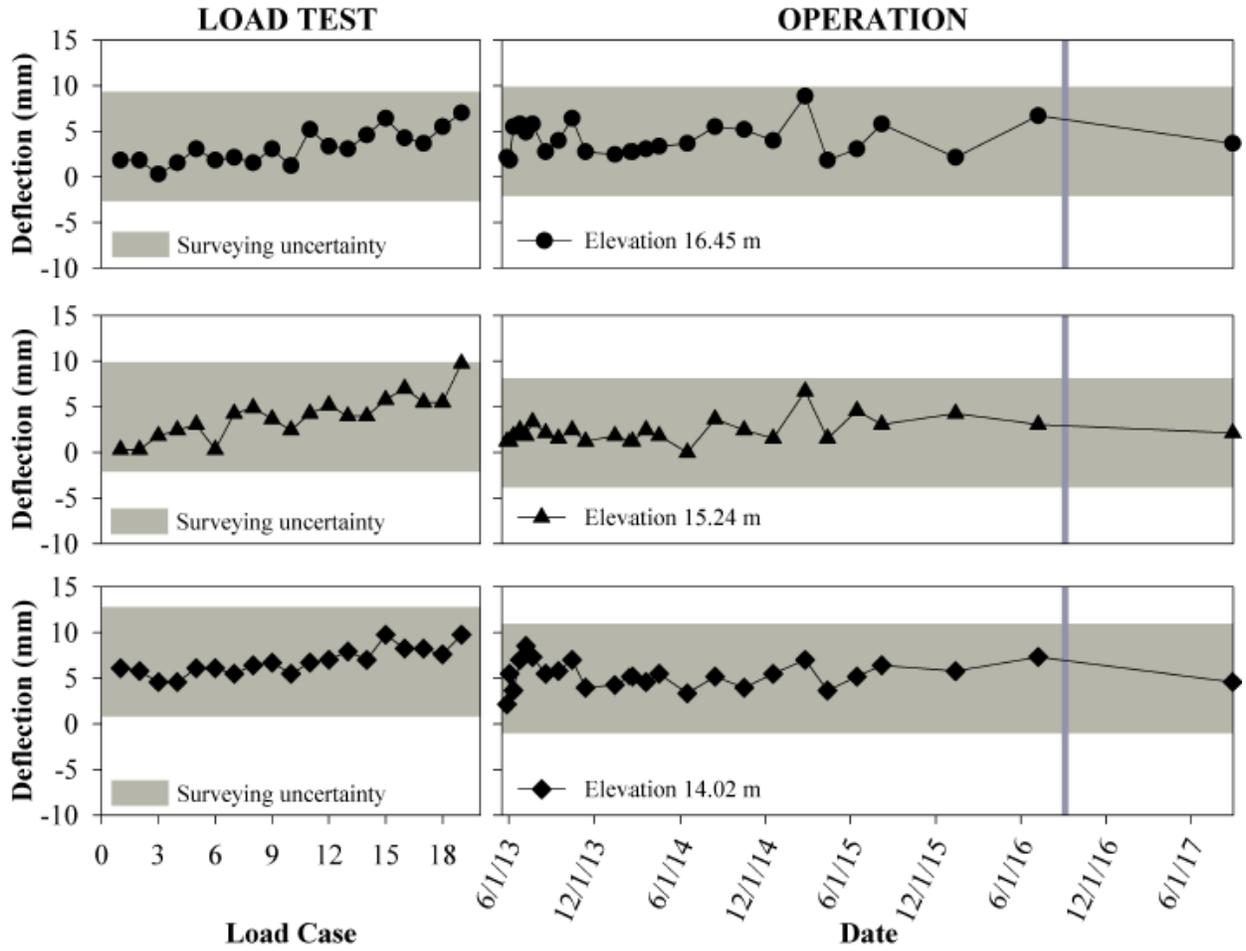
Figure 4.22 Lateral deflection of the west facing wall at the abutment centerline

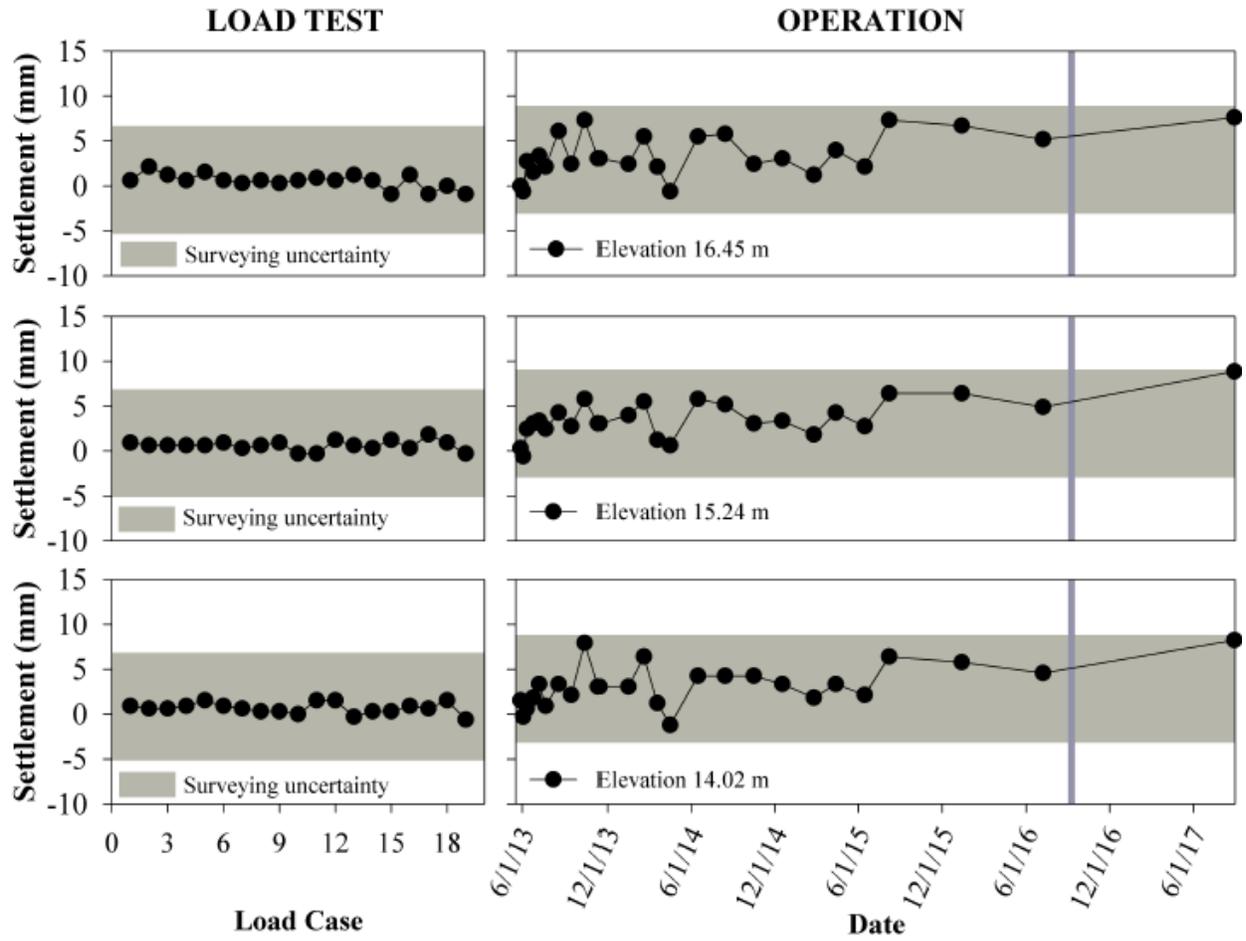
Figure 4.23 Settlement of the east facing wall at the abutment centerline

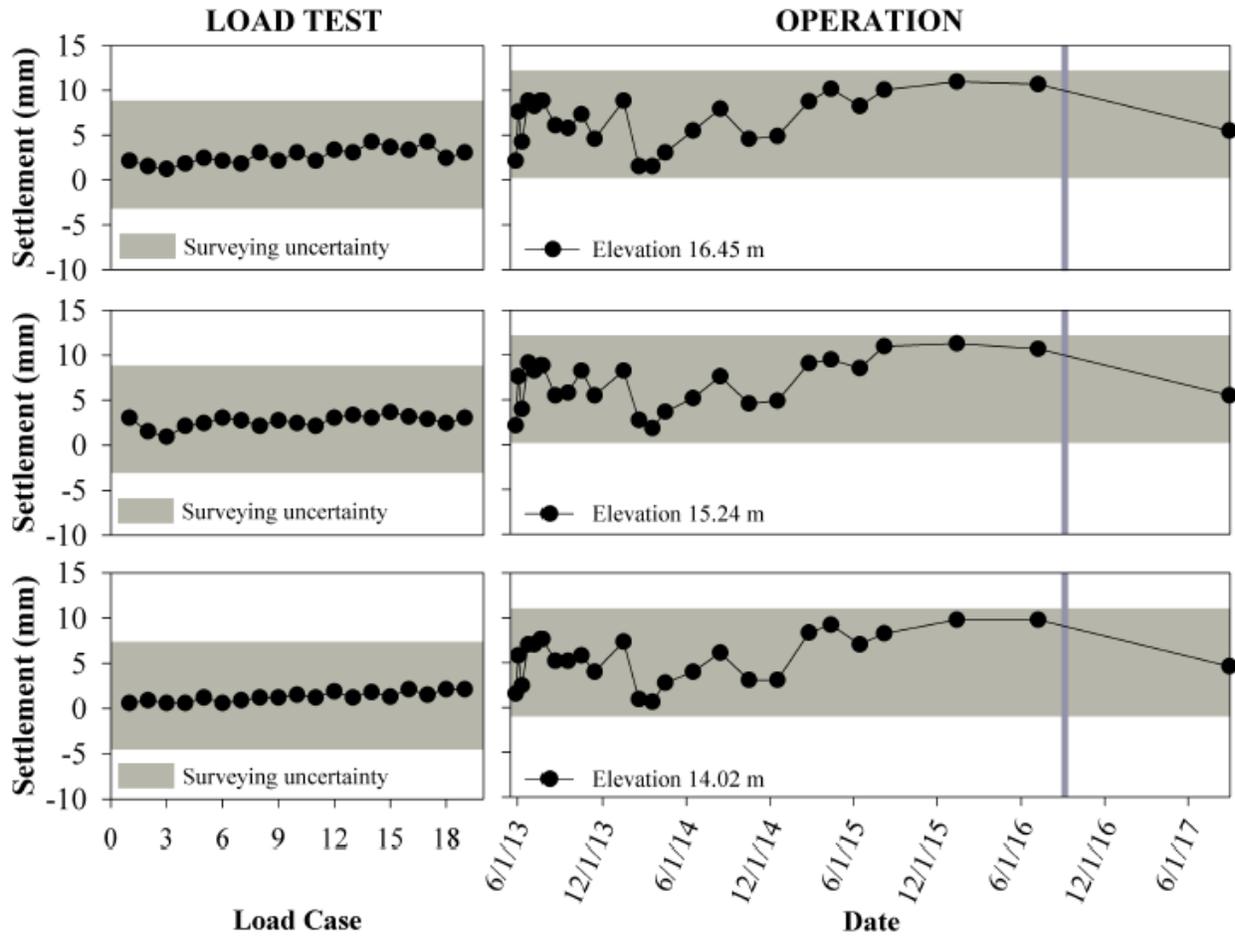
Figure 4.24 Settlement of the west facing wall at the abutment centerline

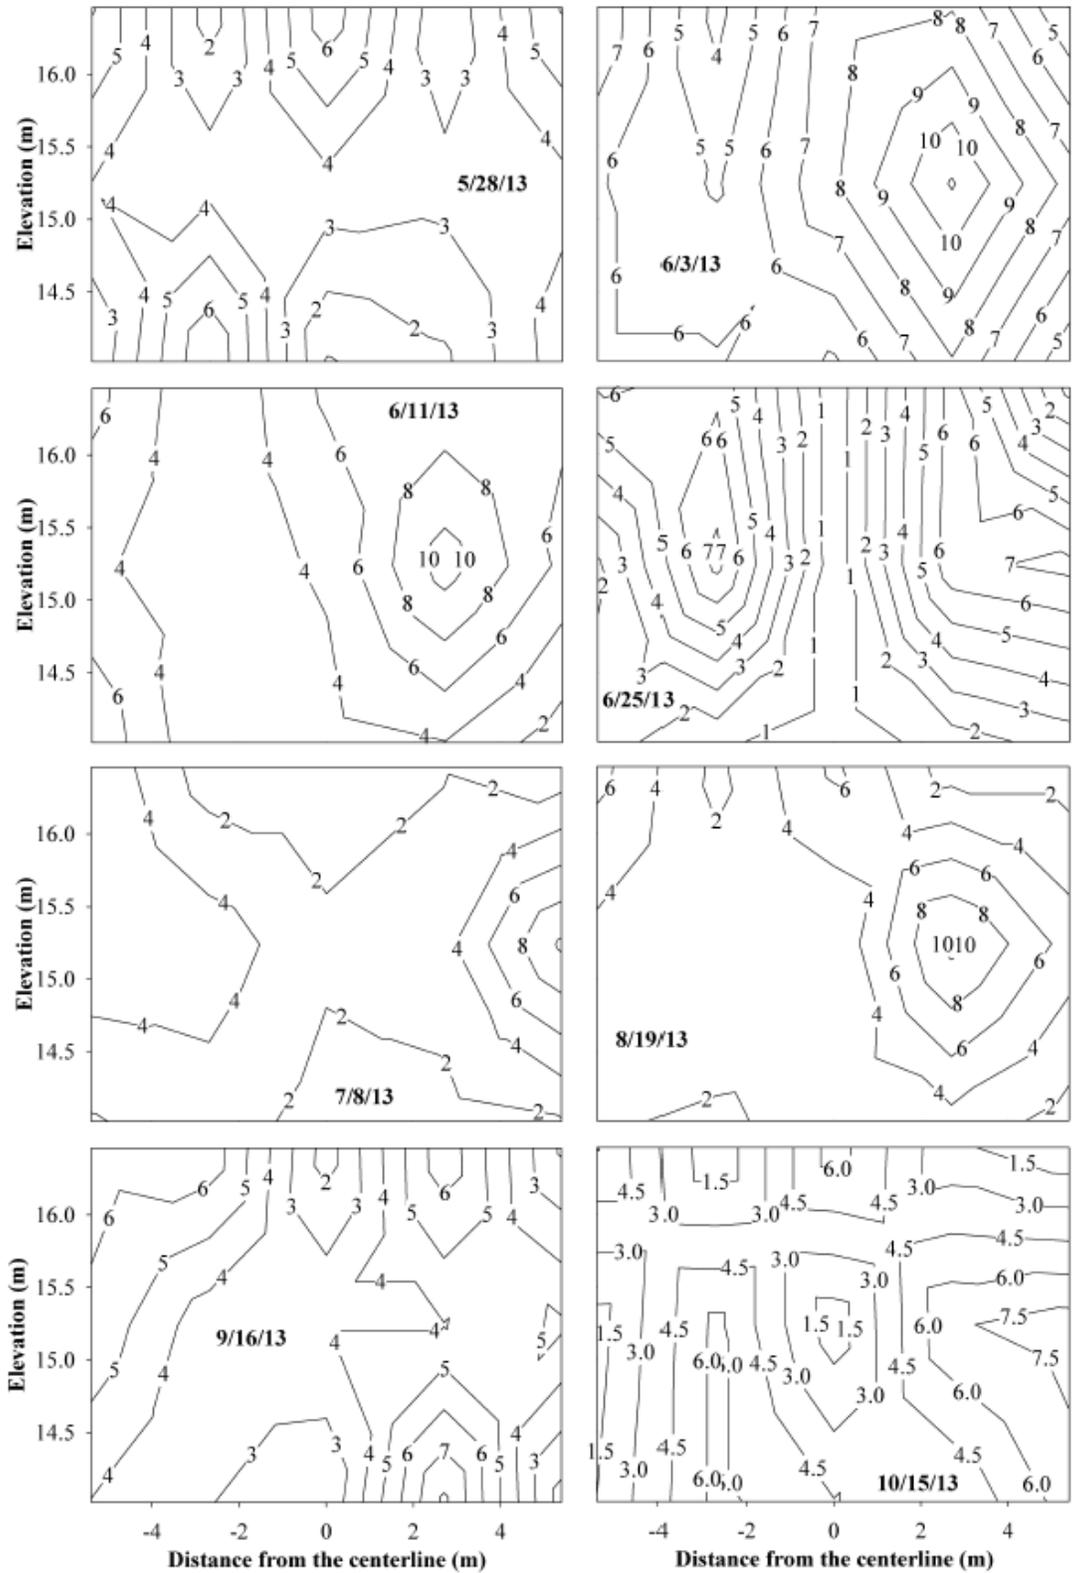
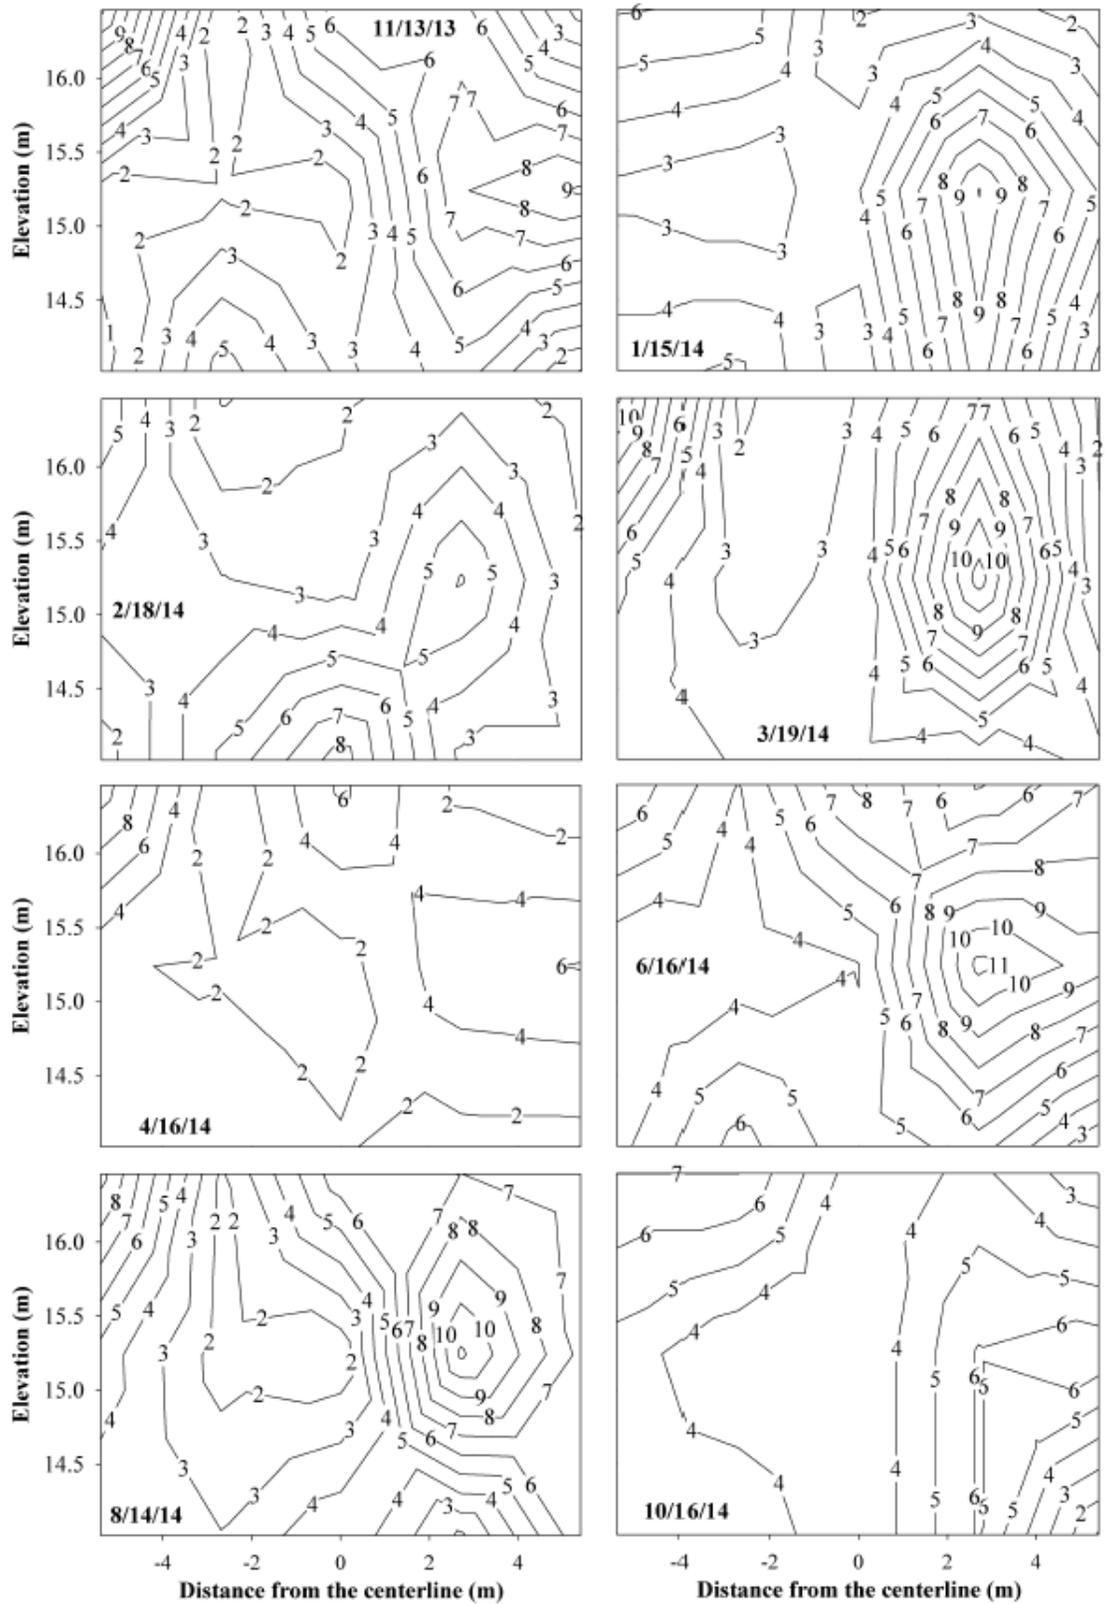
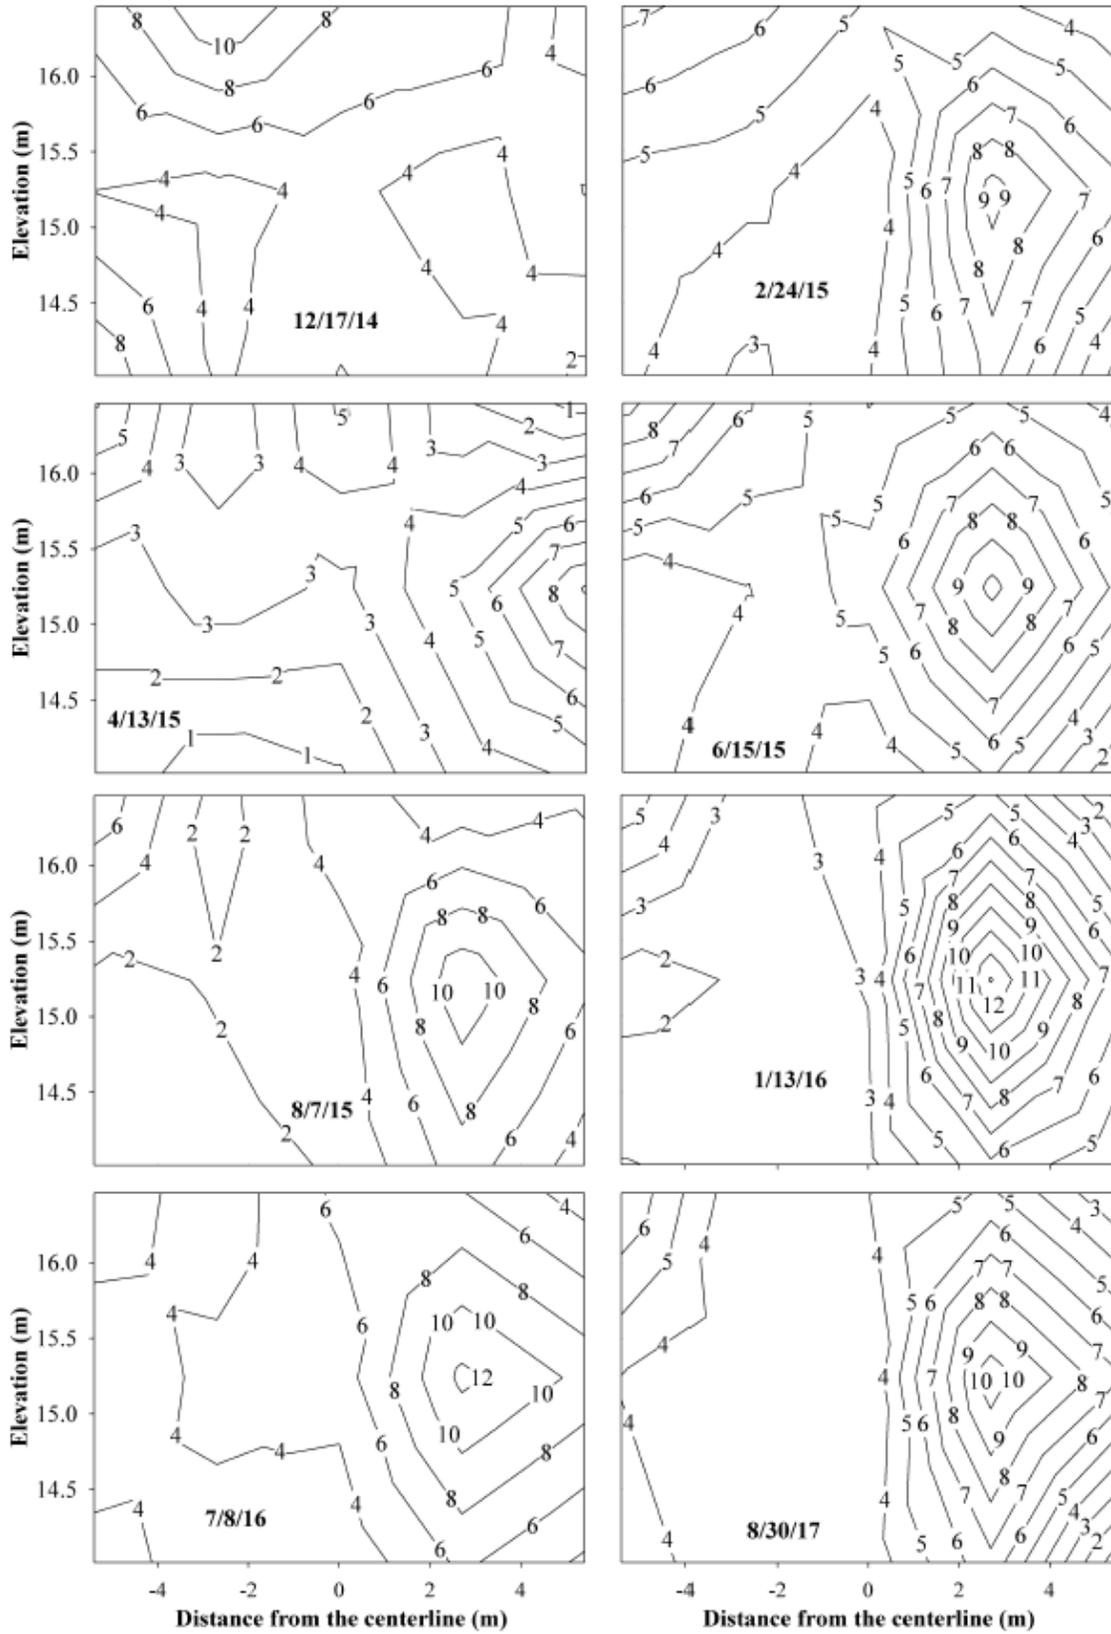
Figure 4.41 Contour plots of the east facing wall deflection over both monitoring periods

Contour plots of the east and west facing wall lateral deflection for both monitoring periods are presented in Figures 4.41 and 4.42 respectively. As discussed in Chapter 3, there was not a continuous trend over time when surveying would be conducted. As time went on and less movement was seen, surveying was conducted less frequently. Figures 4.43 and 4.44 show the contour plots of facing wall settlement for both monitoring periods for the east and west abutments, respectively. Figures 4.41 through 4.44 show that the maximum lateral deflections and settlements were both approximately 13 mm, and also that most measured values were significantly less than that amount (generally in the 5 to 10 mm range).

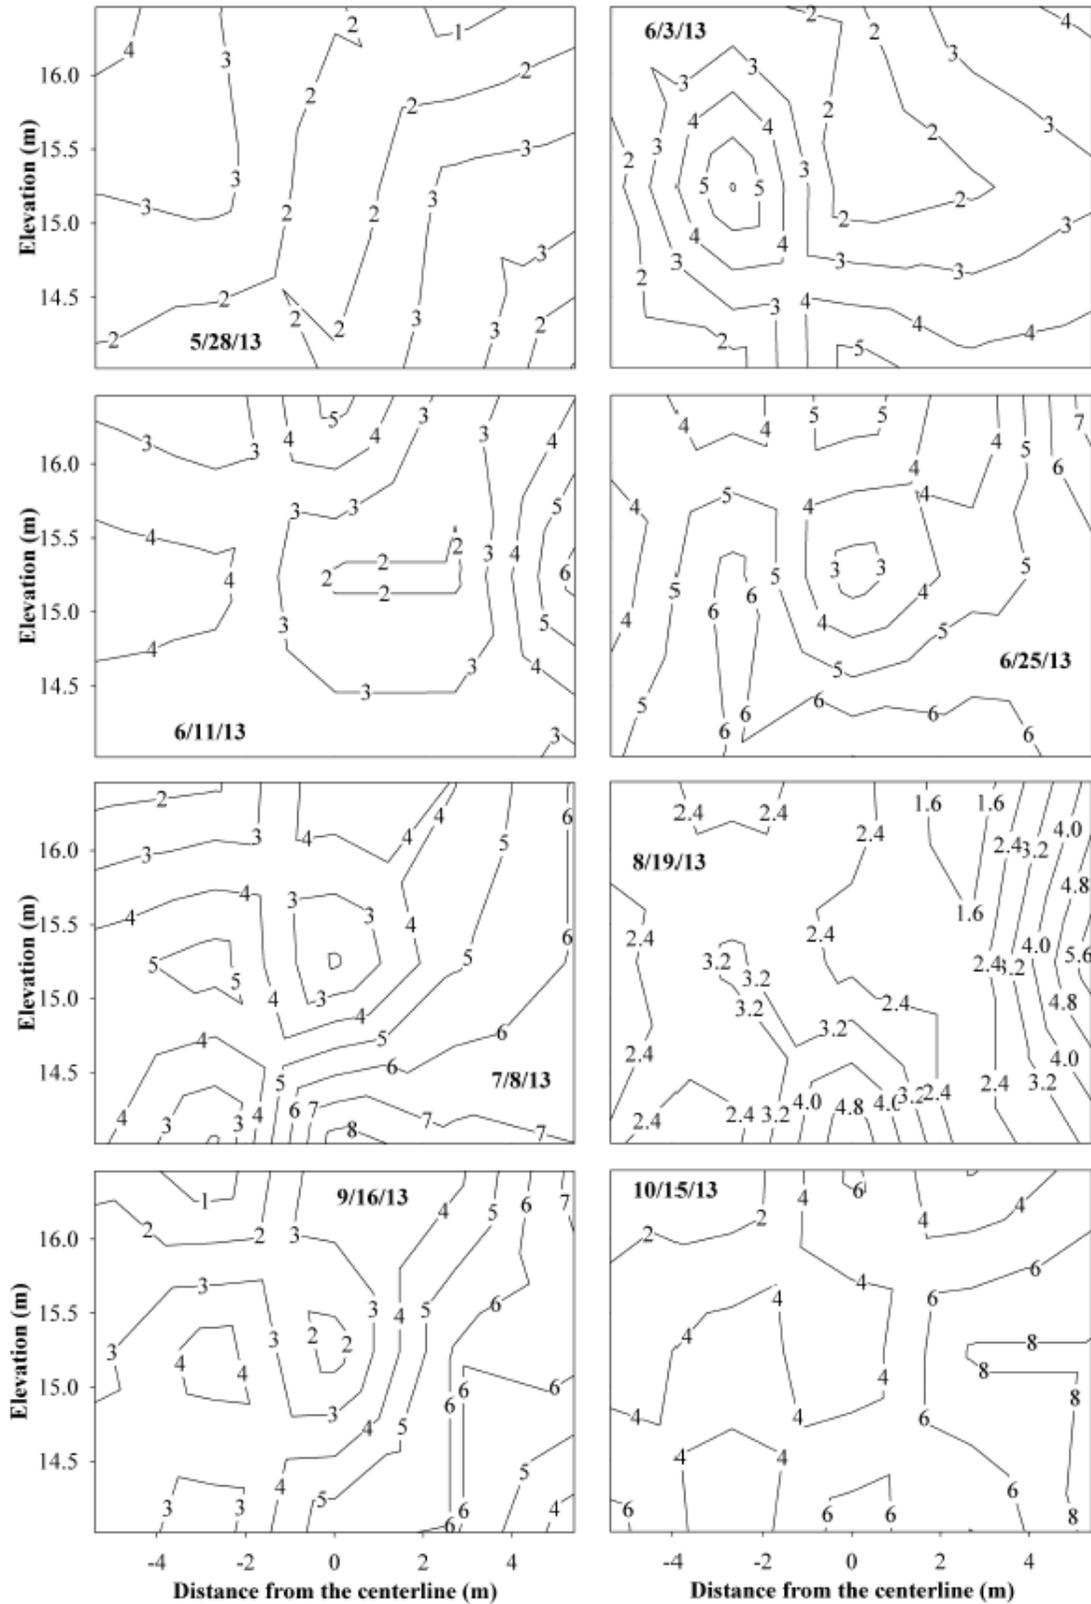
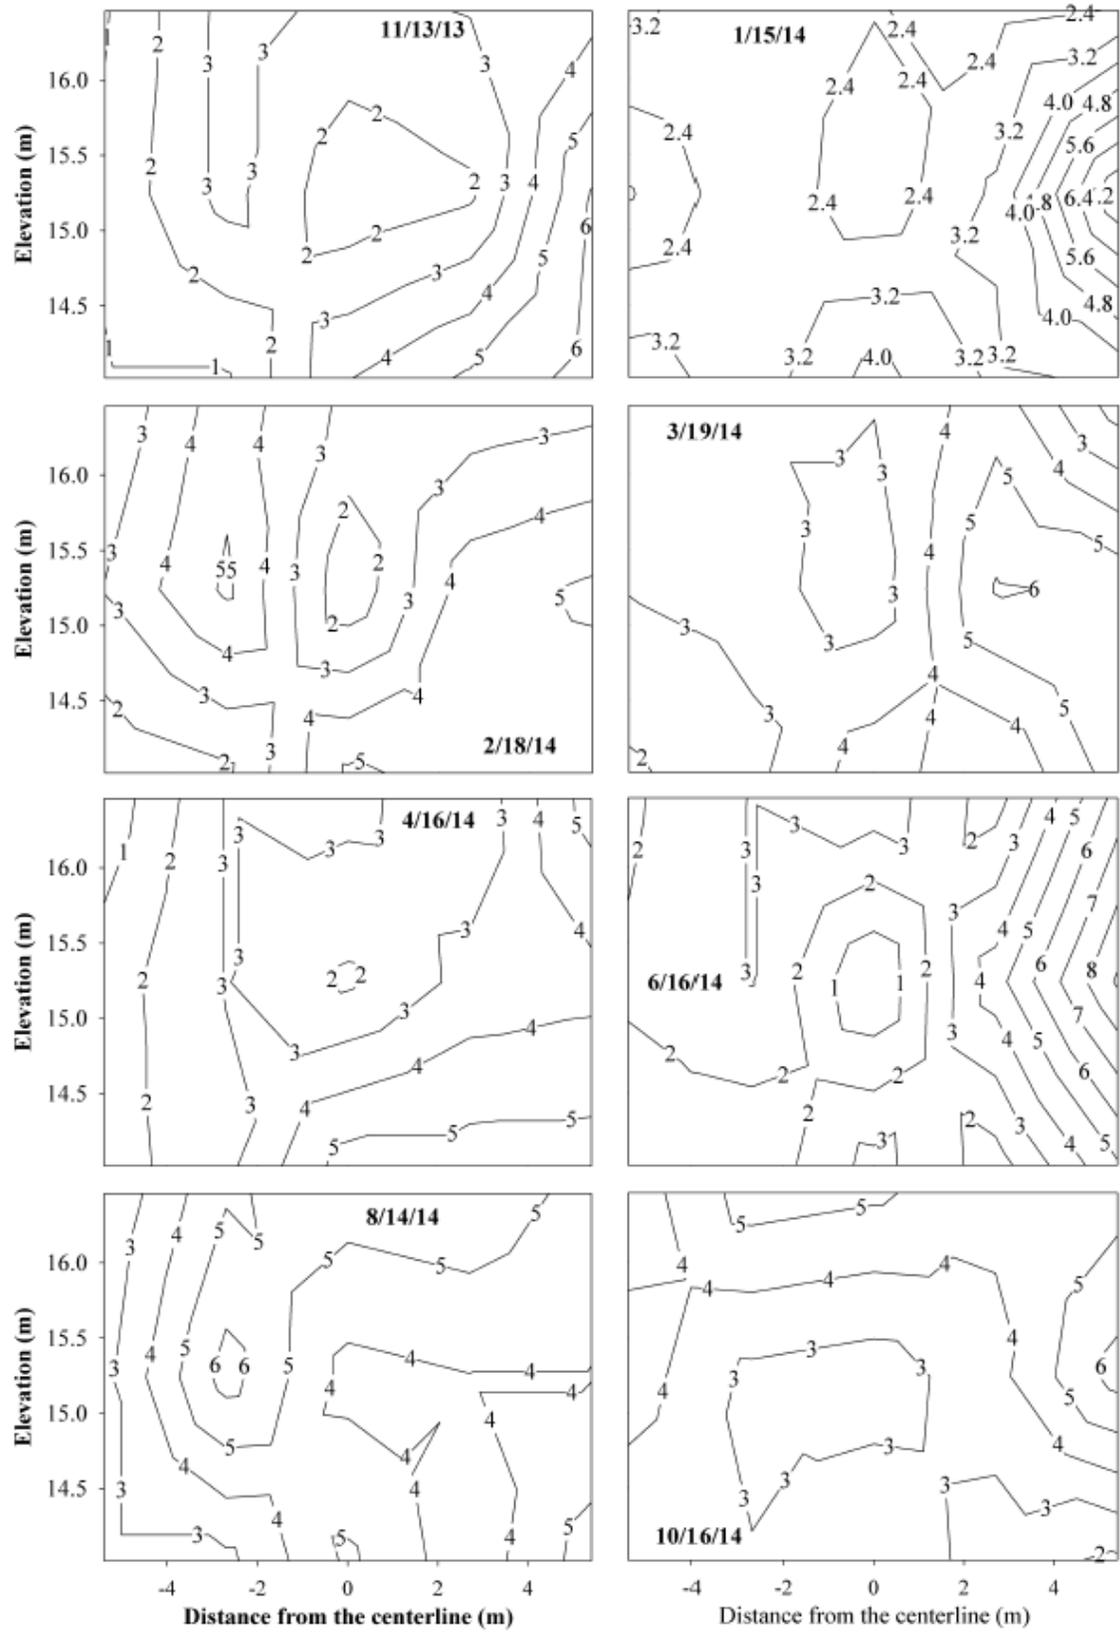
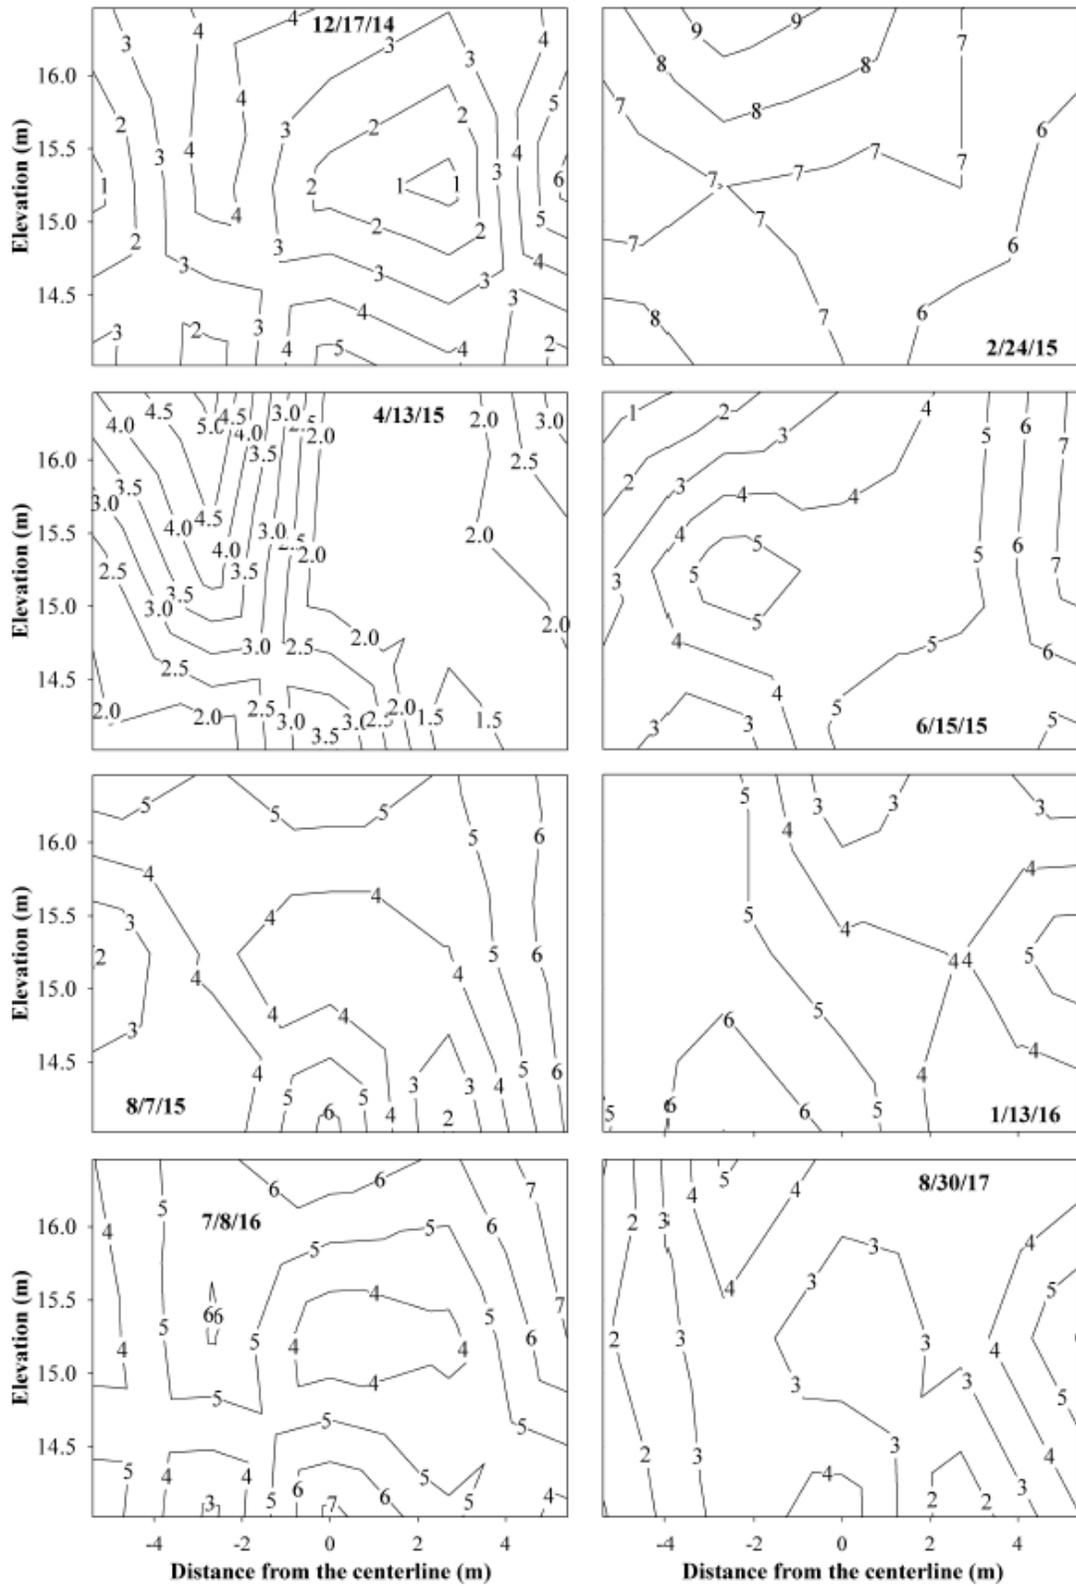
Figure 4.42 Contour plots of the west facing wall deflection over both monitoring periods
