Long-Term Monitoring of a Geosynthetic Reinforced Soil Integrated Bridge System (GRS-IBS)

FINAL REPORT
November 2017

Christopher L. Meehan
Associate Professor

University of Delaware, Department of Civil and Environmental Engineering
301 DuPont Hall, Newark, DE 19716, U.S.A.

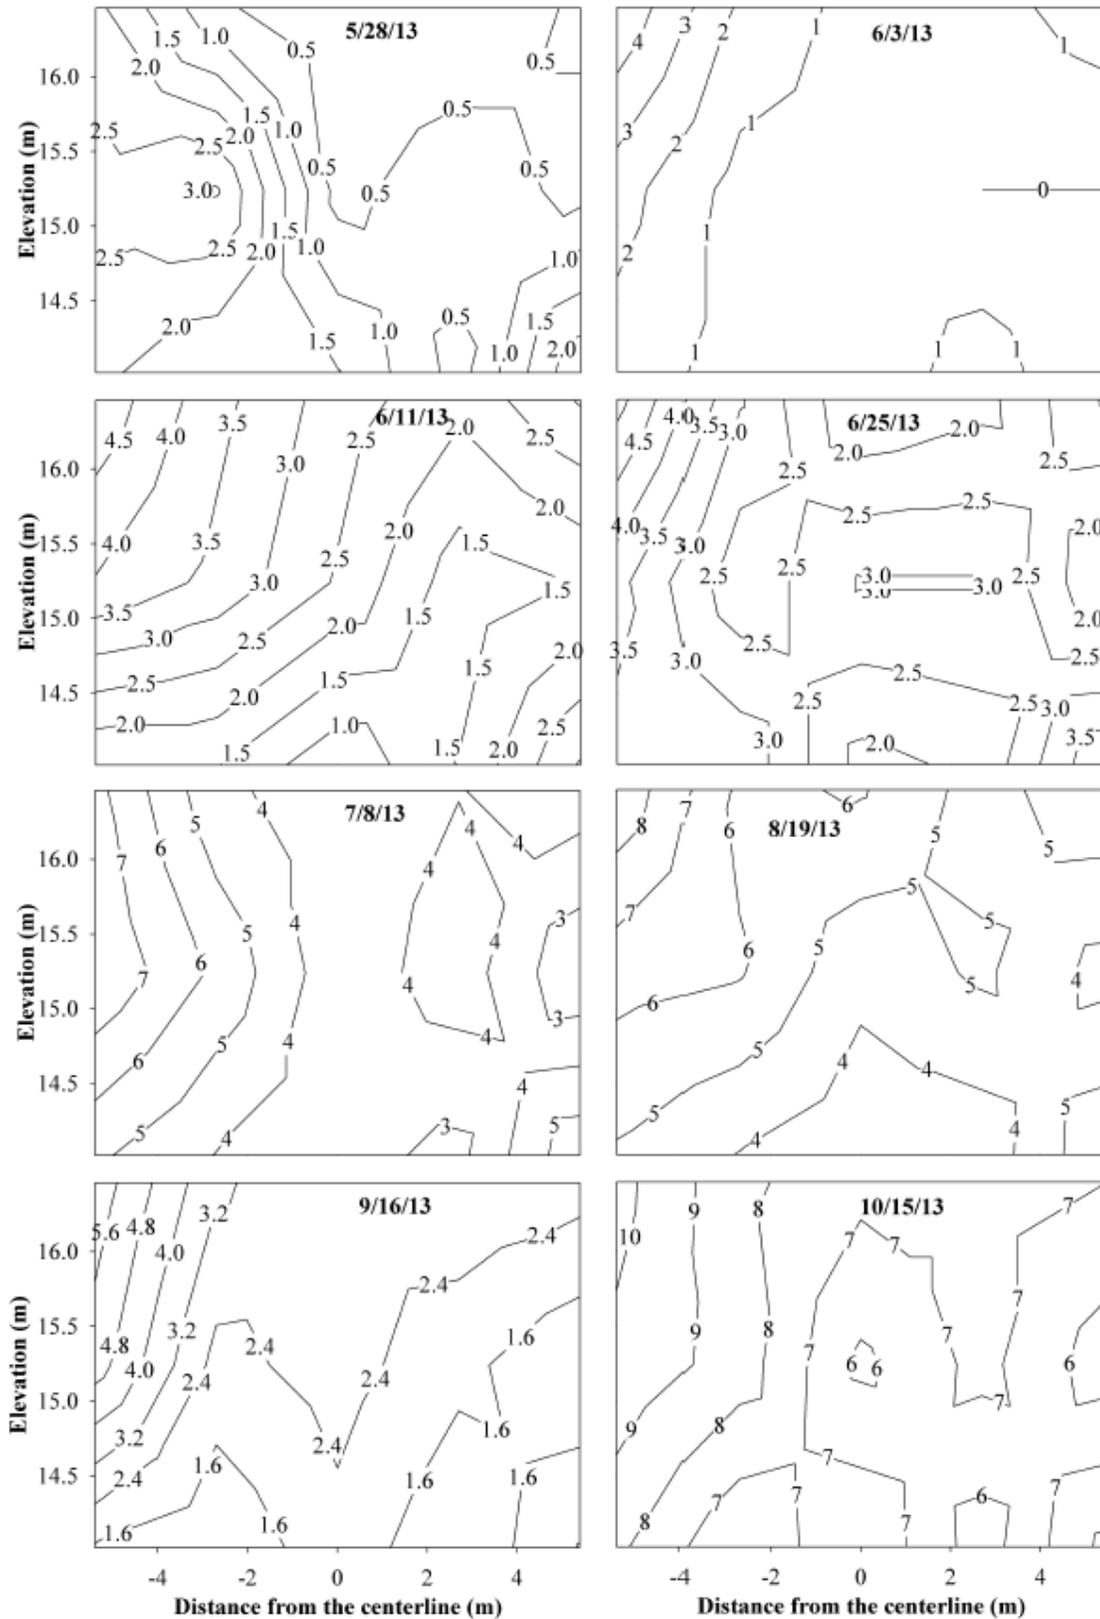
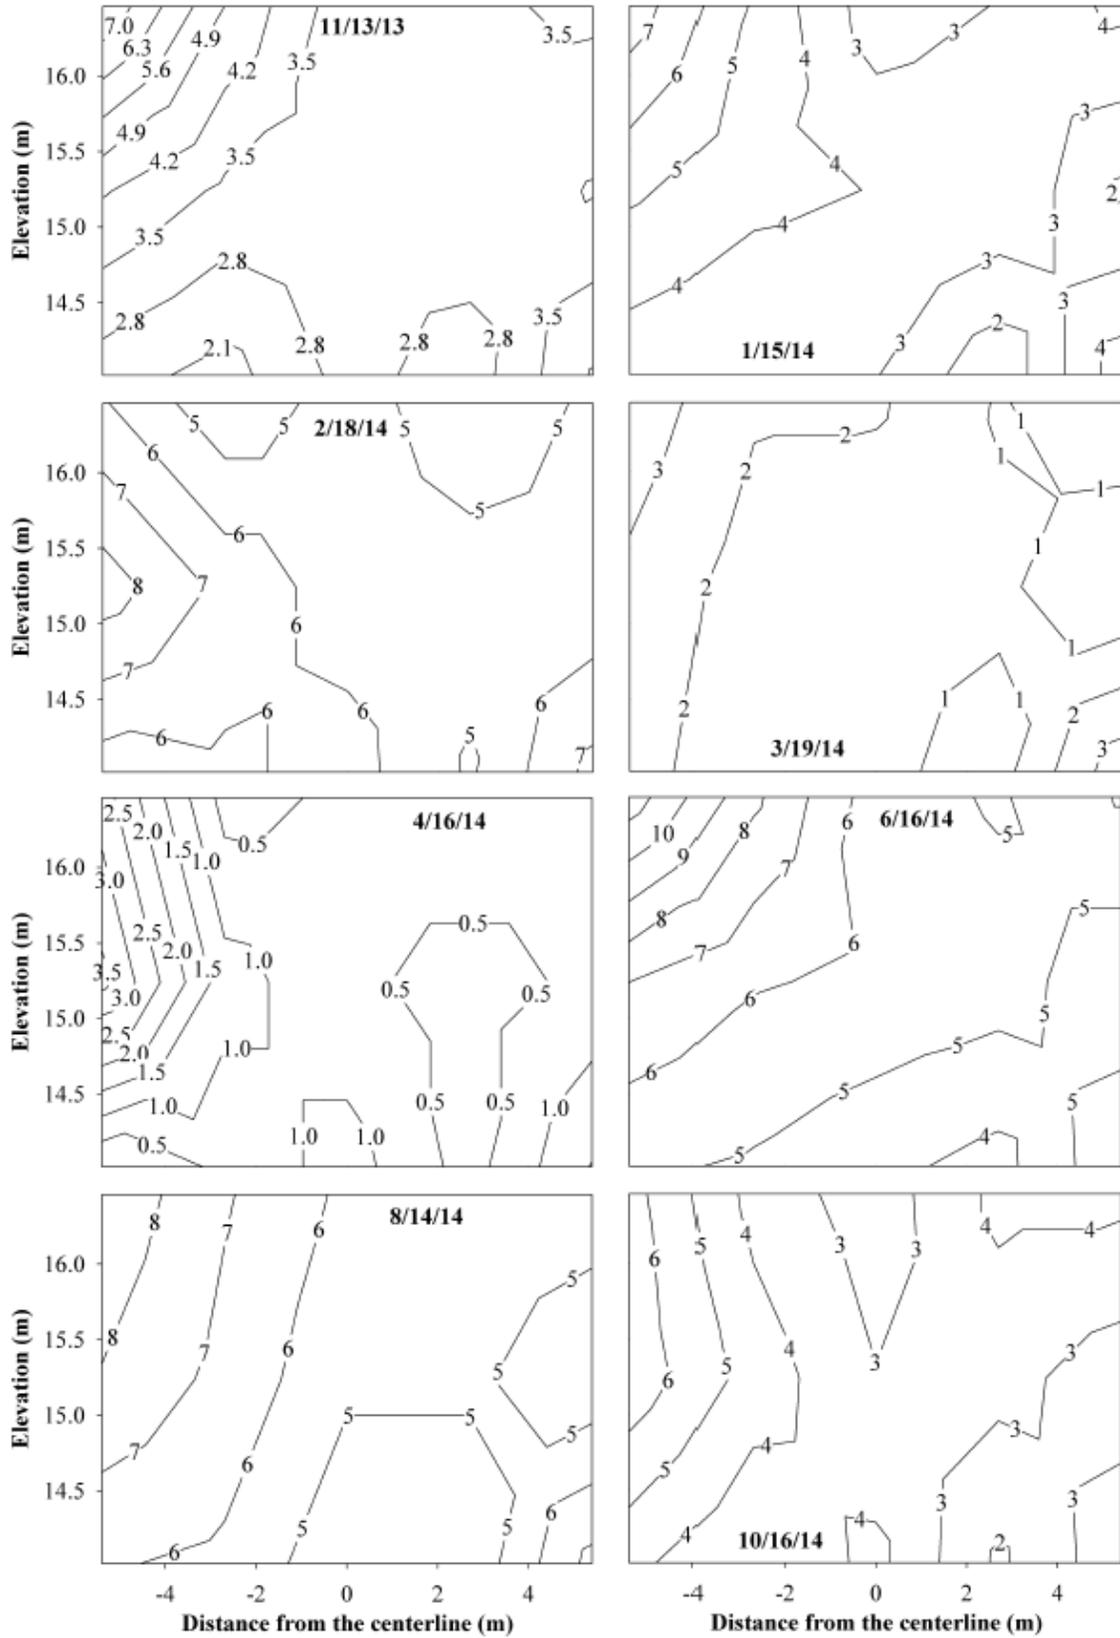
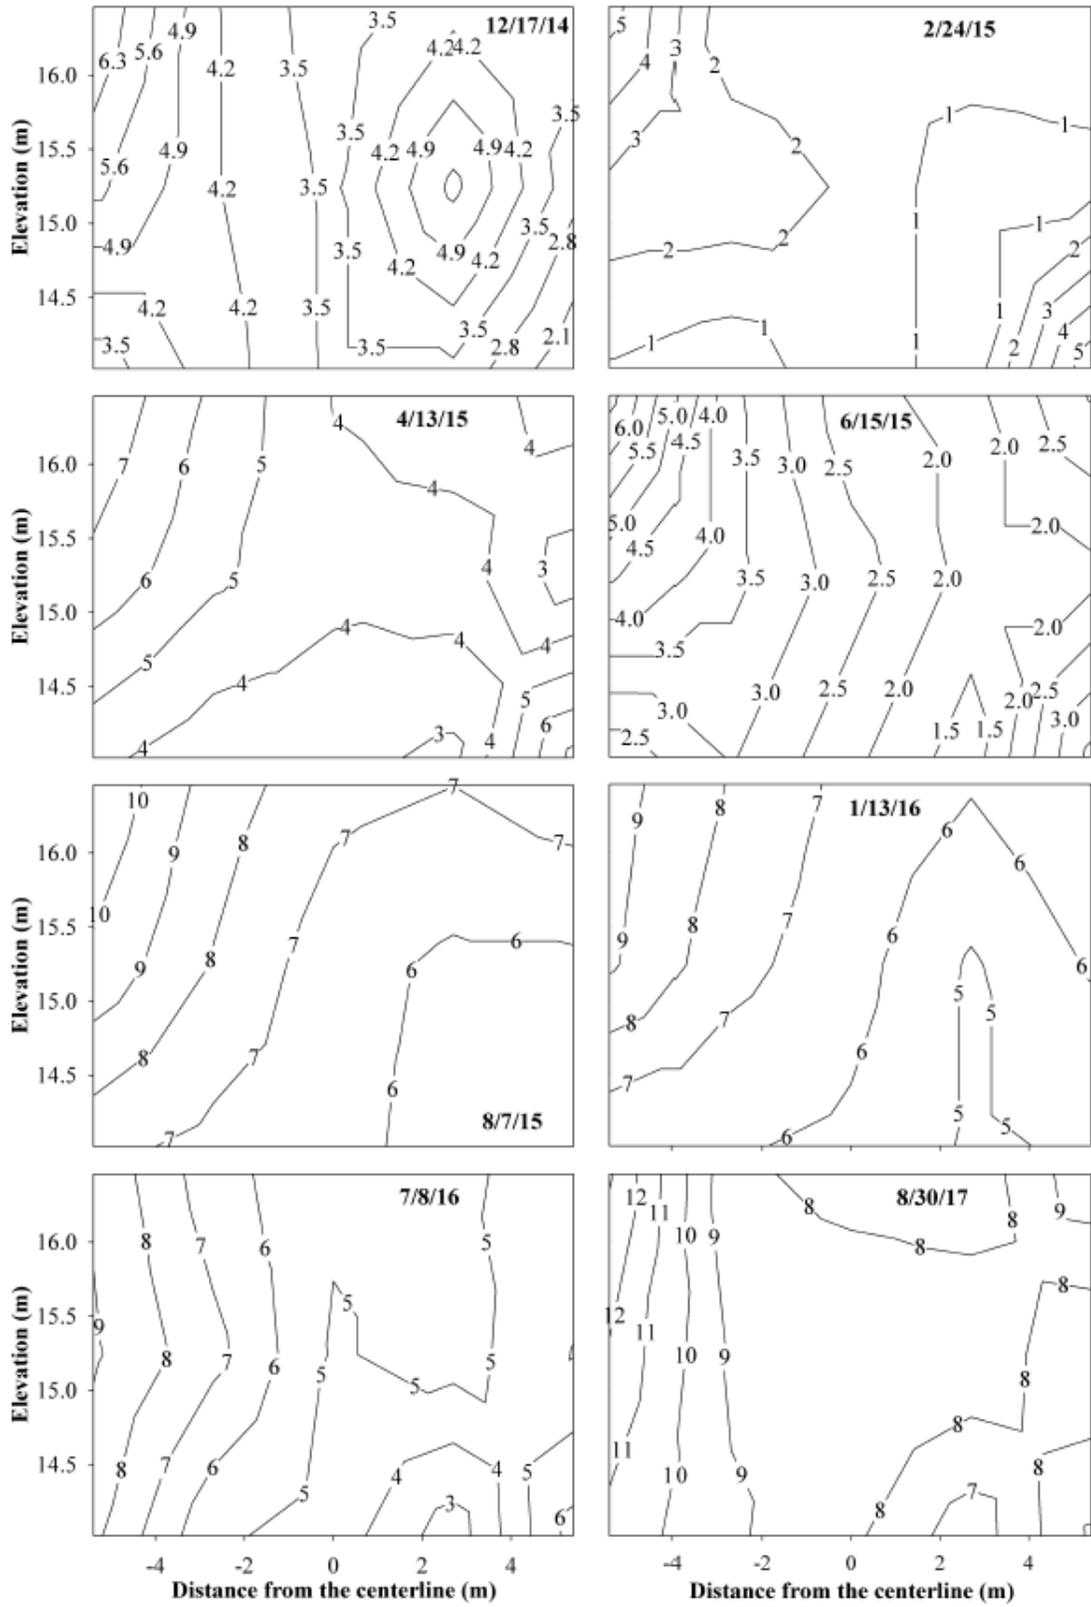
Figure 4.43 Contour plots of the east facing wall settlement over both monitoring periods

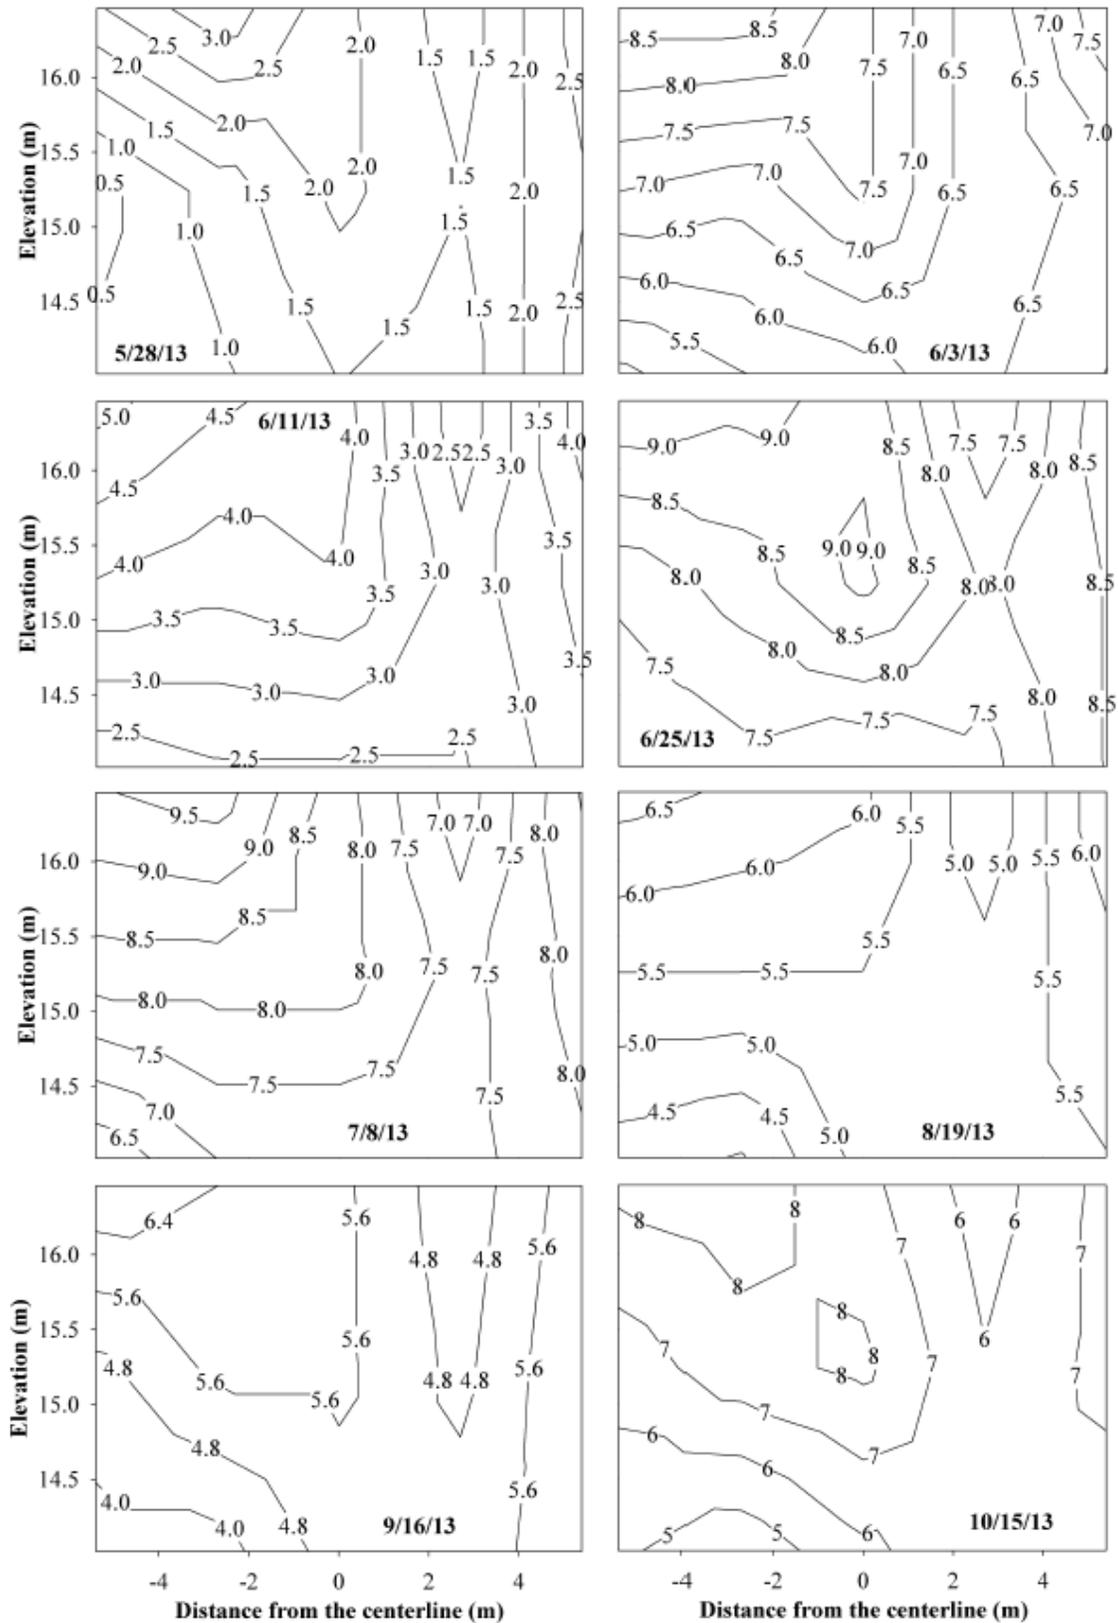
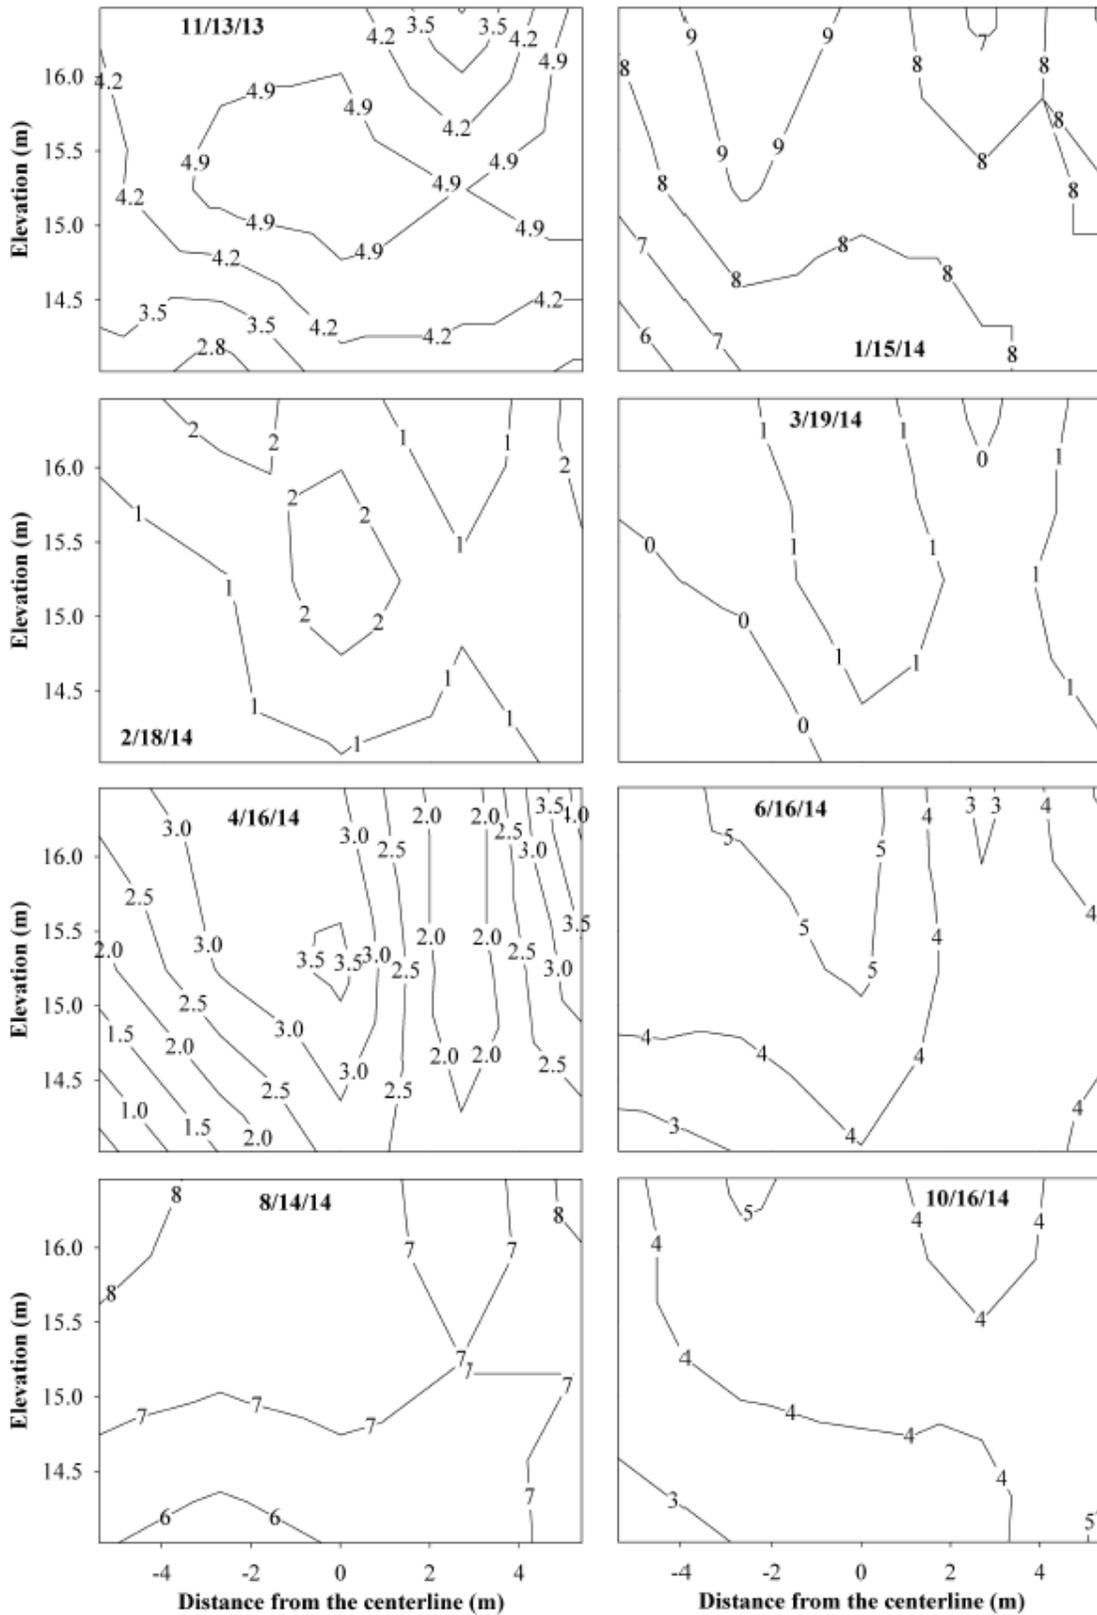
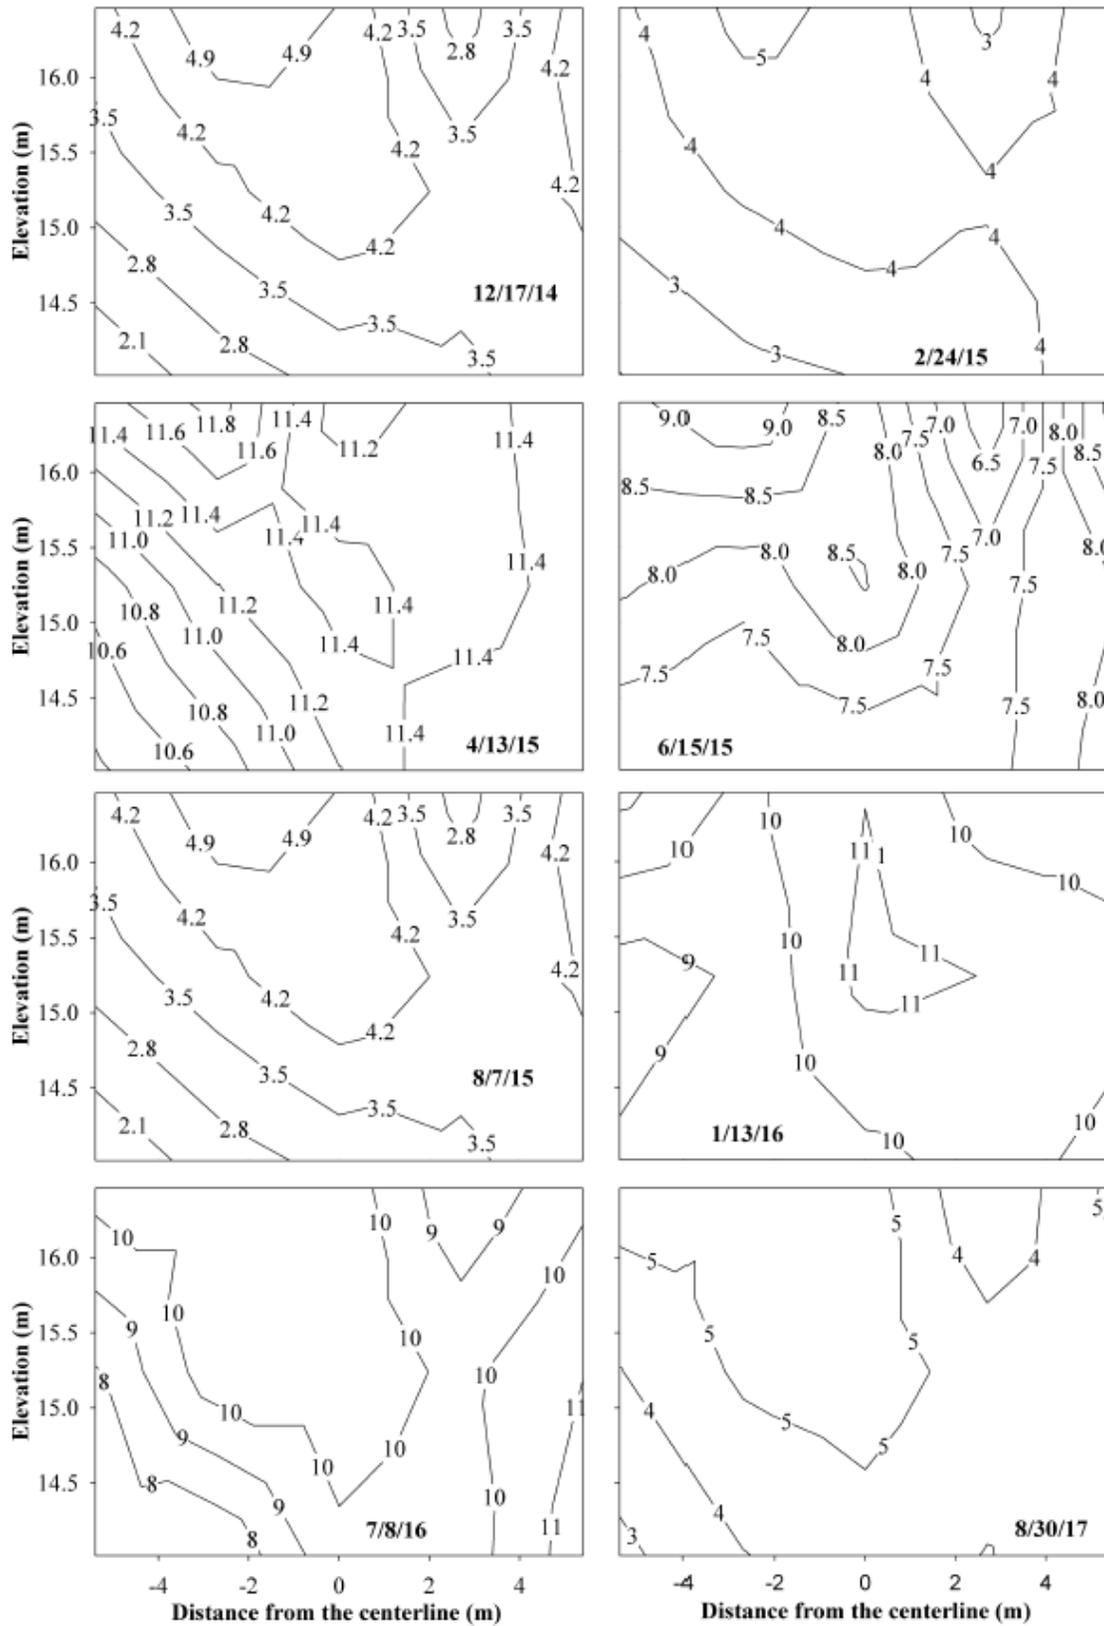
Figure 4.44 Contour plots of the west facing wall settlement over both monitoring periods

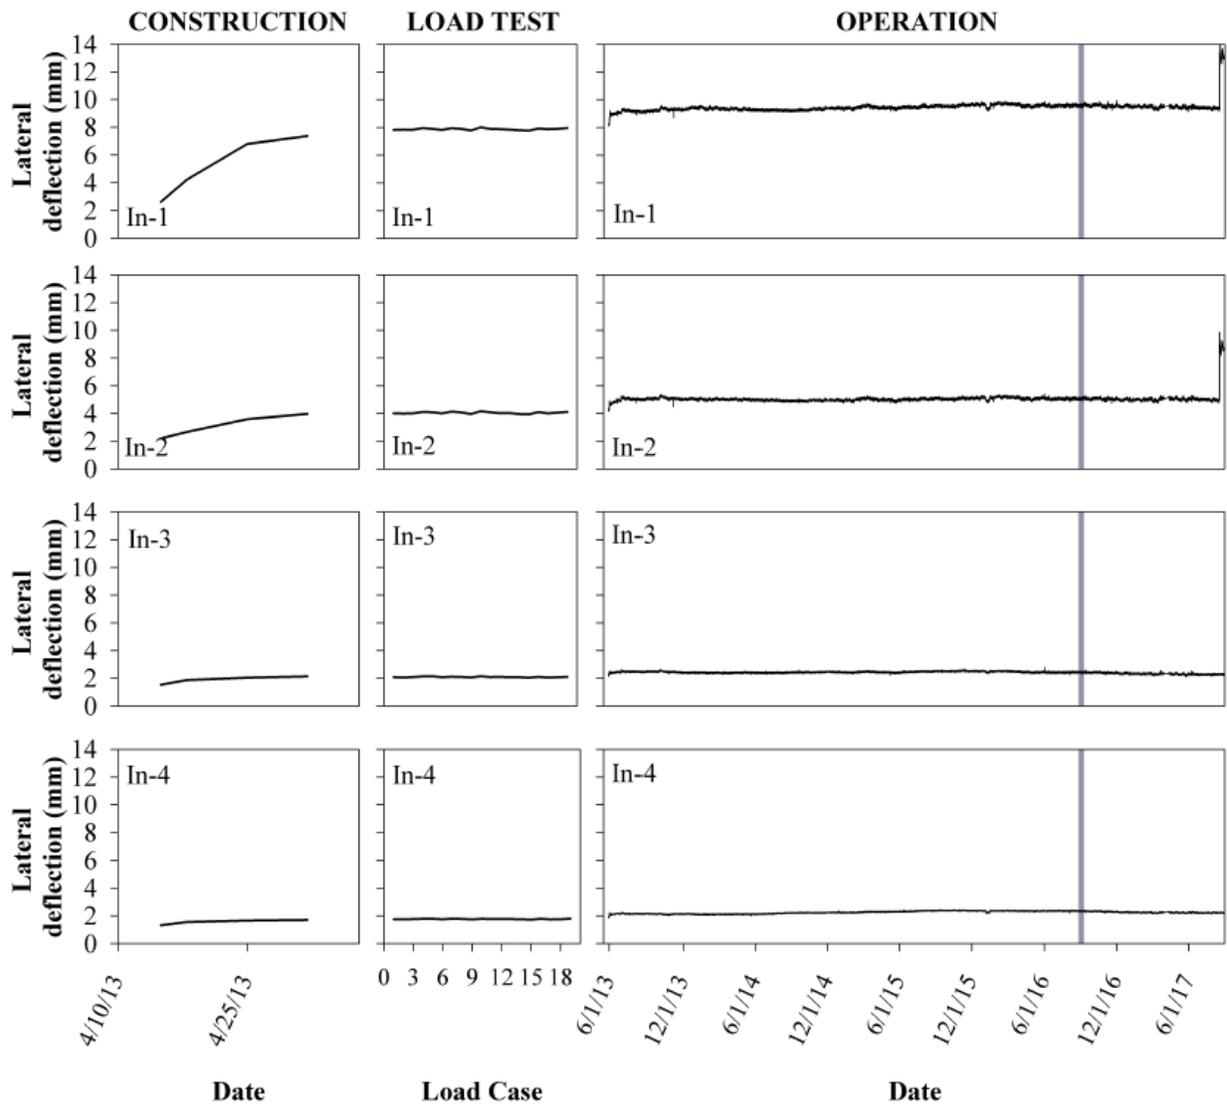
Figure 4.49 Lateral deflection in the E-W direction recorded by the inclinometer sensors

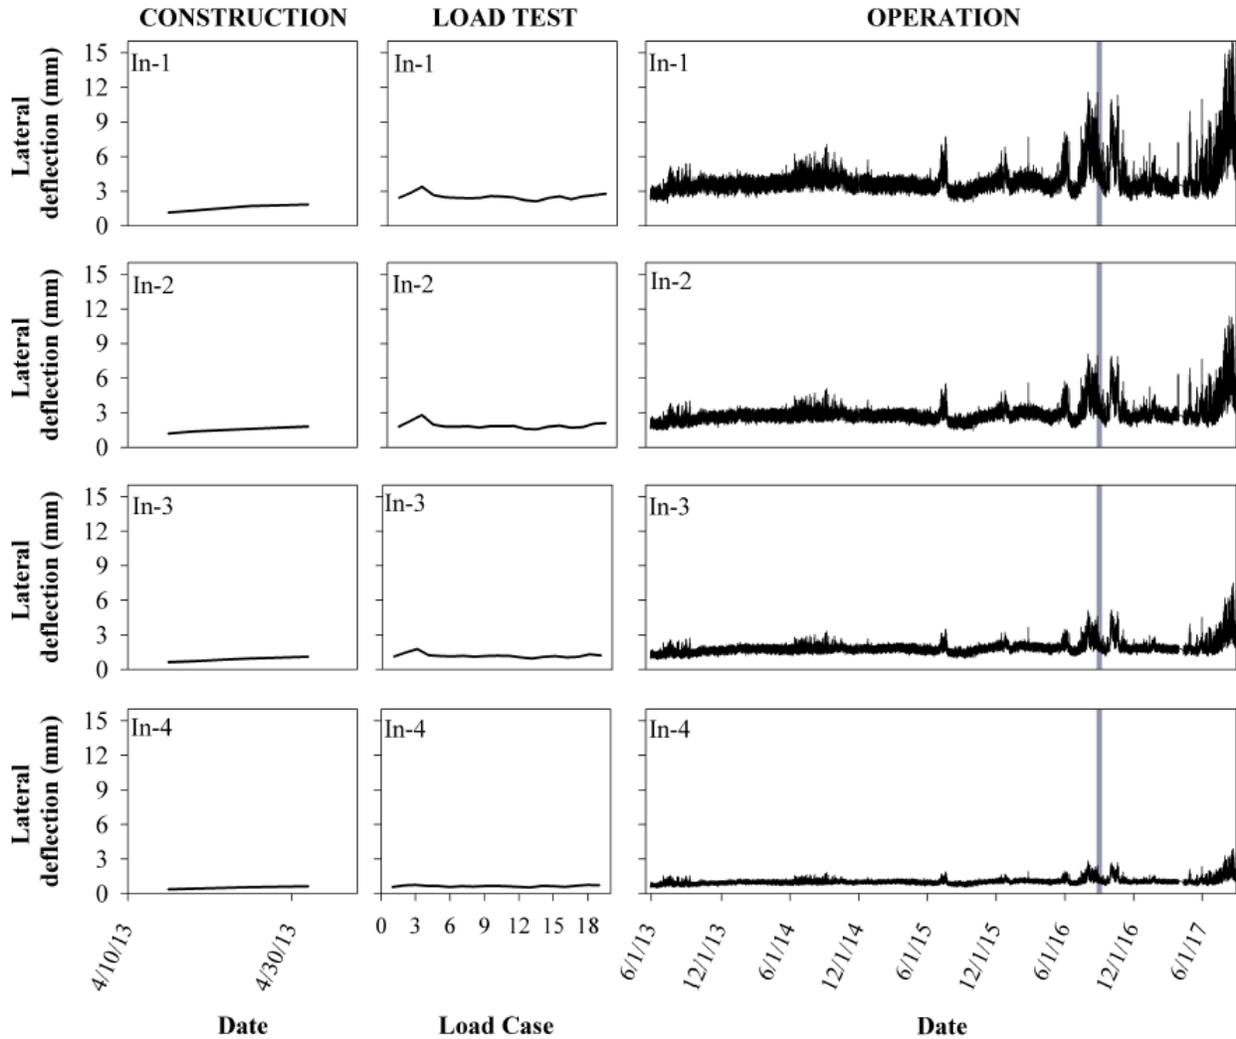
Figure 4.50 Lateral deflection in the N-S direction recorded by the inclinometer sensors

For the N-S direction, significantly more variation was seen during this monitoring period than the previous, although it seemed to start at the end of the first monitoring period, around August of 2016; this should continue to be monitored. Typically, the large spikes dissipate after some time. A maximum deflection of approximately 15 mm was seen in this direction and slightly more creep developed, approximately 2 mm, compared to the E-W direction. Overall, with maximum deflections of 14 and 15 mm and with creep on the magnitude of 2 mm, it can be determined that no significant movement has occurred in the clay foundation.

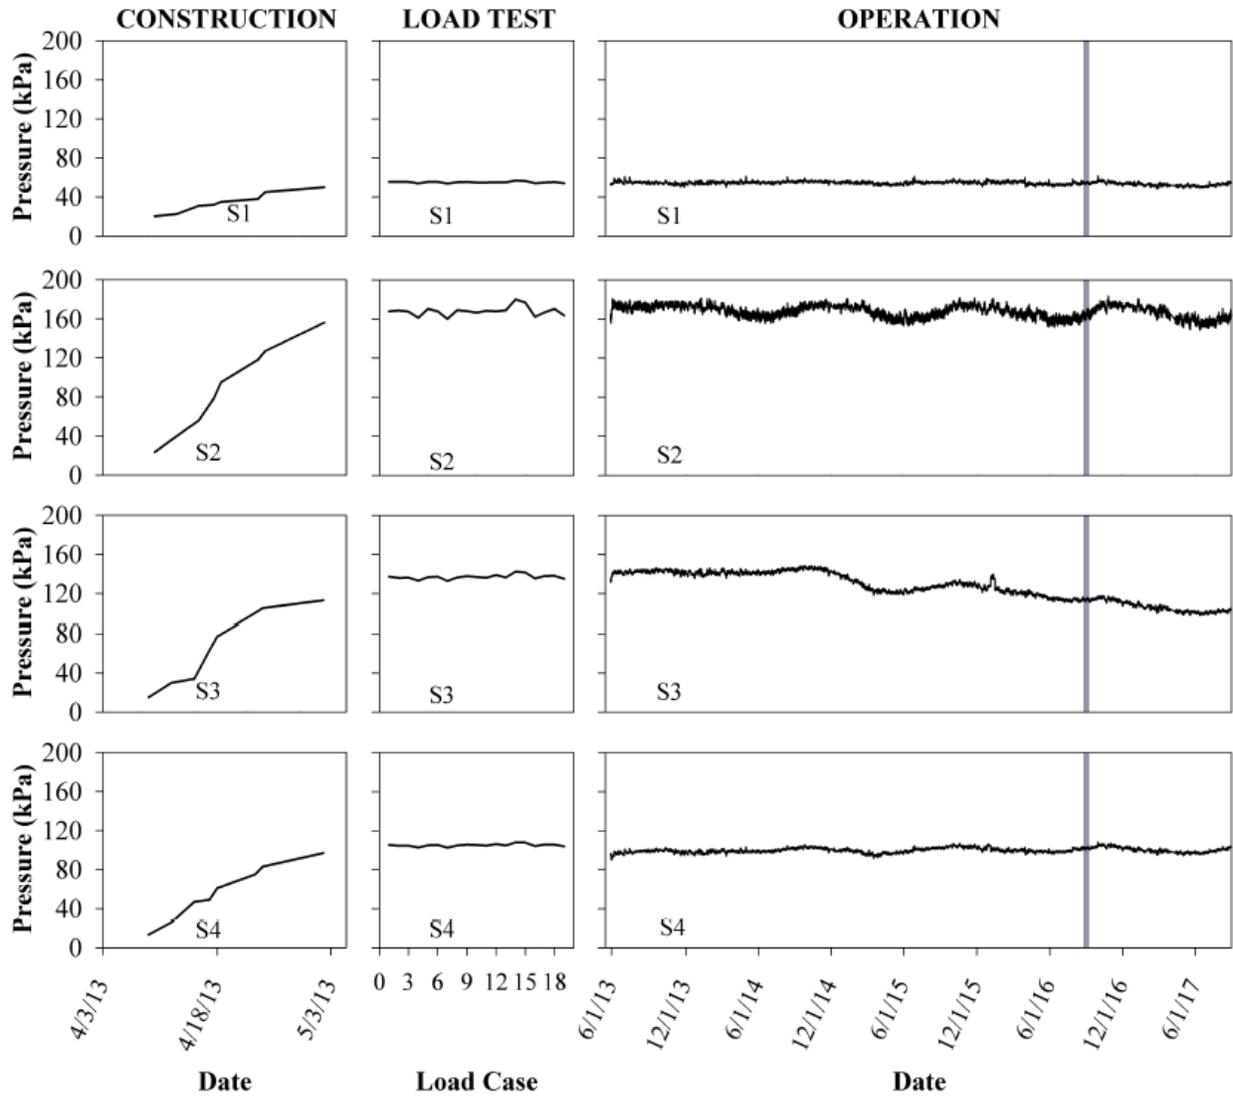
Figure 4.55 Measured total pressures

In both figures, a significant amount of noise can be seen and the data also fluctuated seasonally. Figures 4.57 and 4.58 present the minimum, average, and maximum recorded effective pressure for both monitoring periods combined and this current monitoring period respectively. As expected, a larger scatter of data is shown for both monitoring periods (Figure 4.57), since data is being observed for approximately 51 months compared to just the current monitoring period of 12 months. Histograms of the measured effective pressure for both monitoring periods combined and the most recent monitoring period are shown in Figures 4.59 and 4.60, respectively. Similar trends can be seen in both figures in regards to shape of the distribution, spread of the data, and average. As discussed in Talebi (2016) and Talebi et al. (2017), the pressure distribution beneath the foundation was not uniform. This is shown in Figures 4.57 and 4.58 as the maximum pressure was observed at the location of sensor S2, which was installed beneath the facing wall; the minimum occurred at the location of sensor S1, which was installed at the toe of the foundation.

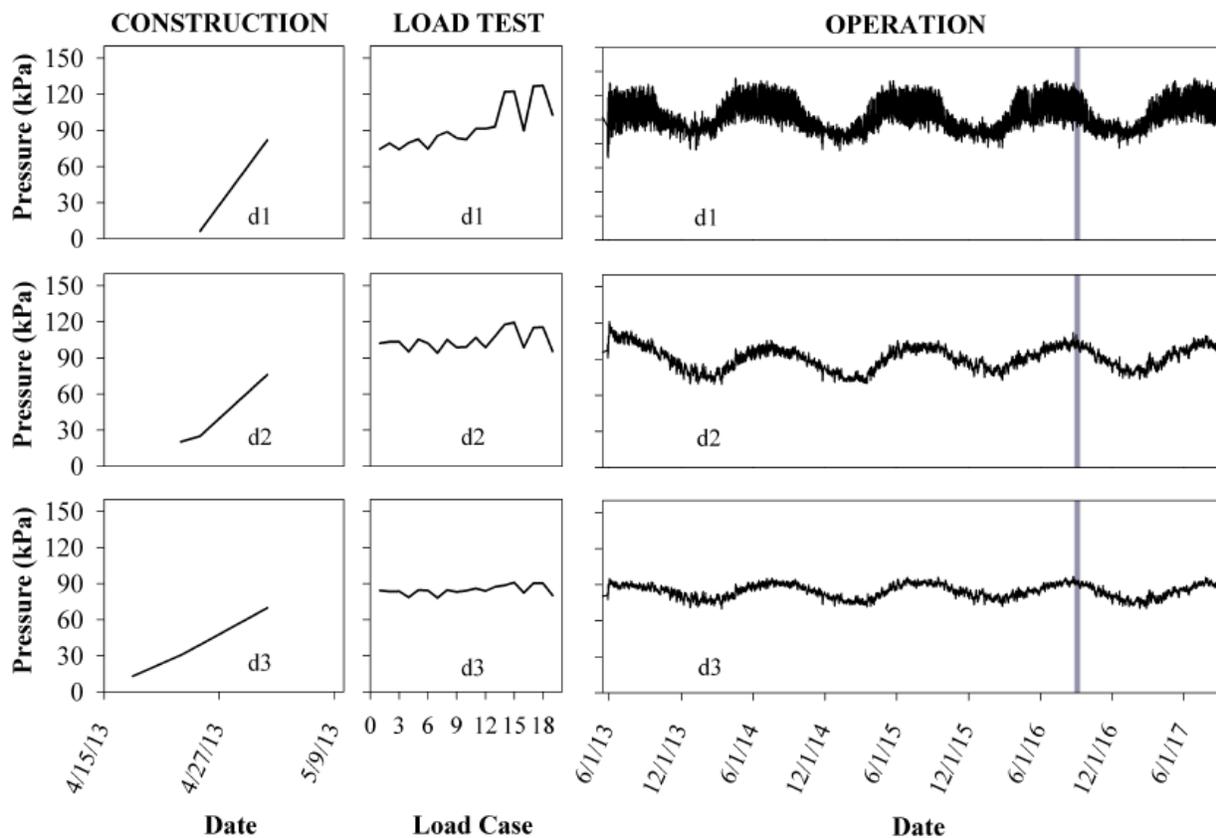
Figure 4.61 Measured abutment pressures

which is much more susceptible to changes in ambient temperature conditions. Figure 4.61 displays the changes in abutment pressure during construction, live load testing, and both monitoring periods. Readings for the current monitoring period are nearly identical to the previous monitoring period. This is further illustrated by the histograms of abutment pressures for both monitoring periods and the current monitoring period as shown in Figures 4.62 and 4.63, respectively. The histograms show very similar shape, range, and average. This is reiterated in the minimum, average, and maximum plots shown in Figures 4.64 and 4.65 for both monitoring periods and the current monitoring period, respectively. Similar to the readings from the foundation pressure cells, the pressure changes seasonally. These fluctuations imply that temperature influences the measured values from the pressure cells.

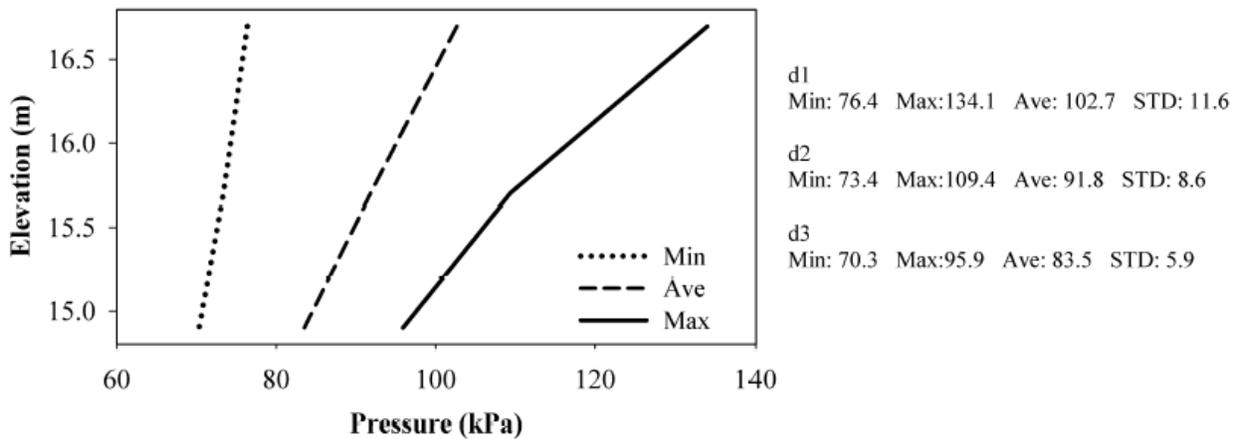
Figure 4.65 Minimum, maximum, and average measured abutment pressures for the current monitoring period
