**ADVANCED GROUND PENETRATING RADAR DATA
COLLECTION AND IMAGING OF BRIDGE DECKS USING 3-D
RADAR**

**Federal Highway Administration's (FHWA's)
"Advanced Ground Penetrating Radar (GPR) Research Project"**

**Infrastructure Condition Monitoring Program (ICMP)
Center for Advanced Infrastructure and Transportation (CAIT)
Rutgers University**

March 21, 2008

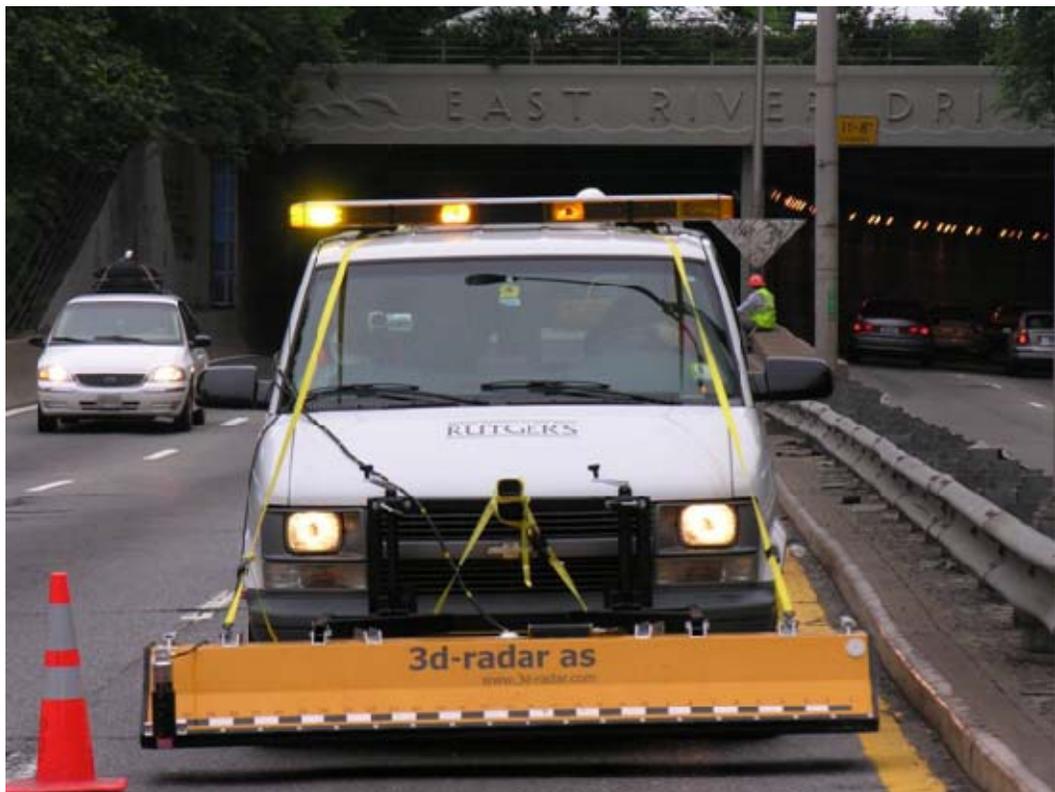
Figure 1. 3-D GPR for pavement surveys.

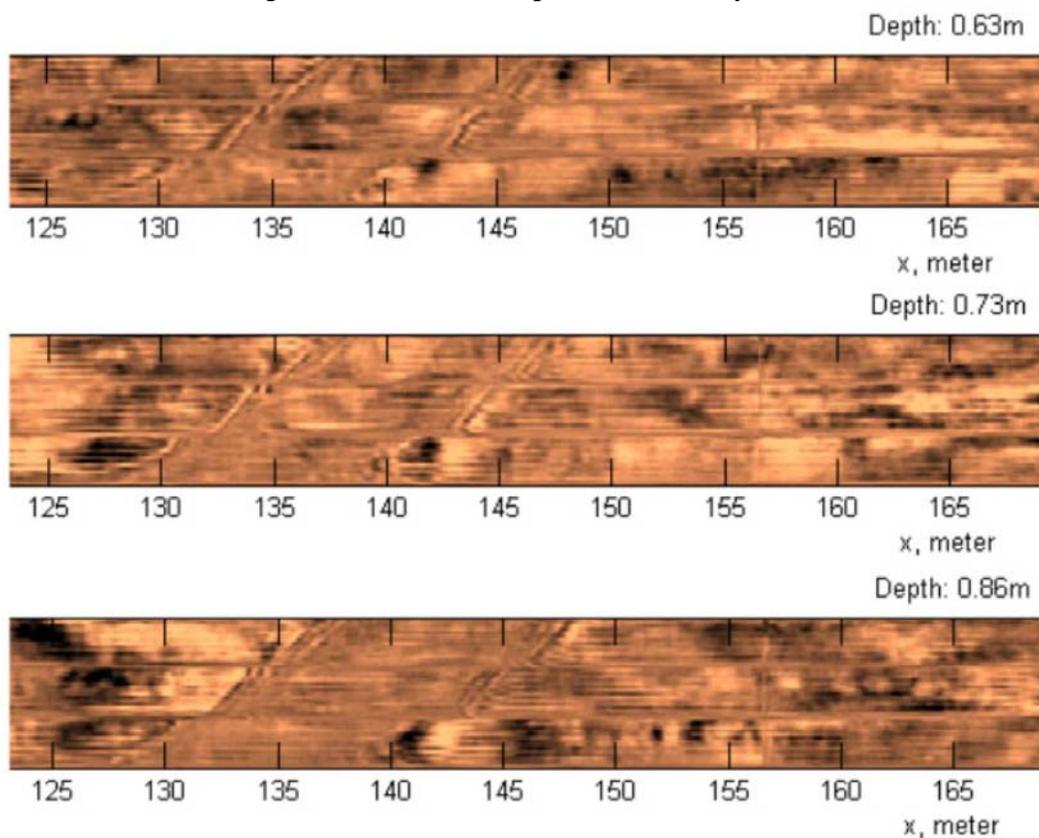
Figure 2. 3-D GPR horizontal plane images at three elevations of a pavement.

As a result of simultaneous surveying by multiple antennas, results of 3D-GPR surveys can be presented in terms of both horizontal planes at different elevations, and vertical cross section planes in the longitudinal and transverse direction to the pavement survey direction. This is illustrated in Figure 5 by a screen with the longitudinal vertical cross section (top left), horizontal cross section or “time slice” (bottom), and transverse vertical cross section (right). By applying various data migration techniques, it is possible to create images of objects in the surveyed areas. This was illustrated in Figure 2 by time slices of a pavement with identified utilities and a pavement cut.

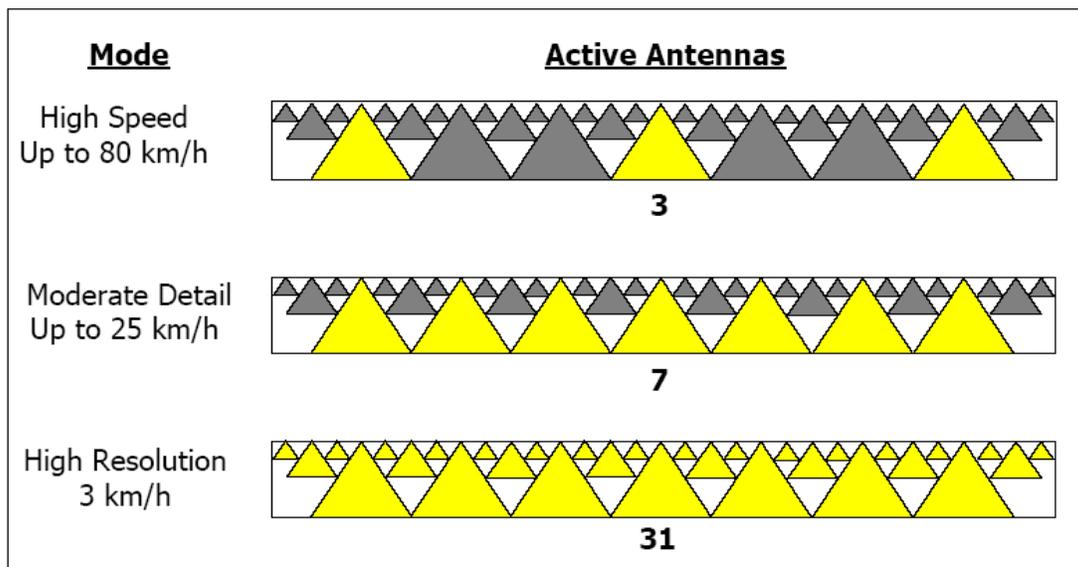
Figure 2: 3D-GPR antenna array.

3D-GPR utilizes different type of antenna arrays. The system described herein utilizes an array of 31 transmitting and receiving antenna pairs, as shown in Figure 2. The number of antennas active during the survey and the frequency range used control the maximum speed of the survey. Therefore, network level surveys of pavements, typically conducted at highway speeds, are done utilizing only three antennas. On the other hand, when of interest is a detailed image of the substructure, for example in imaging and condition assessment of bridge decks, all the antennas are deployed and the survey is conducted at speeds not faster than about 3 km/h (2mph). A clear advantage of the presented antenna array over the traditional single antenna GPR systems is that it covers, and can provide an image of, more than half of the lane width from a single test run with a resolution of 75 mm (3 inches). This will minimize the error due to misalignment of multiple passes of a traditional antenna.

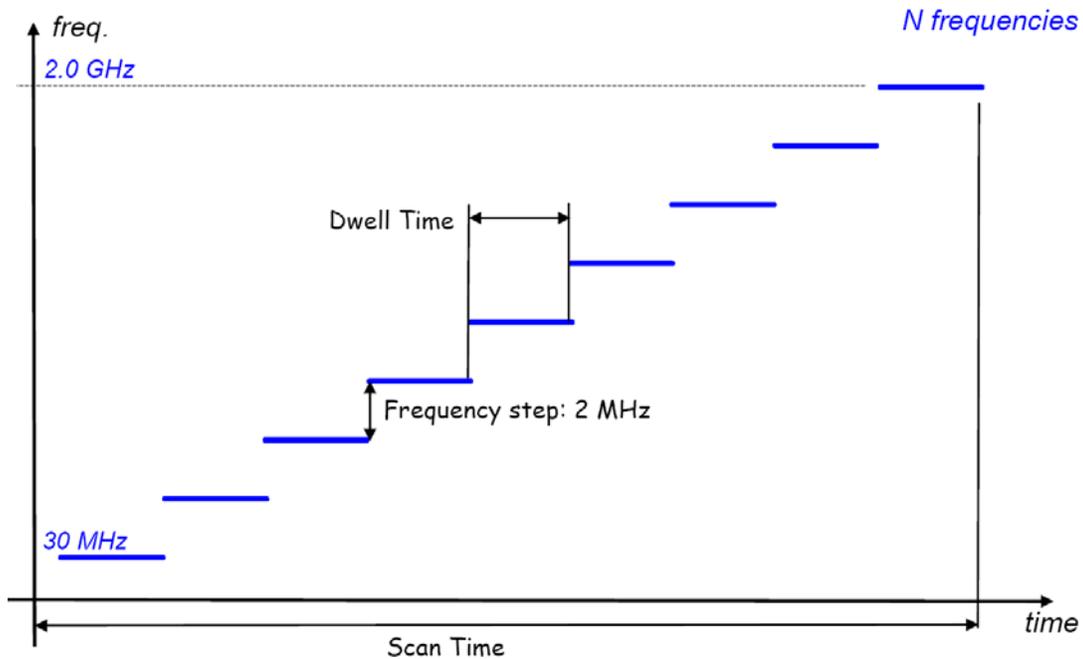
Figure 3: Step-frequency waveform.

3D-GPR operates in the step frequency mode, with a frequency step of 2 MHz (Figure 3). Pulse antennas, even those of ultra wide bands, provide a dominant part of energy around the antenna's center frequency. On the other hand, step frequency systems can cover broad frequency ranges at about same power levels. The 3D-GPR system covers (about uniformly) a frequency range from 140MHz to 2GHz, as illustrated in Figure 4.

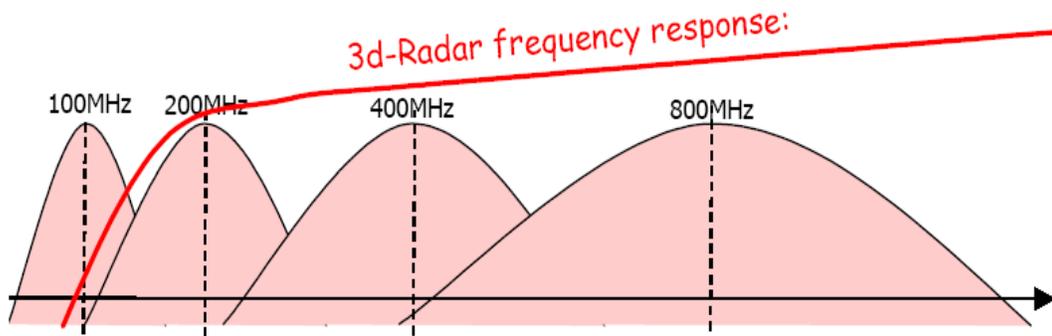
Figure 4: Frequency range of 3D-GPR and typical pulse systems.

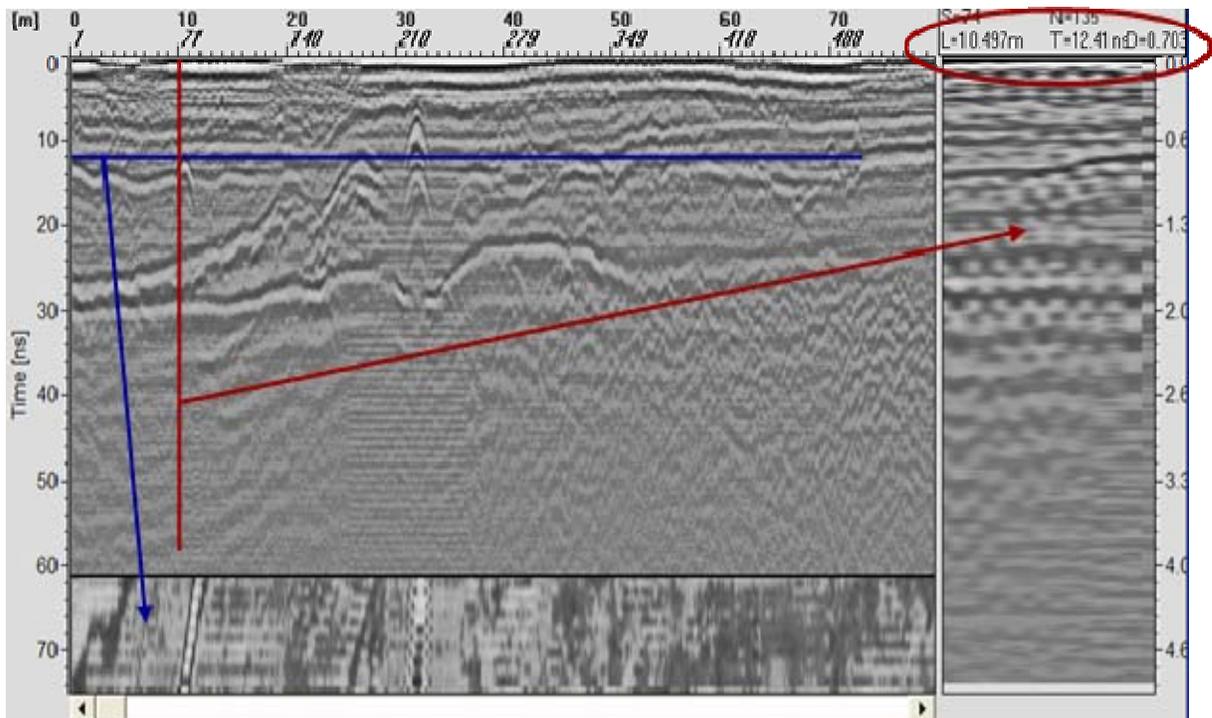
Figure 5. 3D-GPR image of a pavement section: vertical longitudinal (top left), vertical transverse (right) and horizontal/time slice (bottom).

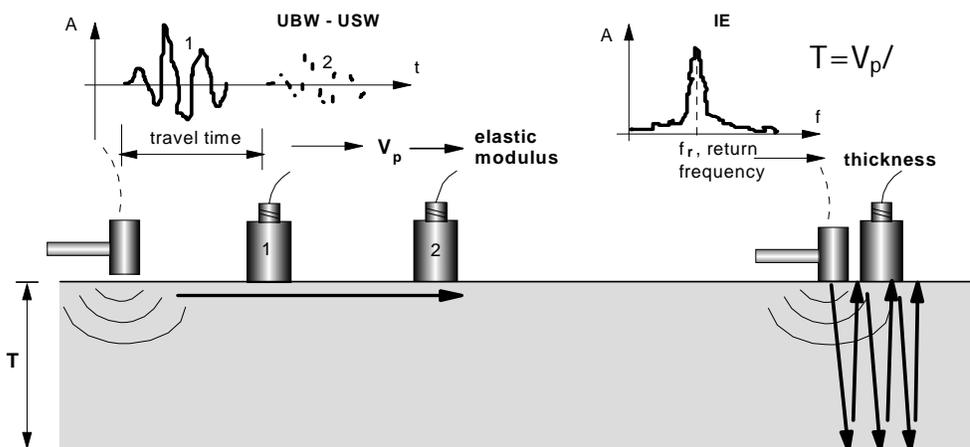
FIGURE 6 Measurement of bridge deck elastic modulus and thickness by UBW and IE methods.

Application of seismic techniques in bridge deck evaluation is illustrated in Figure 6. In the first part of the evaluation, UBW and USW tests are conducted using an impact source and two receivers to find P-wave velocity. Because it is often difficult to identify P-wave arrivals in the UBW test data in an automated way, a more reliable procedure to estimate the P-wave velocity is through a measurement of the surface (Rayleigh or R) wave velocity using the USW test. The USW test is identical to the spectral analysis of surface waves (SASW) test, except that the frequency range of interest is limited to a narrow high frequency range where the velocity of the surface wave does not vary significantly with frequency. In the second part of the evaluation, the IE test is conducted using an impact source and a single nearby receiver. Because of a significant contrast in rigidity of concrete and air, the elastic wave is reflected off the bottom of the deck back to the deck surface. The frequency of the reflection, called return frequency, can be identified in the response spectrum of the recorded signal. Finally, the depth of the reflector, in this case the deck thickness, can be obtained from the return frequency and the previously determined P-wave velocity, as illustrated in Figure 6.

While the primary objective of IE testing is to determine dominant reflectors, according to the relationship described in Figure 6, a unique thickness or depth of the reflector can be correlated to every component of the frequency spectrum. This is illustrated in Figure 7 by a frequency spectrum, and the corresponding thickness spectrum. The thickness spectrum enables simple data interpretation, because positions of the dominant and secondary peaks describe clearly the pattern of energy partitioning, and thus the degree of delamination. Spectra for a set of points along a single test line can be combined to form spectral surfaces. As shown in the same figure, frequency spectra for one test line on a bridge deck are combined to form a frequency spectral surface and are converted into a corresponding thickness spectral surface.

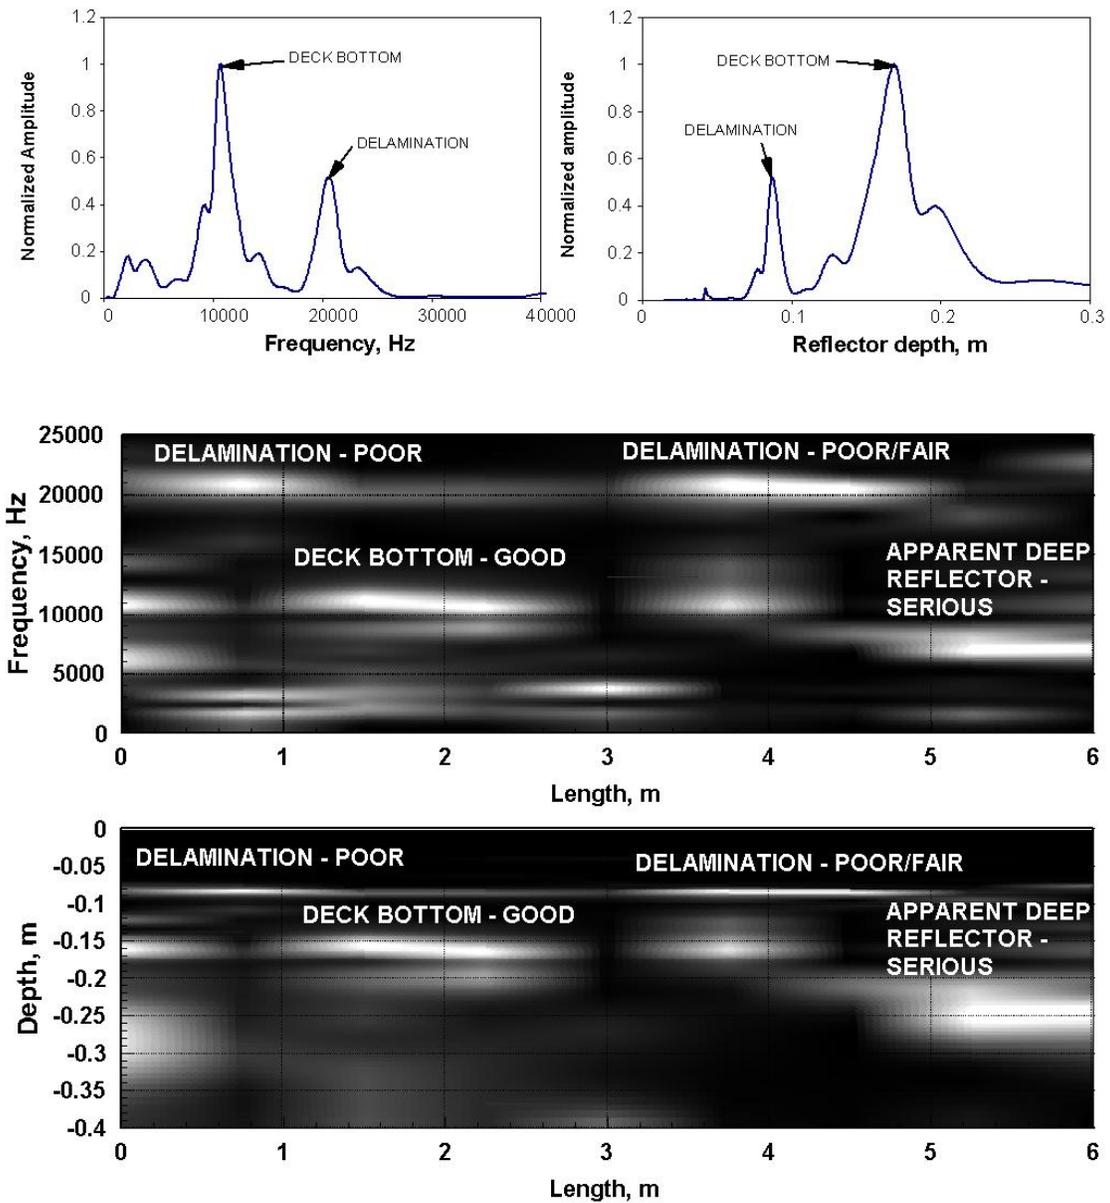
FIGURE 7 Frequency and thickness spectra and spectral surfaces.

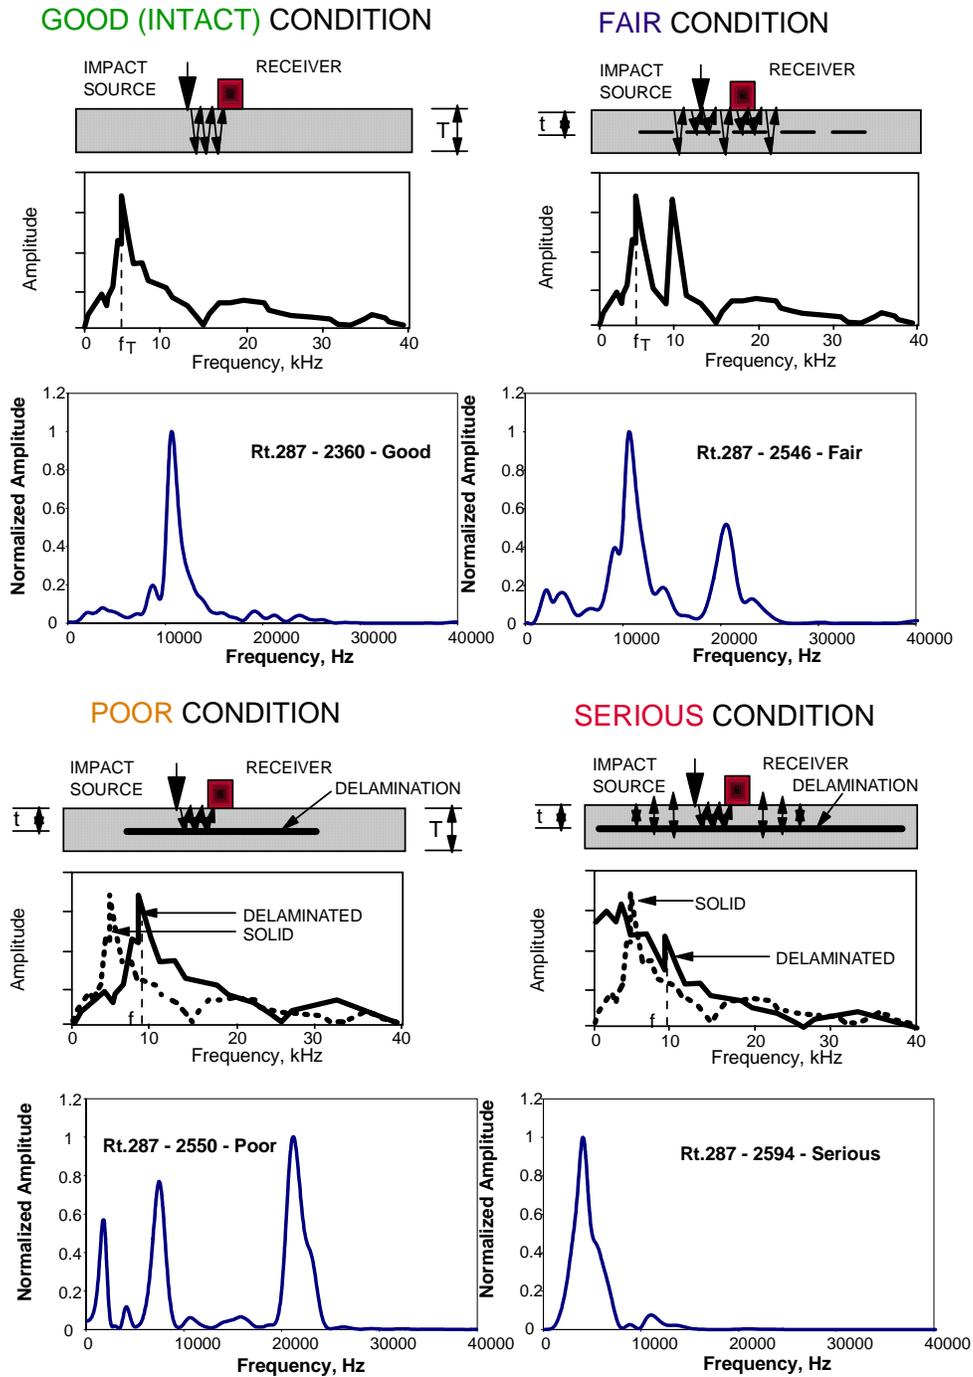
FIGURE 8 Grades for various degrees of deck delamination.

In the case of a delaminated deck, reflections of the P-wave occur at shallower depths, causing a shift in the response spectrum towards higher frequencies. Depending on the extent and continuity of the delamination, the partitioning of energy of elastic waves may vary and different grades can be assigned to that particular section of a deck as a part of the condition assessment process. This is illustrated in Figure 3. In the case of a sound

deck (good condition), a distinctive peak in the response spectrum corresponding to the full depth of the deck, can be observed. This is illustrated by two spectra under the cross section of the bridge deck. The upper spectrum in the figure represents a schematic of the expected spectrum, while the lower spectrum is taken from actual field testing. Initial delamination (fair condition) is described as occasional separations between the two deck zones. It can be identified through the presence of two distinct peaks, indicating energy partitioning from two dominant wave propagation patterns. The first peak corresponds to reflections from the bottom of the deck, while the second corresponds to reflections from the delamination. Progressed delamination (poor condition) is characterized by a single peak at a frequency corresponding to a reflector depth that is shallower than the deck thickness, indicating that little or no energy is being propagated towards the bottom of the deck. Finally, in a very severe case of a wide delamination (serious condition), the dominant response of the deck to an impact is characterized by a low frequency response of flexural mode oscillations of the upper delaminated portion of the deck. This response is almost always in the audible frequency range, unlike response of the deck in the fair and poor condition that may be in the ultrasonic range. Because it is significantly lower than the return frequency for the deck bottom, it produces an apparent reflector depth that is larger than the deck thickness.

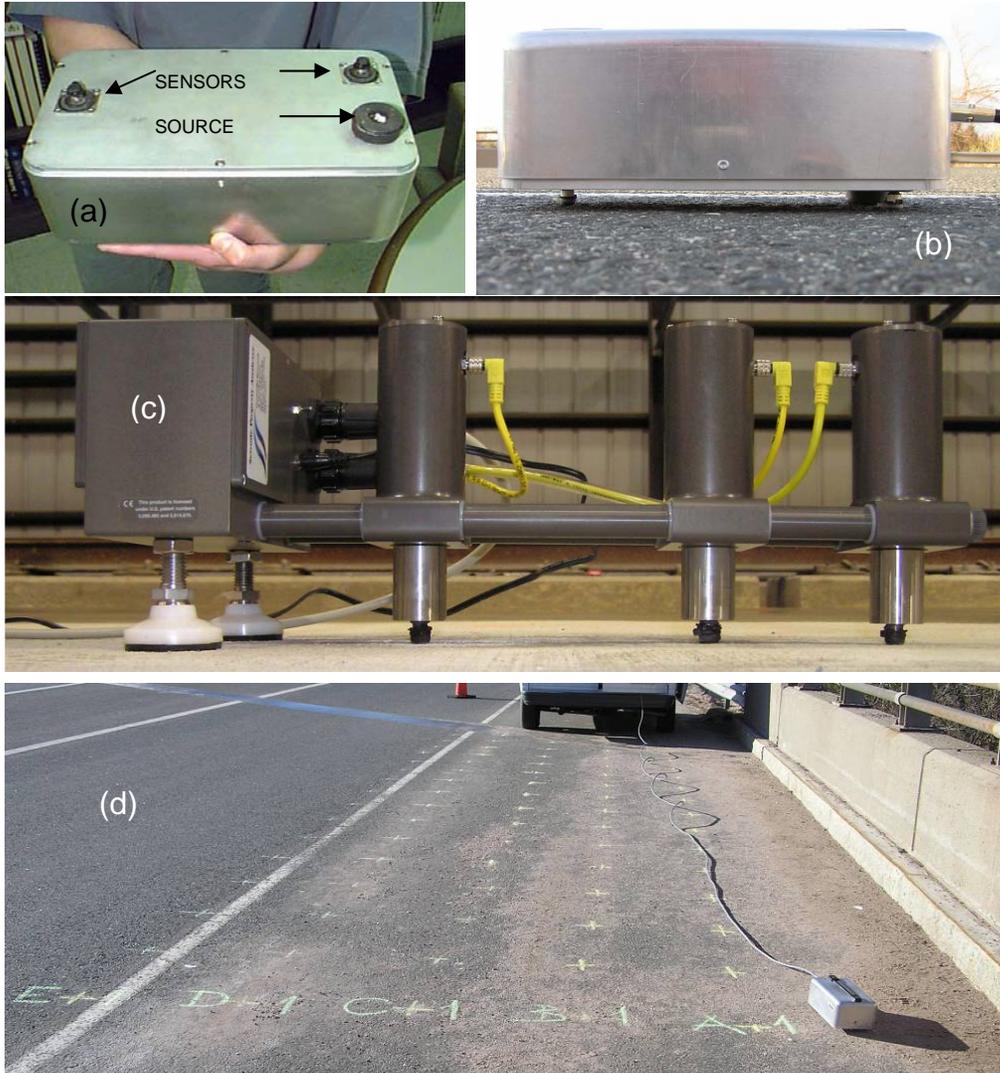
FIGURE 9 Older and newer versions of PSPA sensor box (a and c), and field implementation (b and d).

IE is commonly implemented in deck evaluations by conducting point testing on a grid of selected spacing. The testing is conducted using impact echo devices, which in some cases integrate other ultrasonic seismic methods. One of such devices is PSPA which has a sole purpose of evaluation of surface pavement layers and bridge decks. The device integrates all three previously described ultrasonic techniques (UBW, USW, IE). The core of the PSPA system is a sensor box (Figure 9a) containing a solenoid type impact hammer and two high frequency accelerometers, 7.5 and 21.5 cm away from the hammer. All controls and data acquisition are in a computer that is connected by a serial cable to the sensor box. A new design of the PSPA (Figure 9c) has all data acquisition and control elements as a part of the unit. Field evaluation of decks is typically done on grids of 0.6x0.6 m to 0.9x0.9 m (Figure 9d).

Testing using the PSPA is simple and for a single point takes less than 30 seconds. On an average, about 50 m² of a deck can be tested per hour using 0.9 m spacing, or about 20 m² using 0.6 m spacing. The sensor box is placed at the test point (Figure 4c), a series of impacts (6-10) of 50 μs duration are applied and acceleration histories are recorded. The testing is fairly insensitive to traffic induced vibrations, because those are in a much lower frequency range than the IE test range, which is typically 2 to 30 kHz. PSPA testing results are commonly described in terms of shear and Young's moduli (or P- and S-wave velocity) distributions, and condition assessment distributions (with respect to the degree of delamination). This will be illustrated by condition maps for sections of the two evaluated bridges in Virginia (Figure 18).

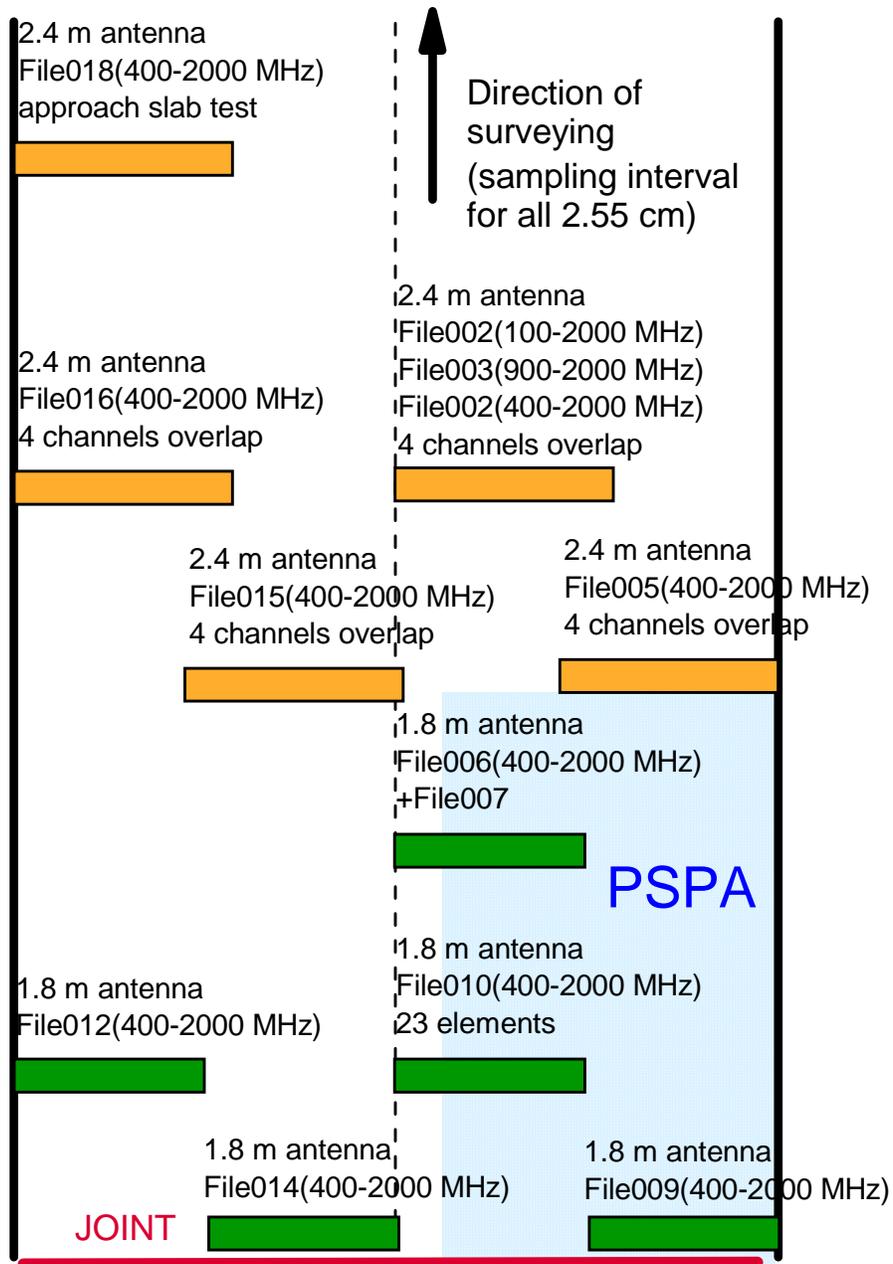
FIGURE 10 Schematic of 3D-GPR and IE (PSPA) surveys on Carter Creek Bridge.

record GPR scans at a distance-based rate of 12 scans per foot for all antennas. The frequency range of antennas used in particular runs, position of antennas, and data file names are given in Figures 10 and 11 for Carter and Van Buren Bridges, respectively. All the 3D-GPR surveys were conducted at a speed of about 1 mile per hour. Bridge deck evaluation by IE was done using Portable Seismic Property Analyzer (PSPA), a device manufactured by Geomedia Research and Development and shown in Figure 9. IE evaluation was done on areas marked in Figures 10 and 11 using a grid of 60x60 cm (2x2 ft).

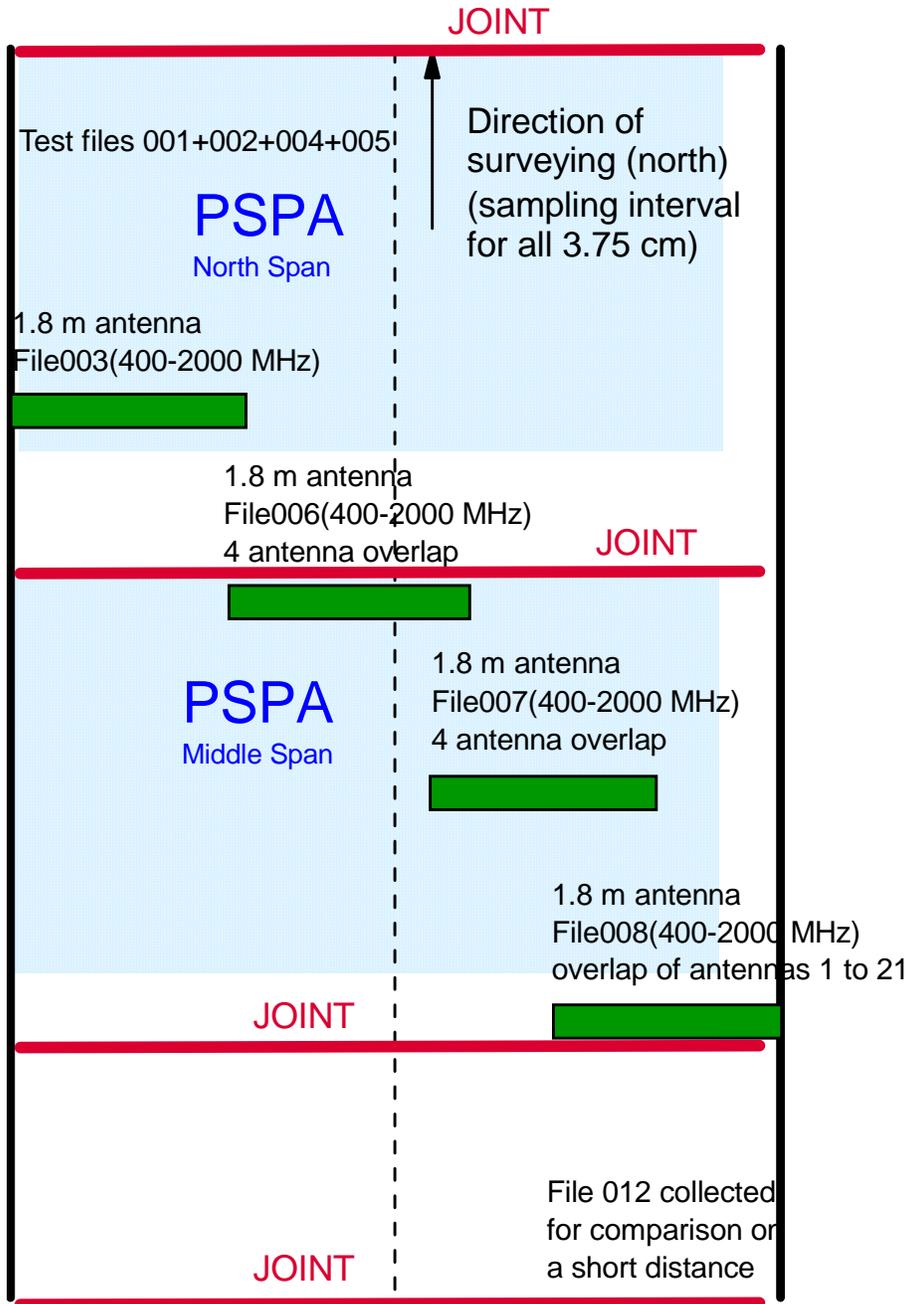
FIGURE 11 Schematic of 3D-GPR and IE (PSPA) surveys on Van Buren Bridge.

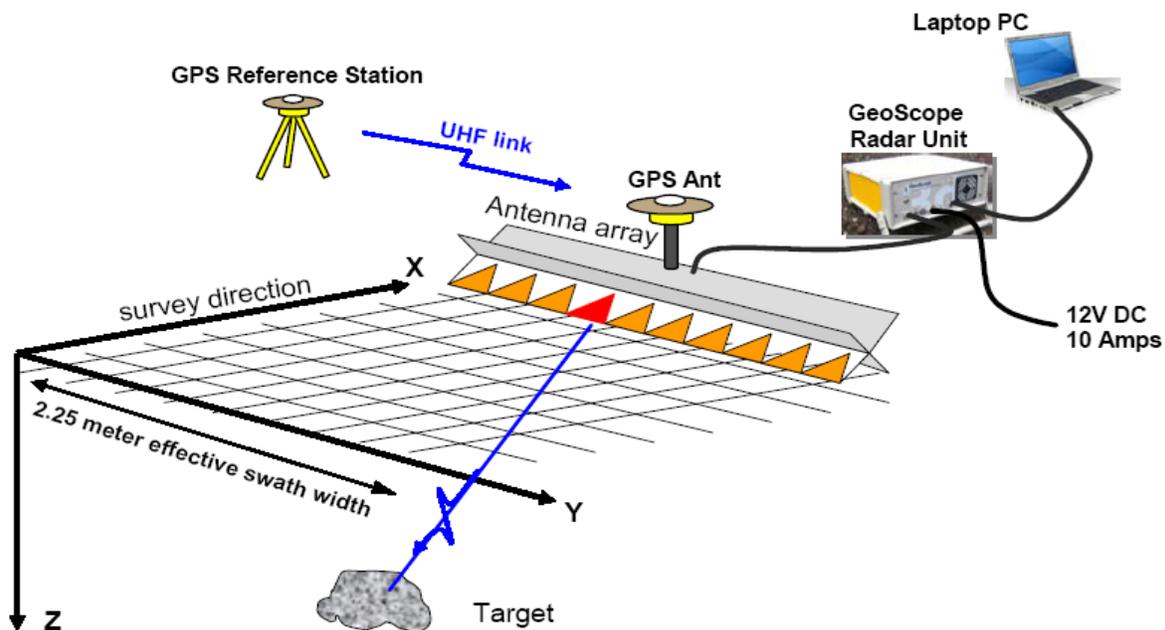
FIGURE 12 3D-GPR setup.

1. GPR setup – The 3D-GPR is attached to the vehicle mounting bracket and to the control unit, GeoScope (typically in the vehicle). The control unit is connected to the control computer, as shown in Figure 12. GeoScope is started, allowed to warm and stabilize and then configured for the survey type. A background and air shot were not

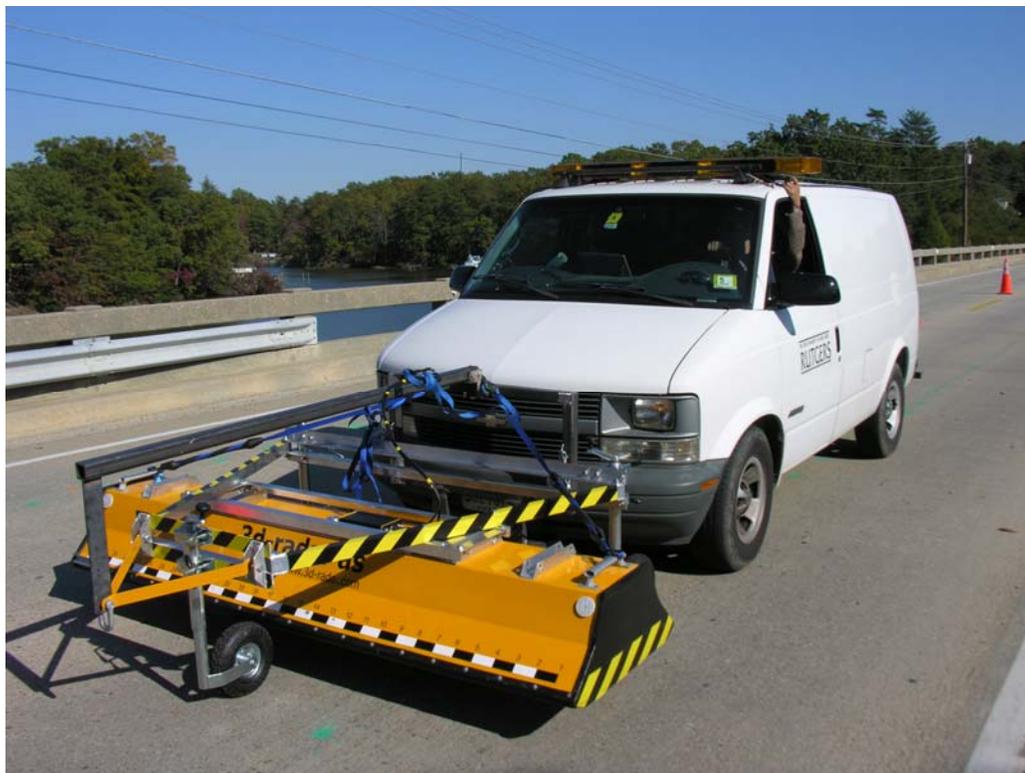
FIGURE 13 3D-GPR survey on Carter Creek Bridge.

2. Data Collection – As the van drives along pre-defined and identified locations on the bridge (Figure 13), a file is collected by the GeoScope. A calibrated distance measuring device is used to trigger capture of a scan at the rate identified during setup. The bridge was surveyed with fixed radar parameters. Therefore each file contains data on all layers to the same depth. Multiple passes with different frequency ranges of antennas were not done during this study.

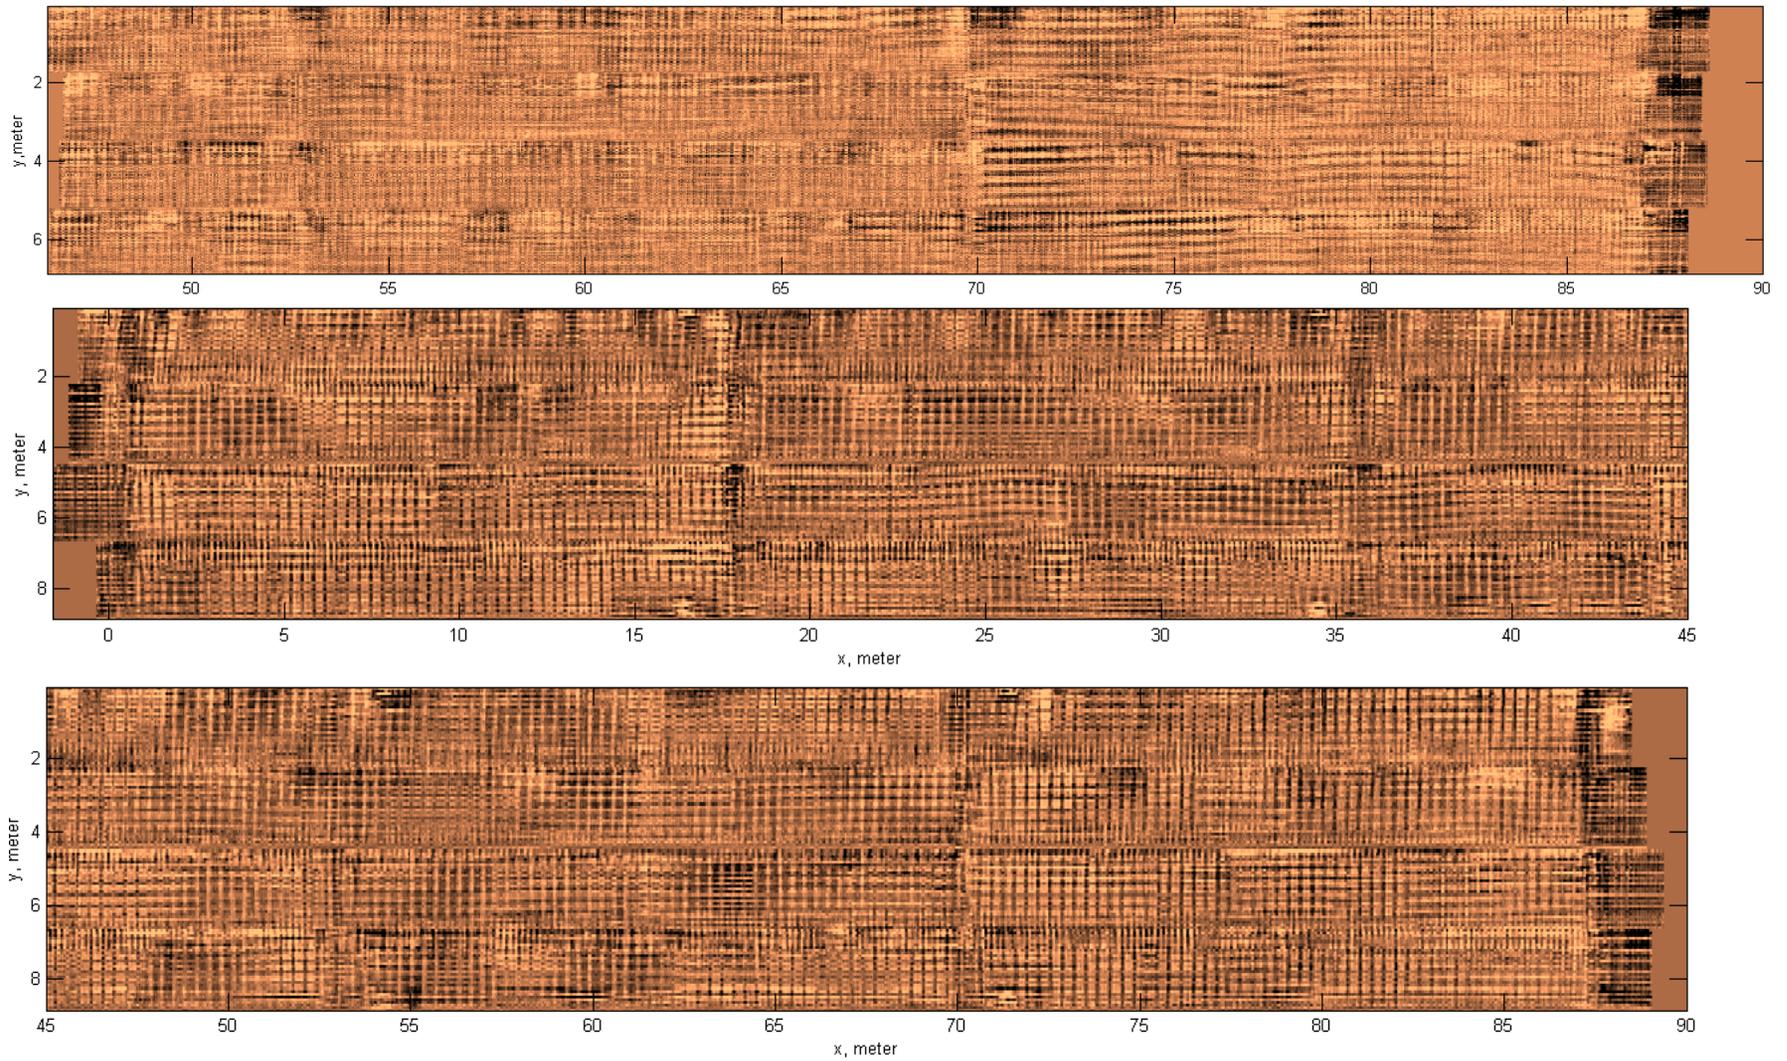
FIGURE 14 Time slices for 11 cm depth of Carter Creek Bridge deck from B1847 (top) and B2431 antenna scans (bottom two).

The first set of images from 3D-GPR data, shown in Figures 14 and 15, is for the Carter Creek Bridge deck. Time slices obtained from data collected using B1847 and B2431

antennas for about 11 cm depth, or approximately top rebar elevation, are shown in Figure 14. Time slices obtained from data collected by the same antenna pair, but for about 31 cm depth, or approximately girder and bracing elevation, are shown in Figure 15. From the comparison of the time slices, it is apparent that the B2431 antenna images are of higher resolution than B1847 images. The second set of 3D-GPR images in Figure 16 is for the Van Buren Bridge deck from the data collected using B1847 antenna. From a comparison with images for the same rebar and girder elevations for the Carter Creek Bridge deck, it is apparent that the Carter Creek Bridge images are sharper. As it will be demonstrated by impact echo results, this is a result of higher deterioration of the Van Buren Bridge deck that caused significantly higher attenuation of the GPR signal.

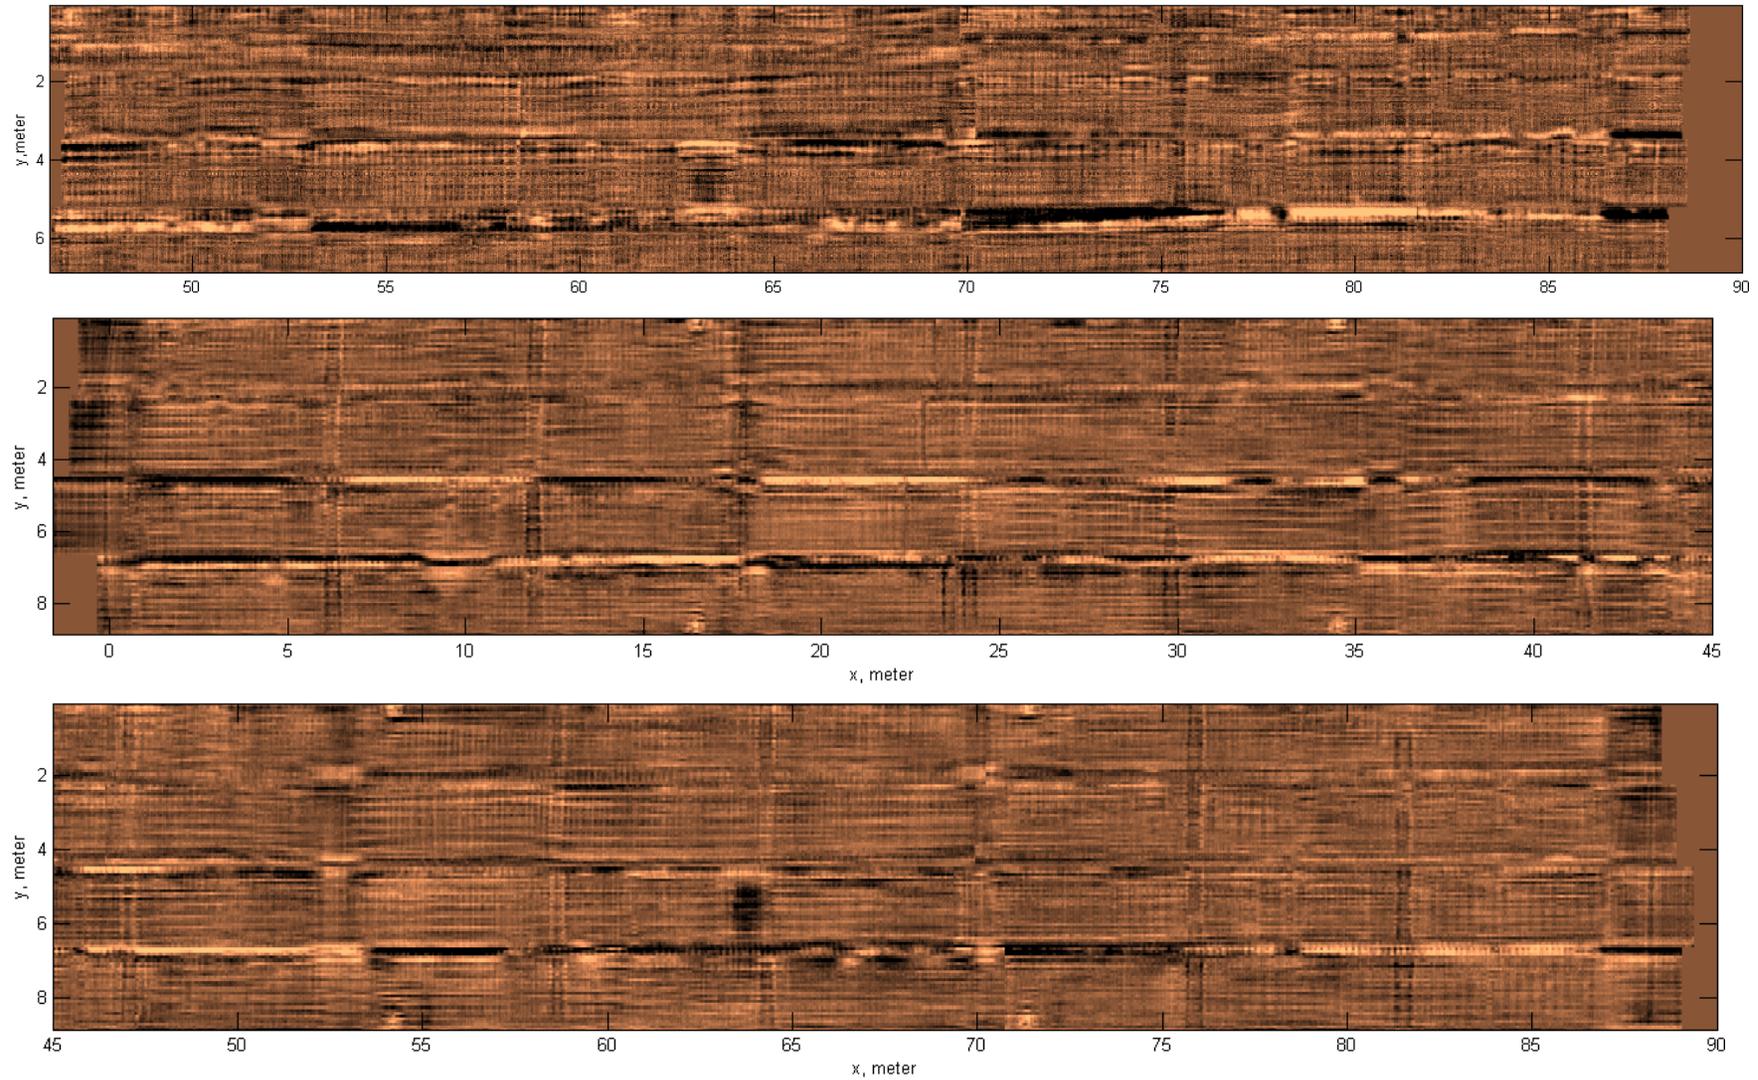
FIGURE 15 Time slices for 31 cm depth of Carter Creek Bridge deck from B1847 (top) and B2431 antenna scans (bottom two).

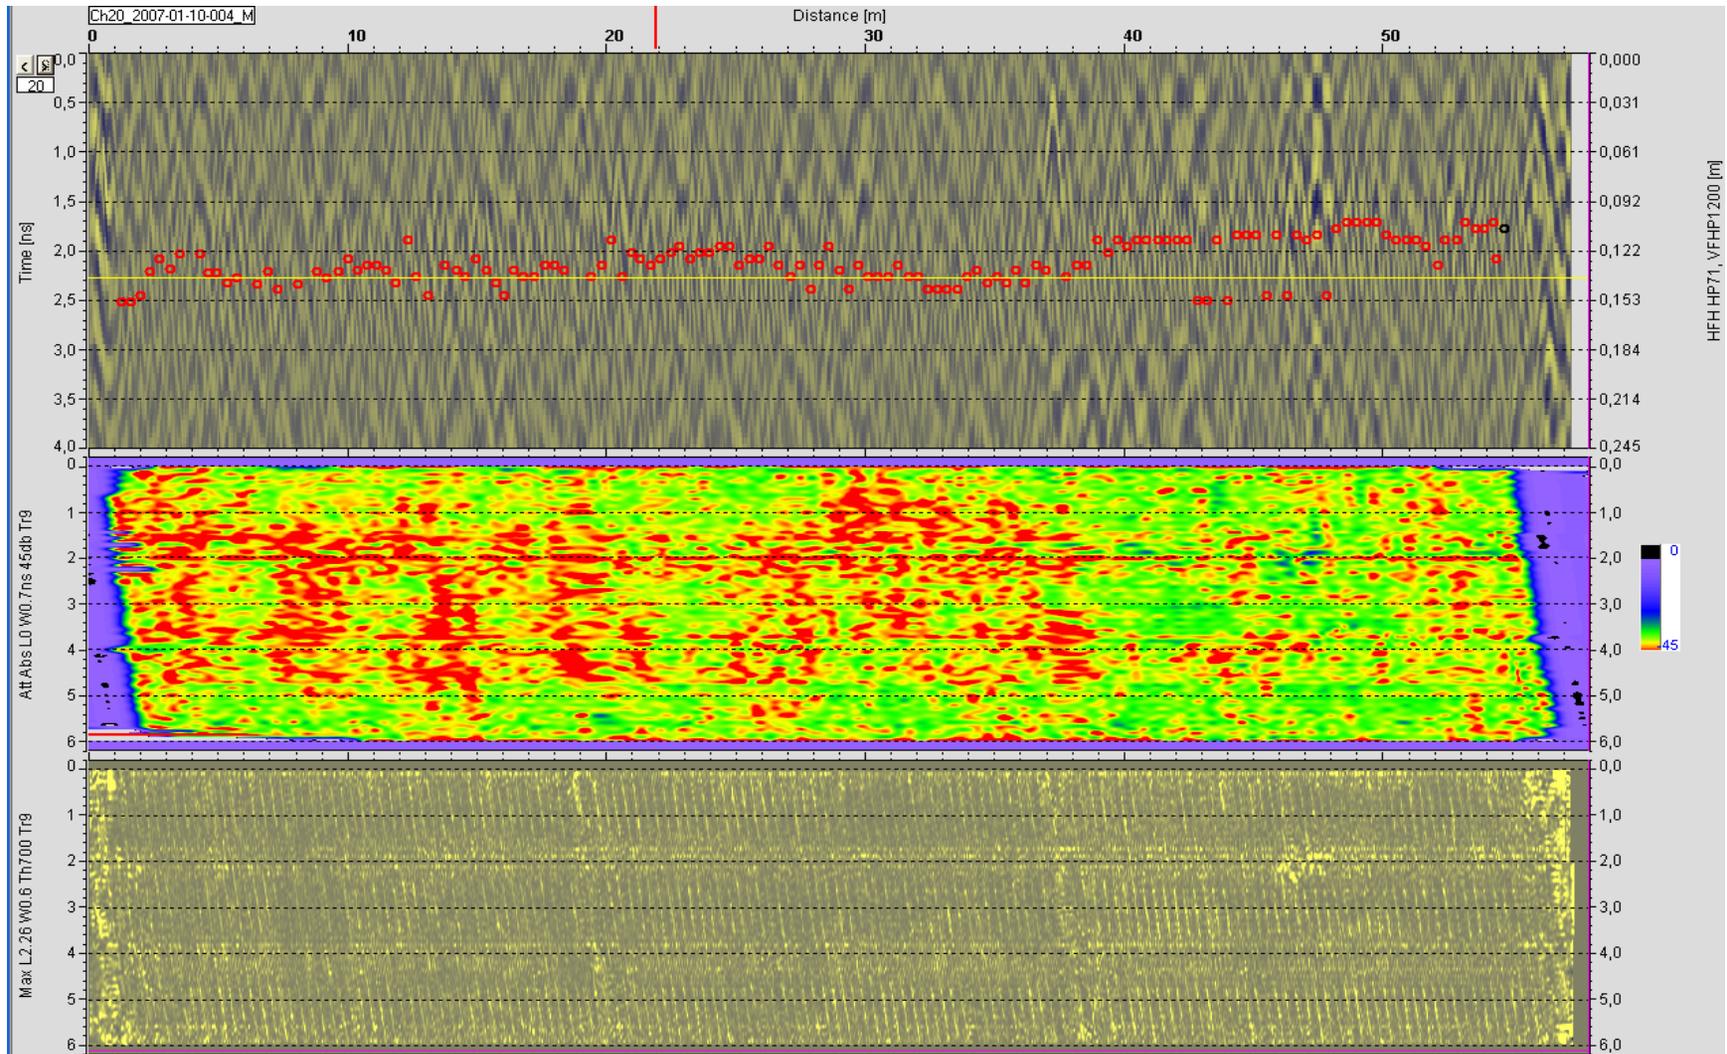
FIGURE 17 B-scan with picked rebars (top), attenuation map (middle) and time slice at 2.2 ns (bottom) for Van buren Bridge deck.

Very commonly, the objective of the use of 3D-GPR in bridge deck evaluation is condition assessment. It is done through evaluation of signal attenuation, or development of deck attenuation maps. Signal attenuation is obtained from evaluation of amplitudes of reflections from rebars, normalized by the amplitude of the signal at the surface of the deck and corrected for the depth of the rebar. A critical part in this process is accurate picking of rebars. An example of an attenuation map is given in Figure 17 for the Van Buren Bridge deck. While it was possible to generate attenuation maps for the tested bridges, the process was not repeatable due inconsistent picking of rebars. This problem should be corrected through improvements on the hardware side (for example increase of antenna frequency on the high frequency end side), improvements on the survey setup side (for example evaluation of the optimum antenna height), and improvements on the software side (most importantly in accurate and automated rebar picking algorithm side).
