**ADVANCED GROUND PENETRATING RADAR DATA
COLLECTION AND IMAGING OF BRIDGE DECKS USING 3-D
RADAR**

**Federal Highway Administration's (FHWA's)
"Advanced Ground Penetrating Radar (GPR) Research Project"**

**Infrastructure Condition Monitoring Program (ICMP)
Center for Advanced Infrastructure and Transportation (CAIT)
Rutgers University**

March 21, 2008

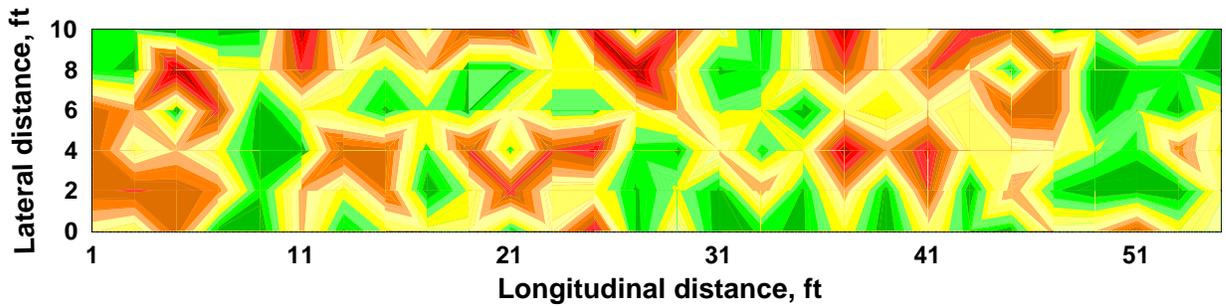
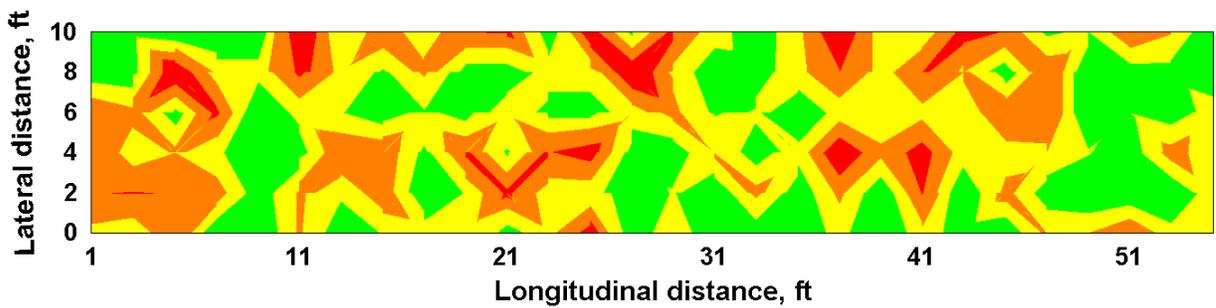
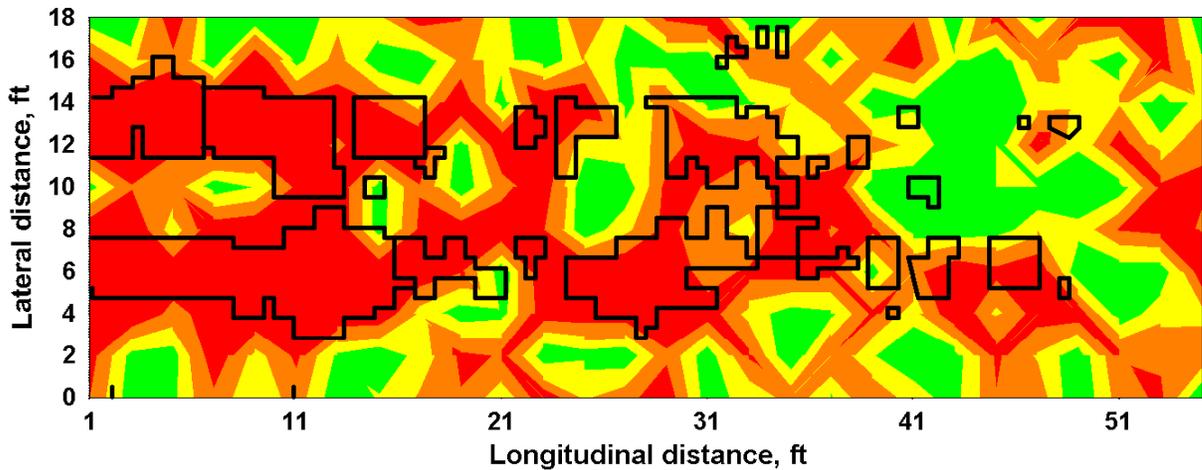
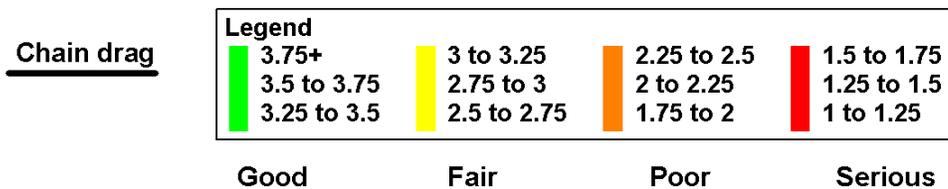
FIGURE 18 Condition assessment maps for Carter Creek Bridge (based on actual test point grades – top, and four condition grades - middle) and Van Buren Bridge (bottom).

Conditions maps for a section of the Carter Creek Bridge deck shown in Figure 10 are plotted in Figure 18. The condition is defined in terms of the actual grades assigned to each test point (top) and four condition grades (middle). As can be observed in the upper condition assessment plot for the Carter Creek Bridge, the deck is in a good condition and only smaller zones of initial and progressed delamination, and minor zones of a deck in a serious condition, can be identified. On the other hand, the bottom condition assessment plot in Figure 18 for Van Buren bridge deck illustrates a deck in a significantly deteriorated condition. Zones of all previously described conditions (grades) can be identified in the condition assessment plot.

The Van Buren Bridge deck was also evaluated by chain dragging. Results of IE testing were compared to those of the chain drag in the same figure. The comparison points to similarity of the two approaches in detection of areas with progressed delamination (poor to serious condition). The ability of the chain drag to identify zones in a serious condition can be explained by the fact that the frequency response in such cases is in the audible range. On the other hand, the most of the zones identified by IE as zones of initial delamination (fair to poor grades) were not detected by the chain drag. This ability to detect signs of initial delamination represents a significant advantage of IE (seismic ultrasonic testing) over the chain drag approach. It allows more accurate definition of boundaries of delaminated zones, better prediction of delamination progression, and leads to better assessment and timing for implementation of rehabilitation measures

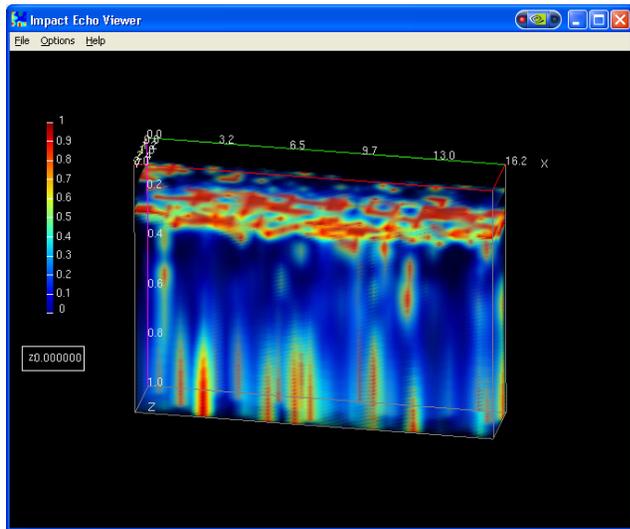
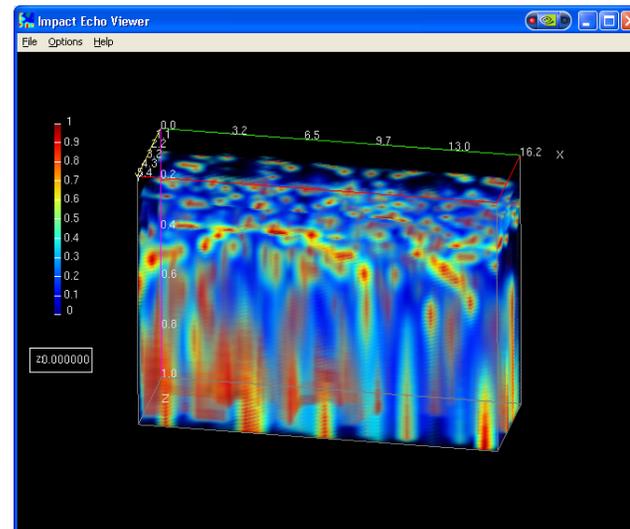
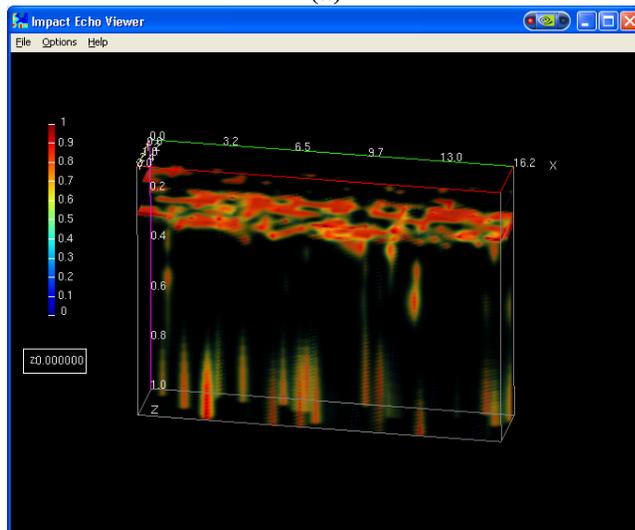
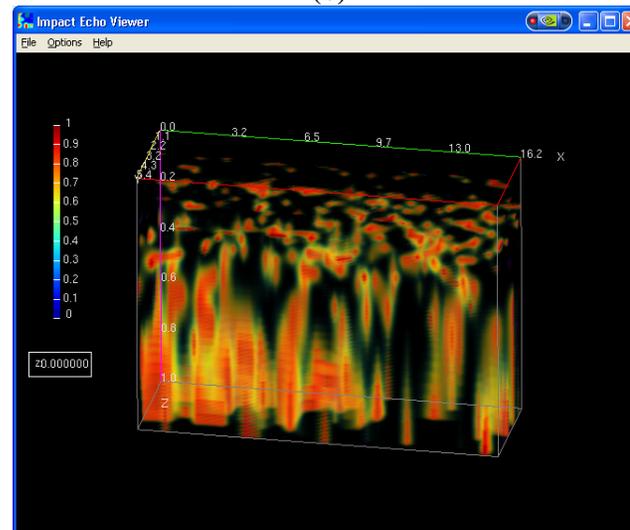
FIGURE 19 Interactive visualization of IE data. Carter Creek Bridge (a) (c), Van Buren Bridge (b) and (d).

3D visualization images of IE data for the two bridge decks were developed. Similar to the observations in the previous section, in the visualizations provided in Figure 19 it can be noticed that the Carter Creek Bridge deck, visualized in 19a and 19c is in a reasonably good condition. Primary reflections for that bridge are coming from the bottom of the deck. In contrast, the Van Buren Bridge, visualized in Figures 19b and 19d, has a large number of reflections throughout the volume, indicating a highly deteriorated condition.

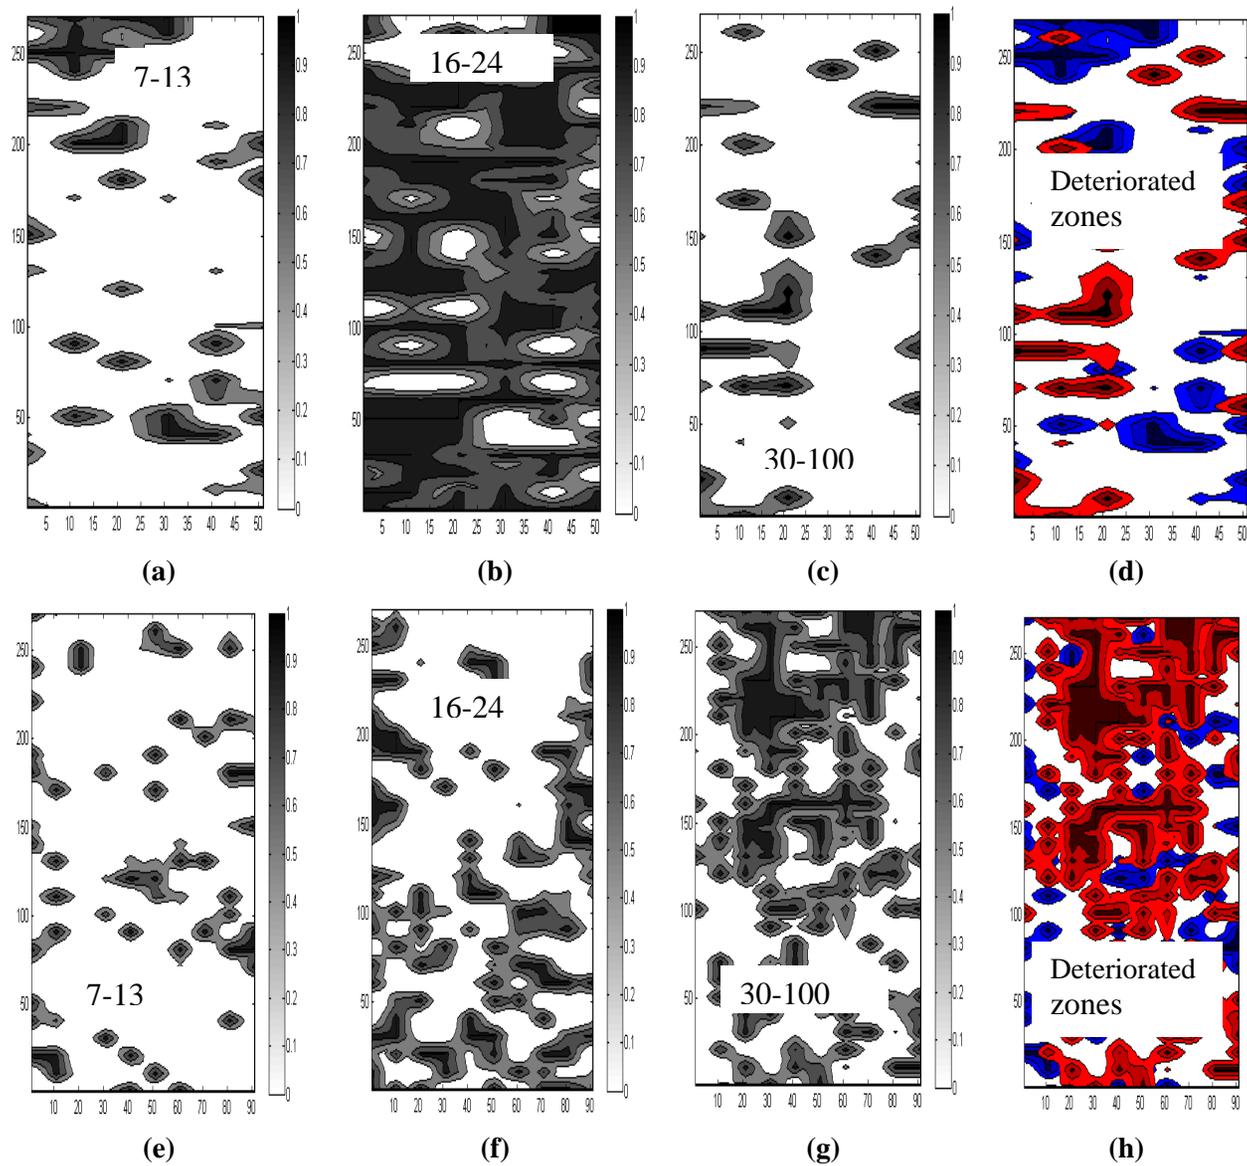
FIGURE 20. Plan view contour plots for deck repair. Top: Carter Creek Bridge, Bottom: Van Buren Bridge. Left to right: maximum reflectance in the “delamination zone” slice (7-13 cm) (a)(e), “bottom of the deck” slice (16-24 cm)(b)(f), and in the “apparent deep reflector” zone (30-100 cm)(c)(g). Identified deteriorated zones (d) and (h) (red - serious condition, blue – fair to poor condition).

From the practical point, of highest interest and benefit is identification of zones on the deck that are in serious condition (progressed delamination) or fair to poor condition (initial delamination). The process of identification of such zones is illustrated in Figure 20. Initial delamination (fair to poor conditions) is primarily identified by medium to strong reflections at the depth corresponding to the position of the top rebars. This is illustrated in Figures 18a and 18e for Carter Creek and Van Buren bridges, respectively, with strong reflection maps for slices between 7 and 13 cm. Similarly, sound zones of the deck are identified by strong reflections from the bottom of the deck, or in this case described by slices between 16 and 24 cm depth in Figures 20b and 20f. Finally, progressed delamination (serious condition) can be described by strong reflection maps for the slice for the depth deeper than the depth of the bottom of the deck. This is illustrated by the strong reflection maps for slices between 30 cm and 1 m in Figures 20c and 20g. To obtain the map of zones candidates for repair, the map for serious condition is superimposed on the map of initial delamination, as e.g. repair map in Figure 20d is obtained from the map in Figure 20c superimposed on the map in Figure 20a.
